LEVEL 1

Your survey report

L1 Example Street, London, SW

17th October 2022

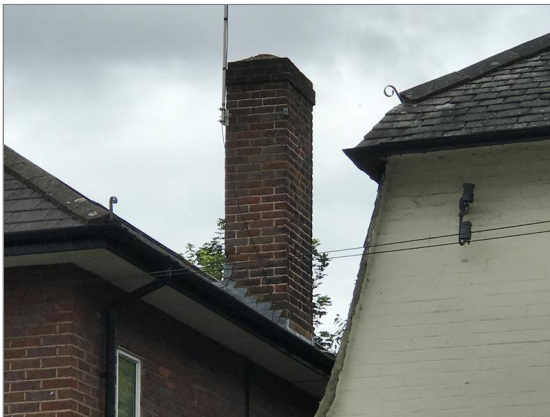
Slight frost damage and minor pointing repairs were noted to the brickwork of both stacks and these structures will require repair within the next 5 years. The flashings weathering the base of the stacks are of lead. No failure of these flashings was noted.

Photo - 4 Chimney stack located to right hand side of property.

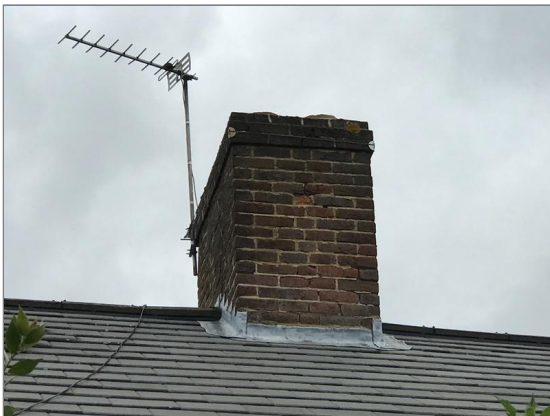
Photo - 6 Frost damage and failure of pointing to main chimney stack.

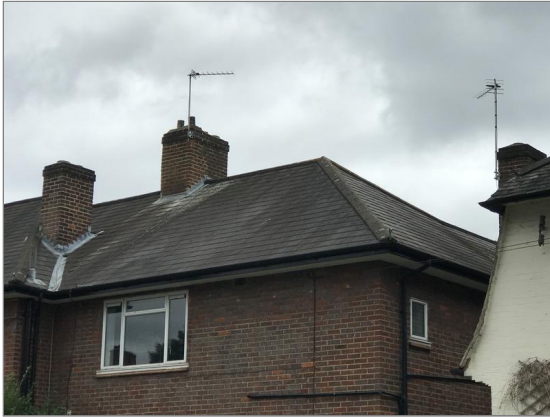
The property features a pitched timber framed roof and this roof has been clad with slate. These roof coverings look to have been renewed in the last 20 years. No failure of the slates was identified and renewal of these roof coverings should not be required for the next 20 years.

Photo - 7 Front pitched roof coverings.

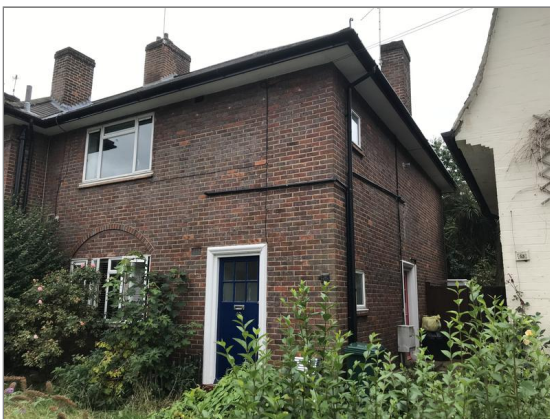
Photo - 9 Rainwater guttering running around main roof.

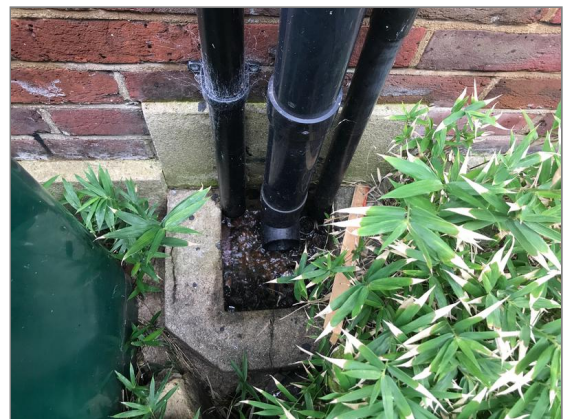
Photo - 10 Build up of debris in open gully.

Surface gullies run around the outside of the property and these elements should be cleared. These gullies run to an inspection chamber in the front garden. No visual defects were identified with the drainage and no damage was noted to the cast iron inspection chamber covers.

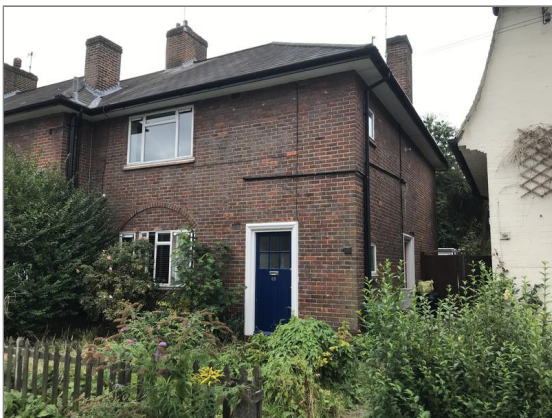
Patch brickwork repair has been carried out to the external walls in the past, however, no areas of cracking and/or current wants of repair were identified. We have no concerns regarding the structural stability of the property.

Photo - 12 External brickwork walls.

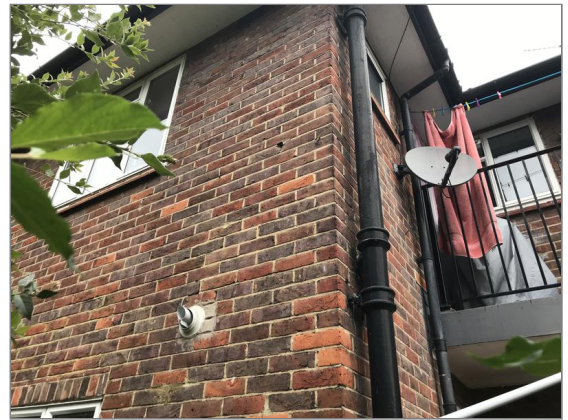
Photo - 15 Brickwork at rear of dwelling.

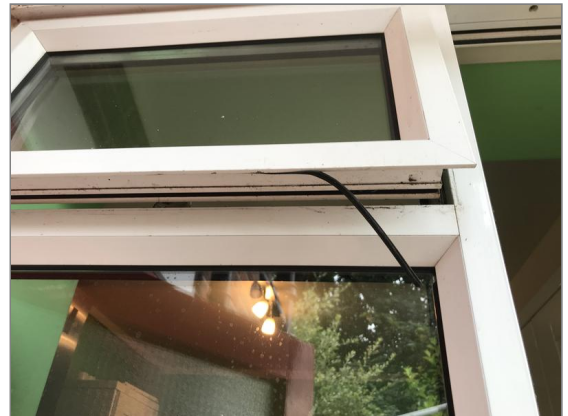
Photo - 17 Loose gasket to kitchen windows.

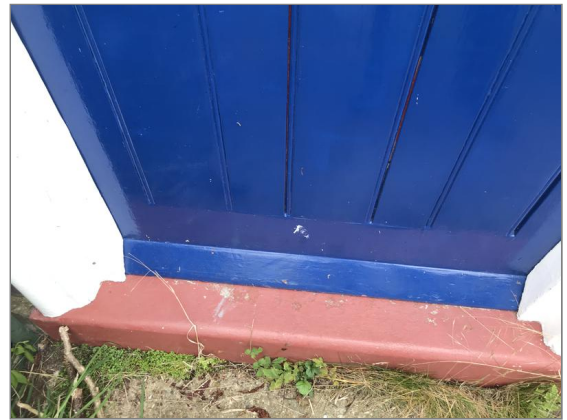
The front door is a timber door set featuring Georgian wired glass. A failure of the decorations to the door frame was identified and these surfaces require redecoration. The door is fitted with a basic night latch and key operated bolt. A new owner may wish to replace these fittings with higher-security furniture.

Photo - 24 Decorative condition of front door.

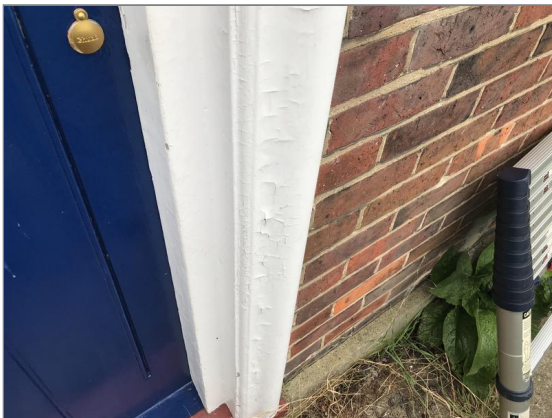
Photo - 25 Failure of decorations to door frame.

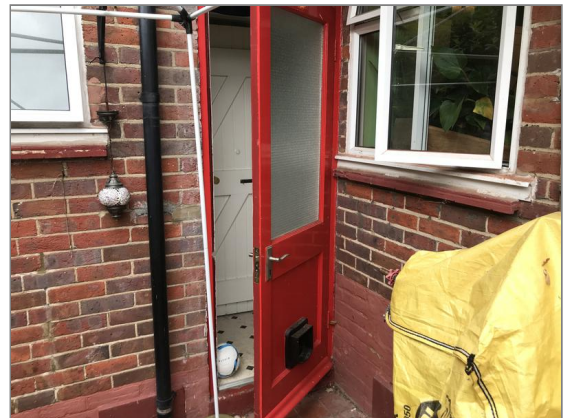
A half glazed timber door leads out from the rear of the property. This door is fitted with a simple five lever latch and this furniture offers a low level of security. The decorations to the door are also slightly tired, however, no significant wants of repair were identified.

Photo - 26 Rear garden door.

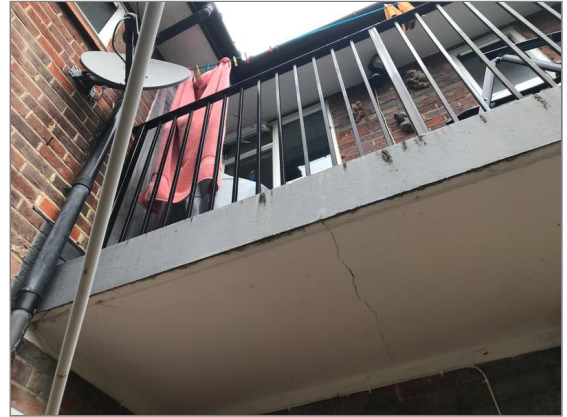
The high level fascias and soffits are in fair decorative condition with no current wants of repair. There is a walkway to the rear of the property. The decorations to the underside of this walkway are beginning to fail and these would benefit from renewal in the next 2-3 years.

Photo - 30 Failure of decorations to walkway at rear of property.

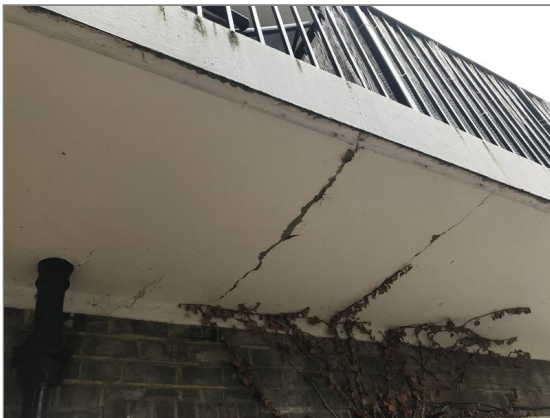
Photo - 31 Failure of decorations to walkway at rear of property.

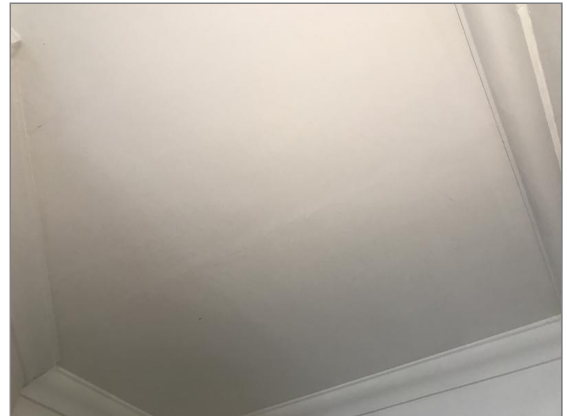
In general, the ceilings are in slightly tired decorative condition and minor areas of cracking were identified to these surfaces. This cracking is not of concern and it can be made good when the ceilings are next redecorated. Otherwise, no significant wants of repair were identified.

Photo - 33 Minor cracking to hallway ceiling.

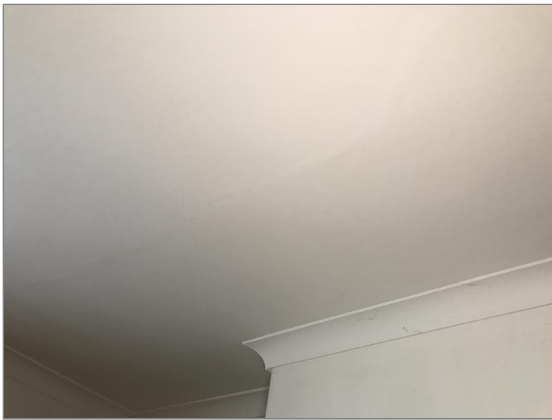
Photo - 34 Minor cracking to living room ceiling.

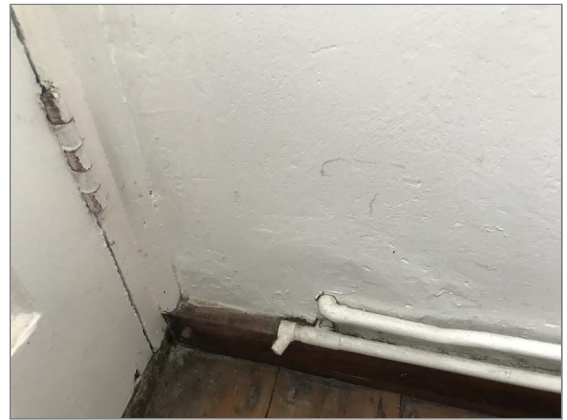
Areas of uneven and live plaster were noted in the entrance hallway. This is not of concern and can be made good when the surface is next redecorated.

Photo - 42 Live area of plaster in entrance hallway.

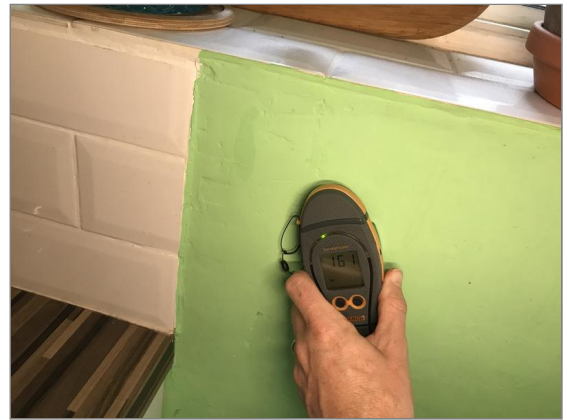
Slight unevenness was identified to the wall surfaces in the kitchen. Elevated damp meter readings were also recorded to the external facing walls in this area. Our readings are consistent with high humidity in this space and we recommend a single room heat recovery fan is fitted. The walls in contact with the kitchen worktop have been tiled and these tiled surfaces are in fair condition.

Photo - 54 Damp meter testing to kitchen walls.

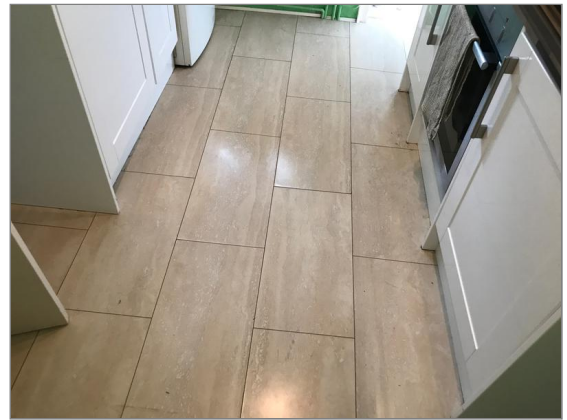
The WC floor has been laid with sheet vinyl and this is in fair condition. The kitchen features a laminate floor and this would benefit from renewal. The adjacent bathroom floor has been fully tiled. Cracking was identified to some of the tiles and these elements require replacement to resolve.

Photo - 69 Kitchen floor.

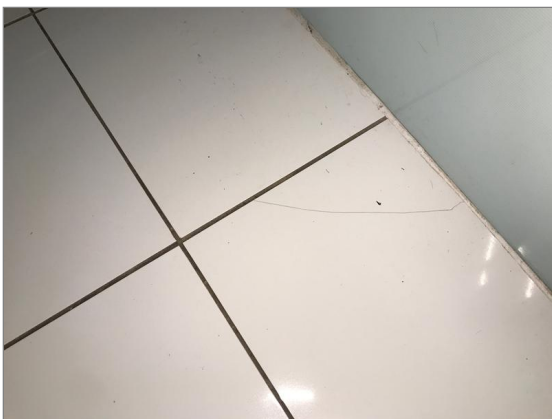
Photo - 72 Cracking to bathroom tiling.

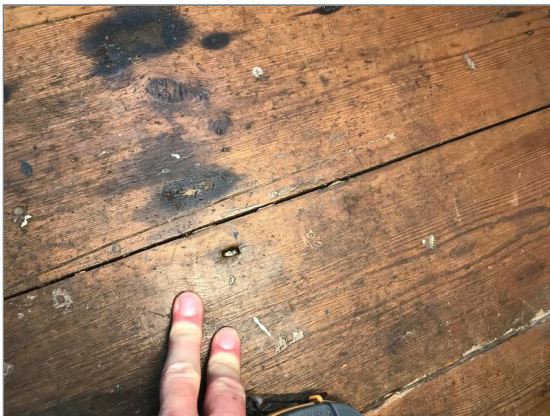
Exposed timber floorboards are present in the bedroom, living area and entrance hallway. Loose floorboards were identified adjacent to the entrance hallway (which a new owner may wish to have fixed down) and slight scuffing was found to the clear finish of these elements (which would benefit from being sanded down and resealed).

Photo - 76 Loose floorboard in entrance hallway.

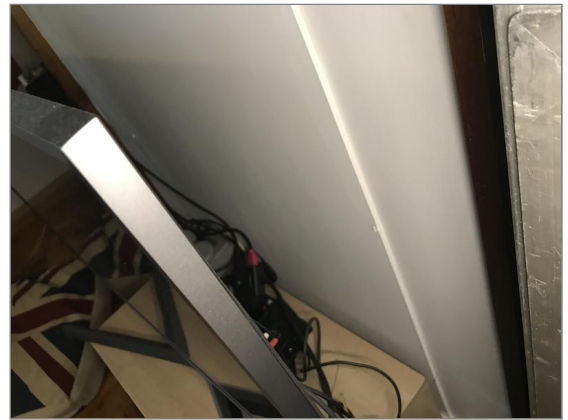
The front sitting room fireplace has been boarded over. No flue vent has been provided to this structure and we recommend that one is fitted. The hearth is of exposed concrete and a new owner may wish to have this painted or tiled.

Photo - 79 Front sitting room fireplace boarded over.

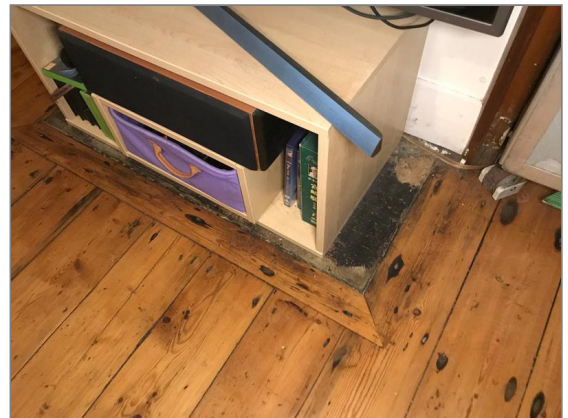
Photo - 81 Hearth to front sitting room fireplace.

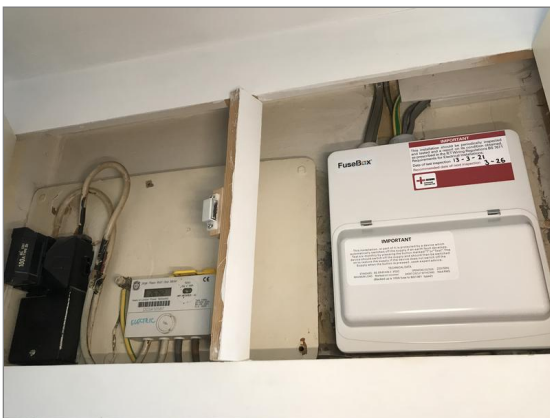
The electricity meter and distribution board are located adjacent to the front door. The property features an RCD protected distribution board. The electrical fittings are dated and they would benefit from renewal. Otherwise, no visual defects were identified with this service. The most recent test certificate for this installation should be sought.

Photo - 102 Electricity meter and distribution board.

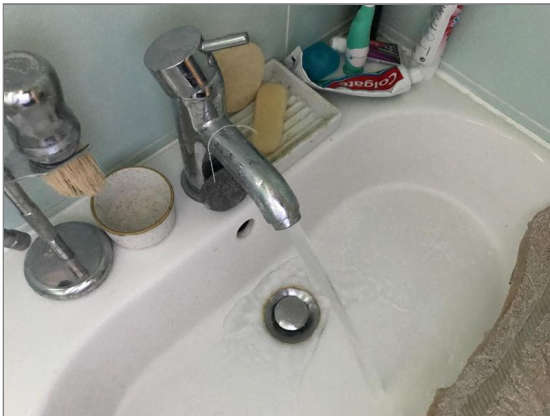
Water is supplied under direct mains pressure. We tested the flow of cold water by opening one and then two outlets and a significant drop in supply pressure was found on opening the second outlet. Despite this, the water pressure is sufficient for a dwelling of this size. The location of the cold water isolation valve should be confirmed by the vendor.

Photo - 106 Testing cold water supply with one outlet open.

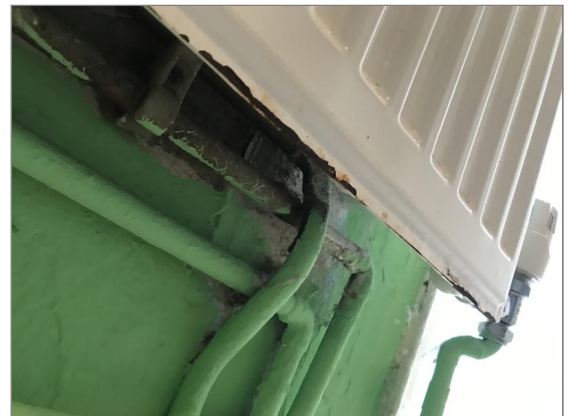
The property is heated by a gas fired combination boiler which is located in the rear WC. This element is nearing the end of its life and rust was identified to some of the radiators. The radiators and boiler will likely require renewal in the next 2-3 years.

Photo - 109 Rust to kitchen radiator.

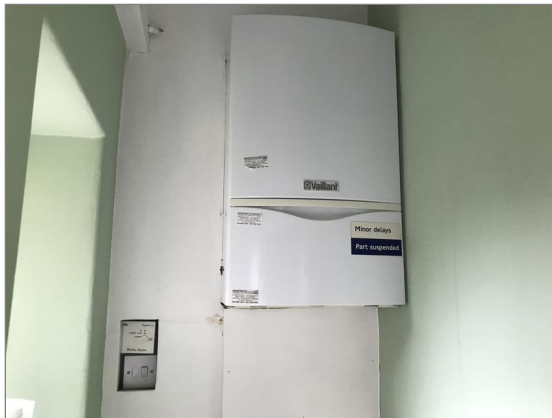
Photo - 110 Combination boiler.

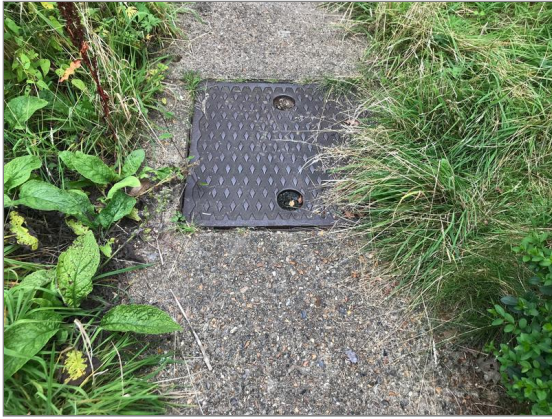
Photo - 114 Inspection chamber in front garden.

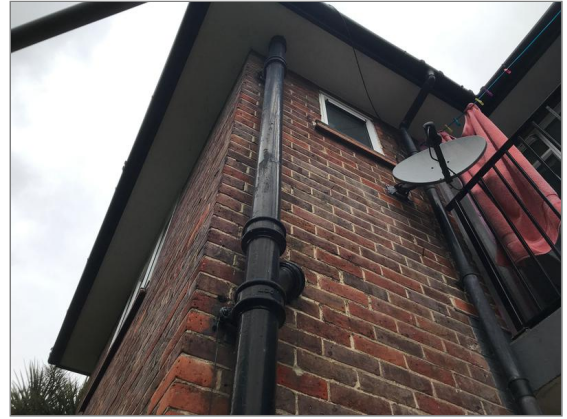
The drainage system is original to the date of construction of the property. The drainage is connected to a cast iron soil stack at the rear of the property. Based upon the age of the pipe, renewal (with a uPVC stack) will likely be required within the next 3 years. No evidence of leaking was found during the inspection.

Photo - 115 Cast iron soil stack at rear of property.

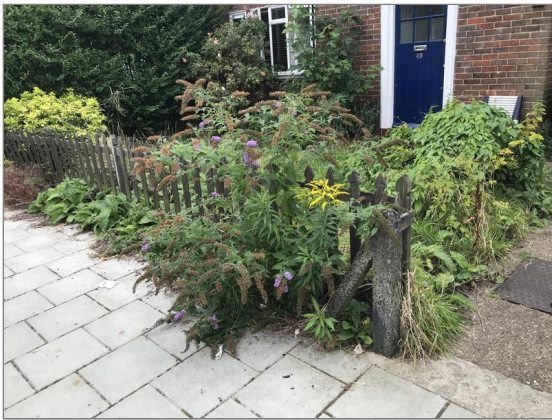
The grounds to the property are overgrown and a new owner will likely wish to have these plants cut back. The front garden is bordered by a low timber fence and this element is tired. In addition, cracking has developed to the oversite concrete path running around the front and side of the dwelling. (2)

Photo - 118 Front garden.

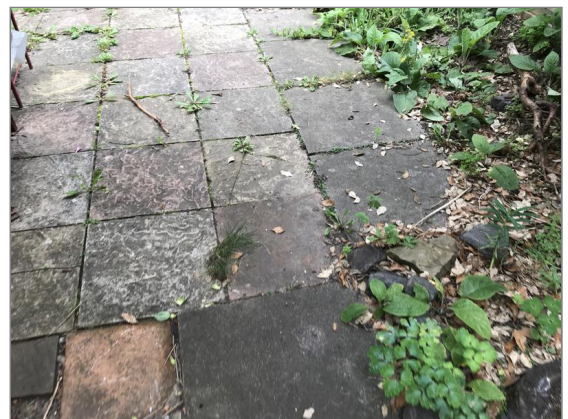
The rear garden has been inexpertly paved and the paving does not look to have been laid onto a suitable sub base. This will require relaying of the paving to resolve. There is a timber shed to the rear of the garden. The roof covering to this shed has failed and this structure requires renewal. The fencing in the rear garden would also benefit from repair. An area of orange quarry tiling is found to the rear of the dwelling. This tiling would benefit from being relaid.

Photo - 123 Paving in rear garden.

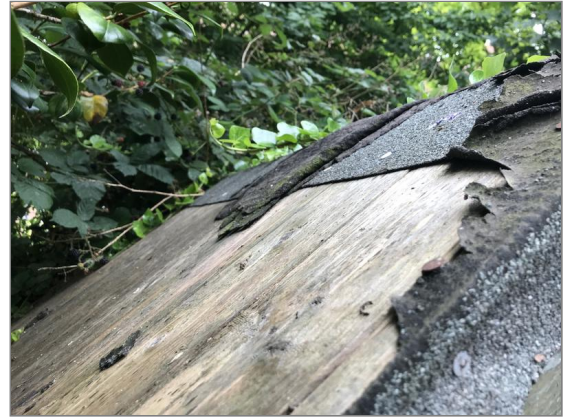
Photo - 125 Failed roof coverings to shed.
