# Your survey report

L2 Example Street, London, SW

17th October 2022

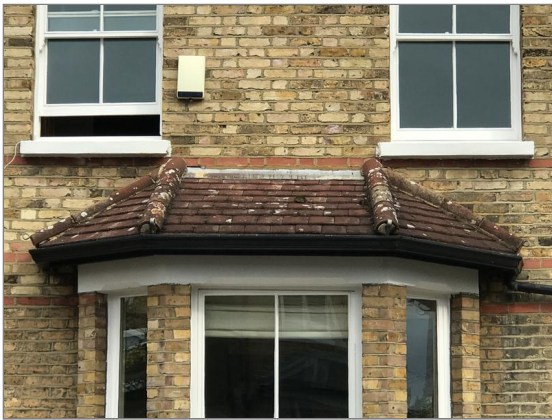
The front bay has been covered with plain tiles. Whilst the tiles are tired, no failure of these elements was noted. The ridges feature half round ridge tiles laid onto a bed of mortar. The mortar is cracking and failing and re-bedding of the ridge tiles will be required within the next 2-3 years. The abutments between the roof coverings and adjacent walls have been weathered with lead flashings. Sections of the pointing, which supports the flashings, are failing and these areas require repair.

*Photo - 9 Plain tiles to bay roof.*

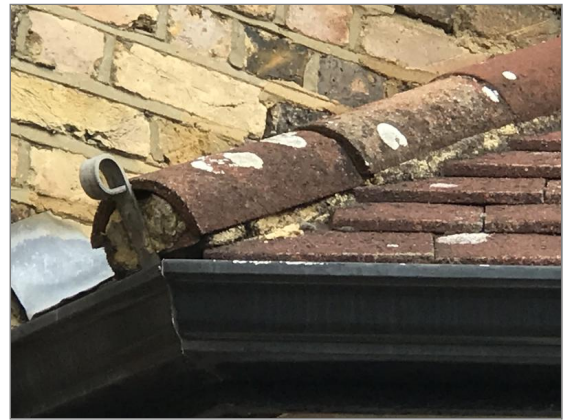
*Photo - 10 Failure of mortar below ridge tiles.*

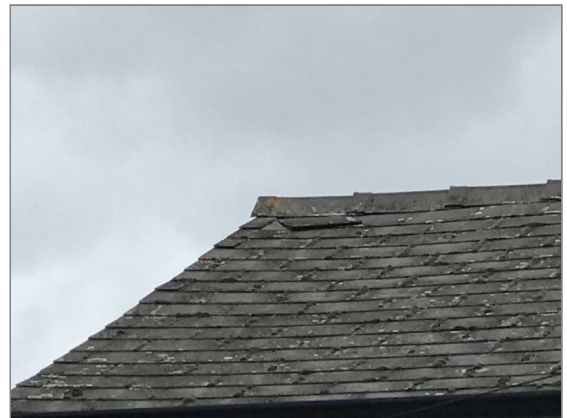
The main pitched roof has been clad with manmade slate. We noted one loose slate to the front pitched roof and this requires re-fixing. Overall, these roof coverings are nearing the end of their life and should be renewed within the next 5 years. The flashings weathering the abutment of the roof and the parapet walls should also be renewed at that time.

*Photo - 12 Loose slate to front pitched roof.*

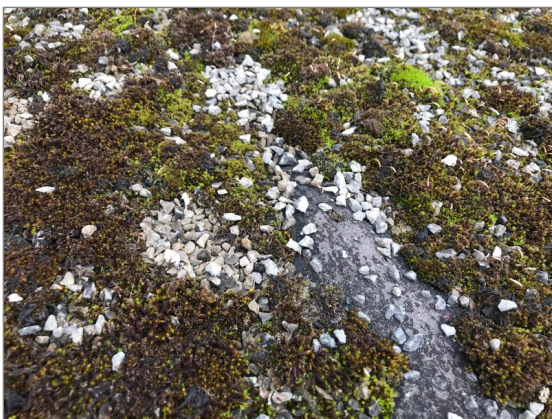
The flat roofs above the ground floor extension and first floor extension have been covered with felt. These felt roof coverings have reached the end of their life and they will require renewal within the next 12 months. During the internal inspection, evidence of water penetration into the bathroom and first floor landing was found due to a failure of these elements.

*Photo - 19 Failure of felt to ground floor extension roof.*

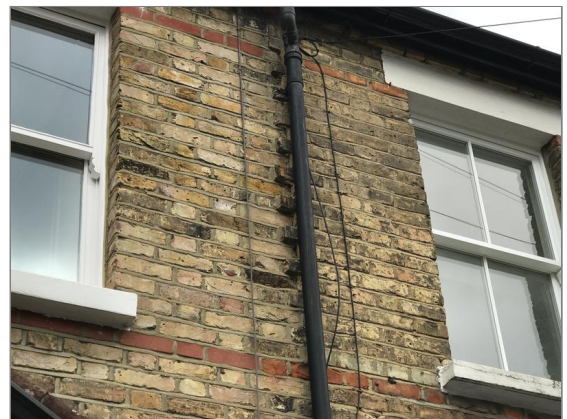
The walls at the front elevation of the property look to have been partially rebuilt. The works have included rebuilding the face of the property at first floor level and reconstruction of the bay. There has been subsidence to the bay in the past (as evidenced by deflection of the heads of the windows), however, no current cracking was identified during the survey (which would indicate progressive structural movement of the bay).

*Photo - 29 Repaired brickwork to the front elevation.*

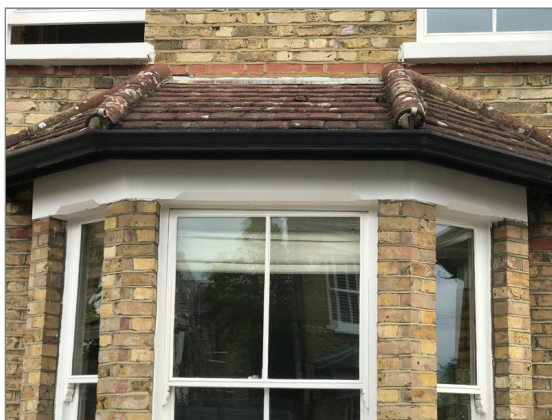
Evidence of subsidence was identified to the bay at the front of the property and internal cracking above this structure was also observed. Further internal cracking was found to the rear corner of the property. These areas should be monitored for any further movement and repaired as required.

*Photo - 30 Slight deflection of bay structure.*

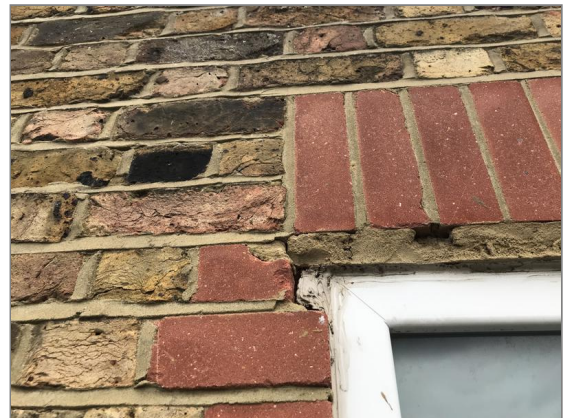
*Photo - 35 Minor repair required to rear bathroom walls.*

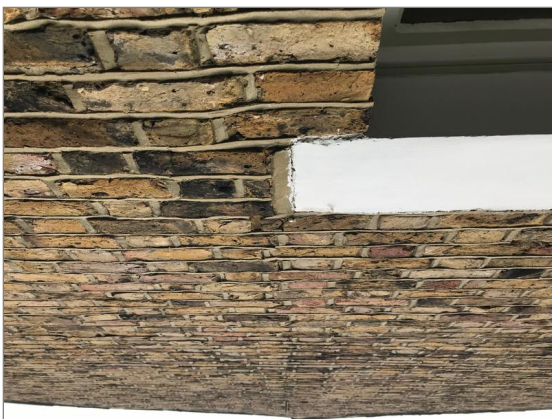
The flank wall to the left hand side of the property features exposed yellow London stock brickwork. Slight cracking was noted above the front door. This has resulted due to normal seasonal movement of the building and whilst it is not of concern, minor repair of the brickwork is required. Minor frost damage was also observed to some of the red bricks at the side of the property. This can be made good as part of the normal maintenance of the building.

*Photo - 36 Cracking above front door.*

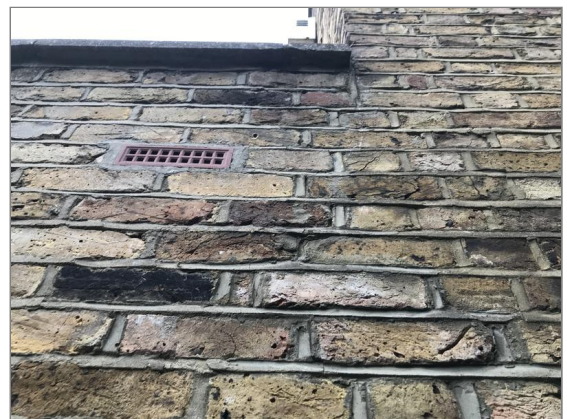
Minor cracking was evidenced at the abutment of the rear addition and the rear part of the property. This has resulted due to differential movement between these two structures. Minor pointing repairs are required to resolve the cracking. Otherwise, no structural wants of repair were identified with these walls. The rear addition walls feature a damp proof membrane located two bricks above ground level (in accordance with good practice).

*Photo - 37 Cracking at abutment of rear addition and original part of the property.*

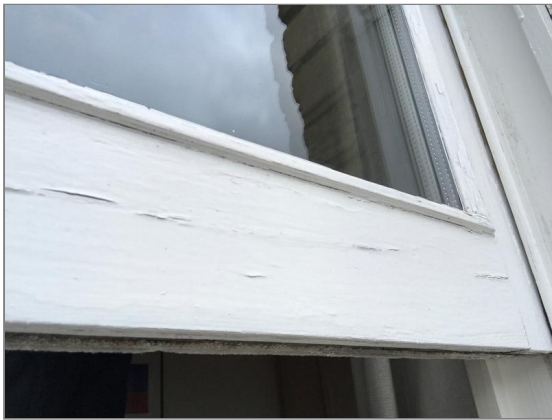
*Photo - 45 Failure of decoration to front bedroom window.*

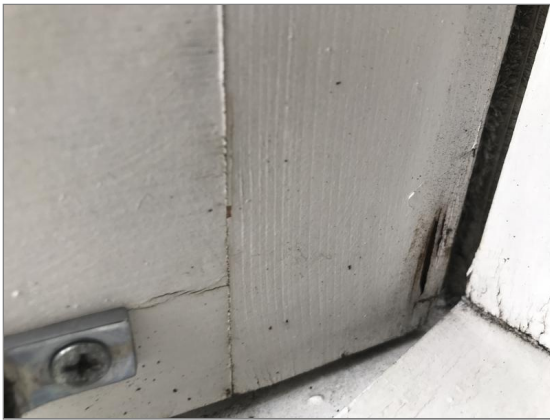
The first floor landing features a timber framed double glazed casement window. The decorations to this window have failed and minor timber decay was found to the frame. This window requires redecoration and repair within the next 12 months.

*Photo - 51 Slight decay to landing window.*

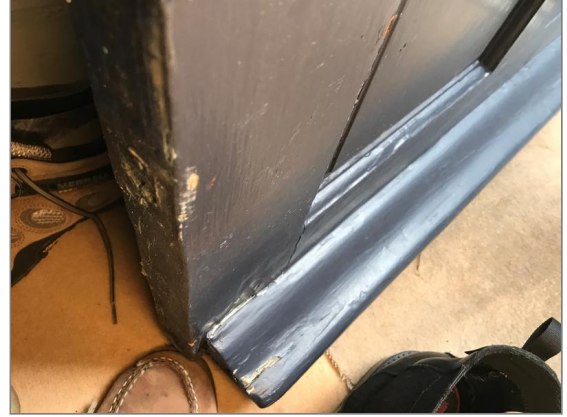
*Photo - 63 Minor damage to decorations of front door.*

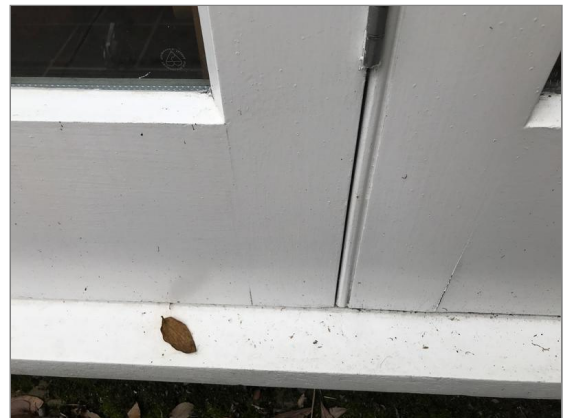
*Photo - 67 Condition of folding doors.*

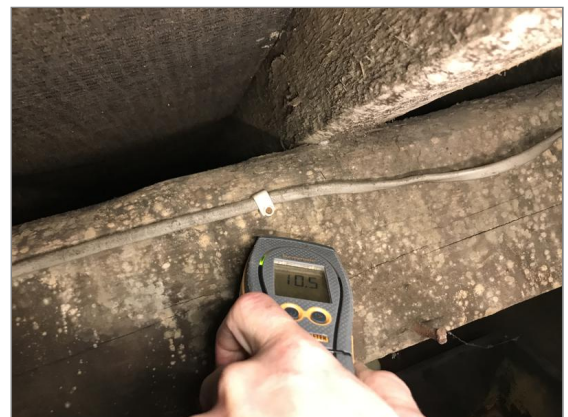
Photo - 79 Damage to roof timbers.

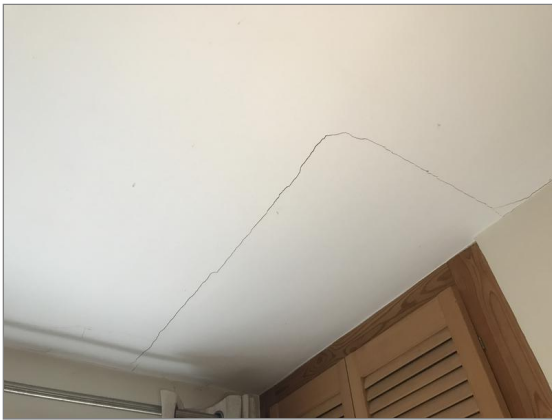
*Photo - 82 Cracking to the bedroom ceiling.*

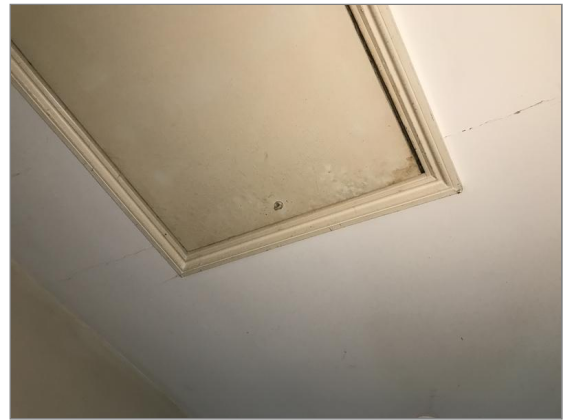
*Photo - 83 Cracking to the landing ceiling.*

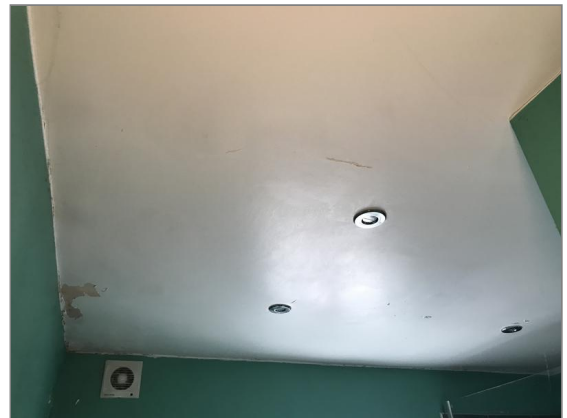
*Photo - 85 Humidity damage to bathroom ceiling.*

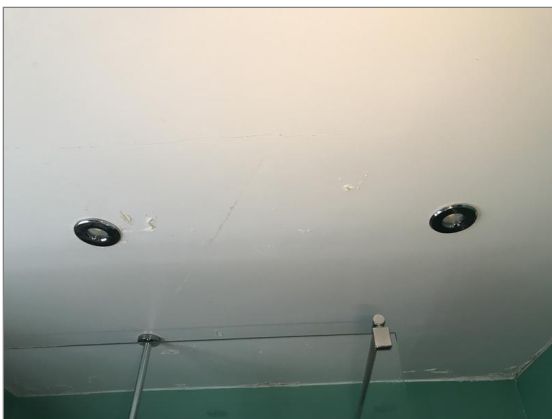
*Photo - 86 Humidity damage to bathroom ceiling.*

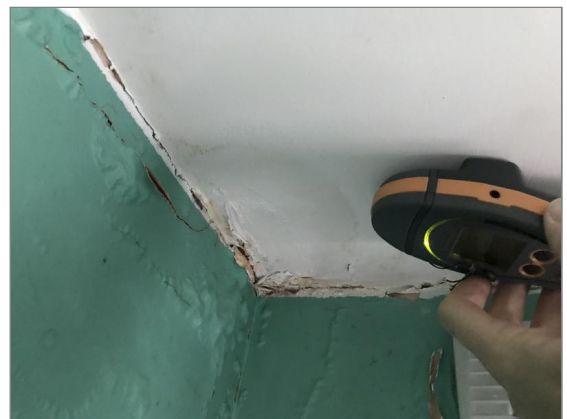
*Photo - 87 Water penetration damage to bathroom ceiling.*

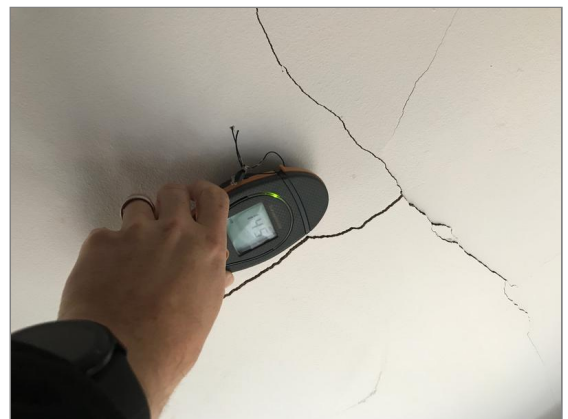
*Photo - 93 Damage to kitchen ceiling.*

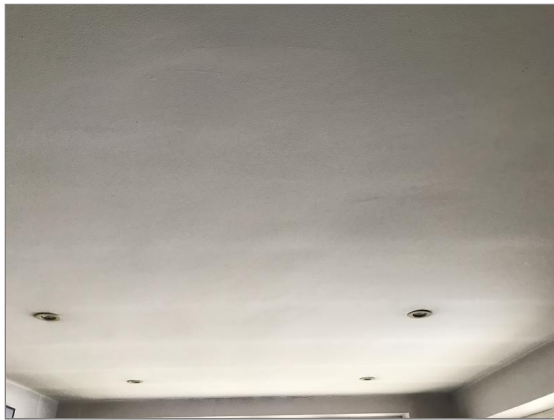
Photo - 94 Thermal shadowing to rear addition ceiling.

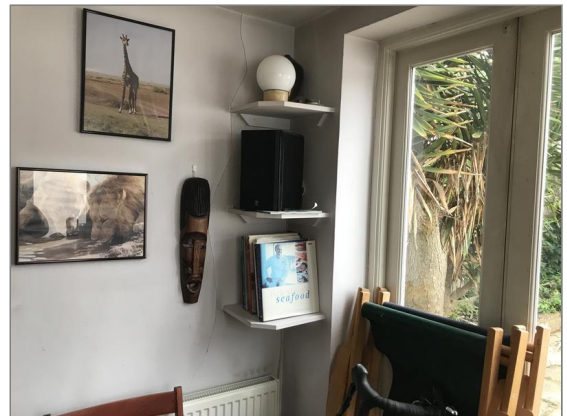
*Photo - 98 Cracking to dining area walls.*

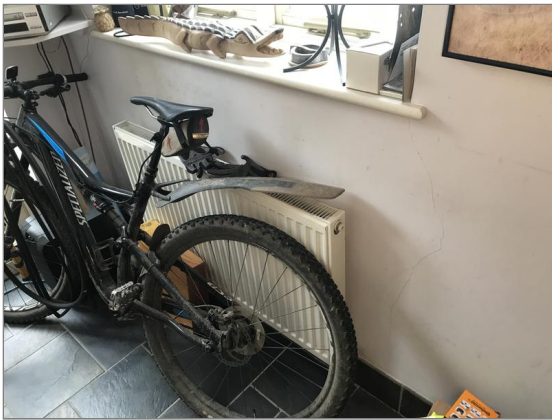
Photo - 99 Cracking to dining area walls.

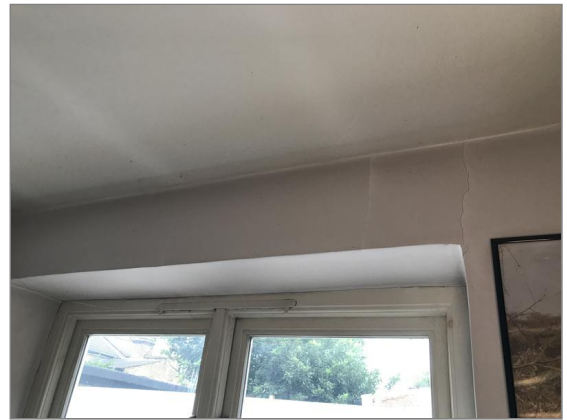
Photo - 100 Humidity damage to kitchen walls.

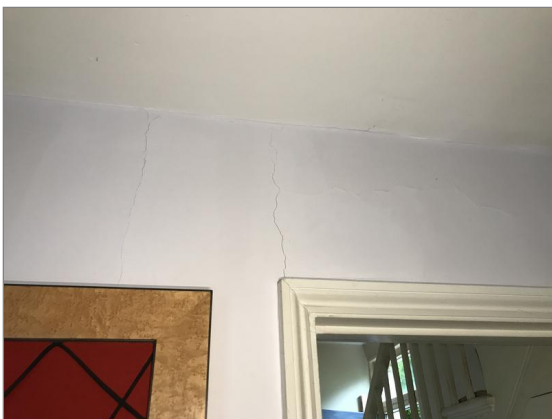
Photo - 103 Cracking to kitchen walls.

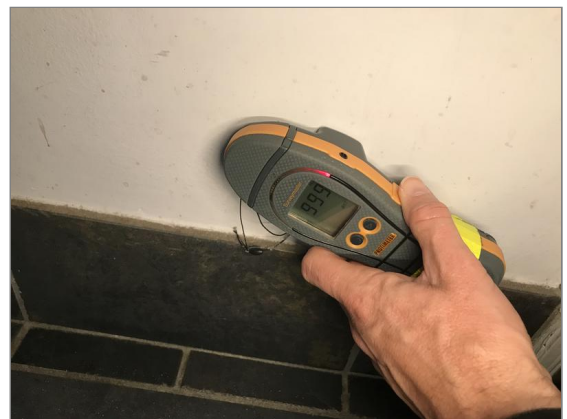
Photo - 104 Dampness to kitchen walls.

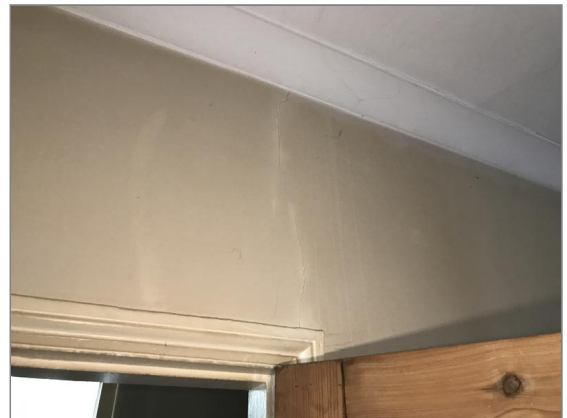
*Photo - 114 Cracking above door leading to sitting area.*

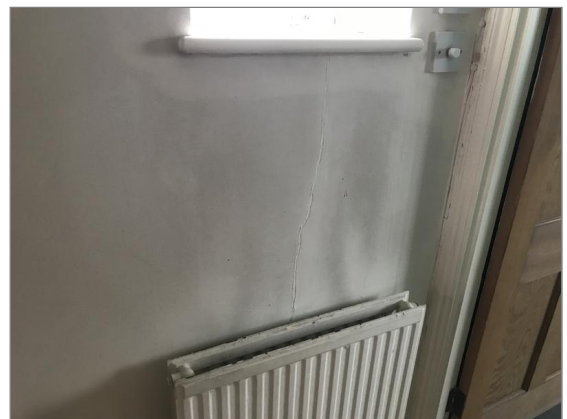
*Photo - 116 Cracking to first floor landing walls.*

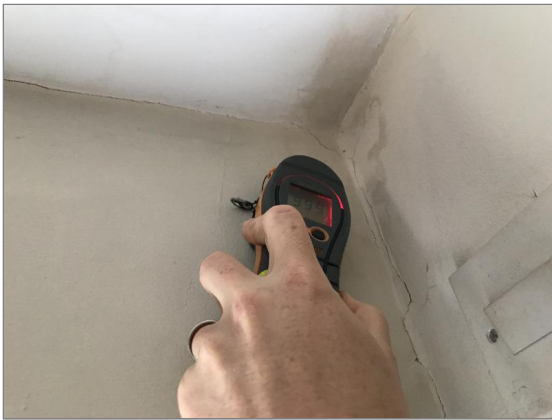
*Photo - 117 Dampness to first floor landing walls.*

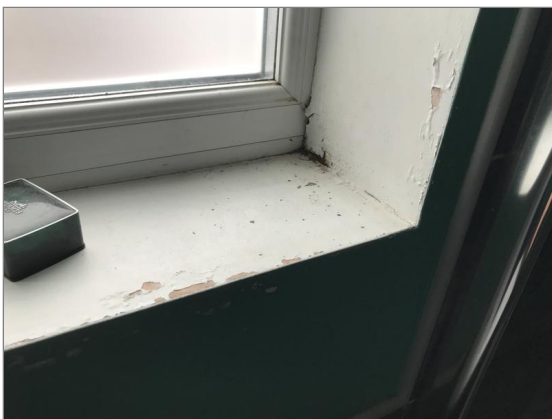
*Photo - 121 Humidity damage to bathroom walls.*

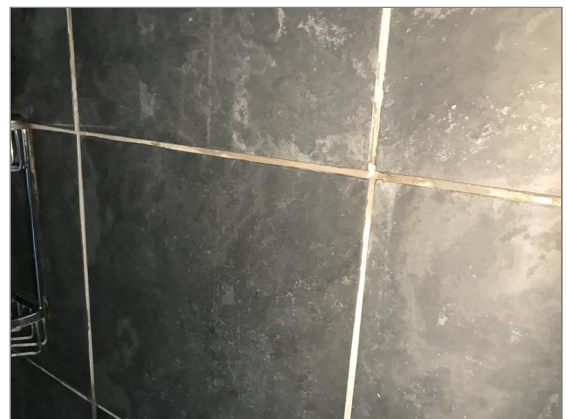
*Photo - 122 Failure of tiling in shower enclosure.*

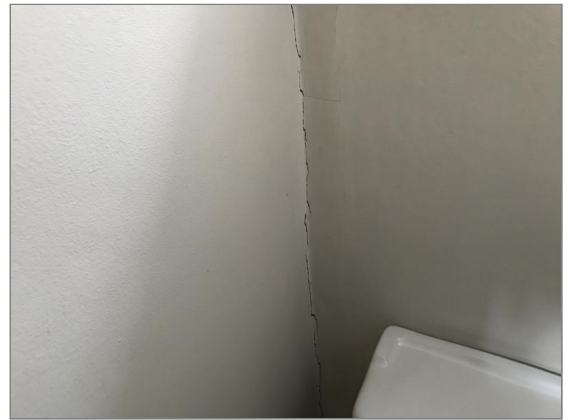
*Photo - 124 Cracking to WC walls.*

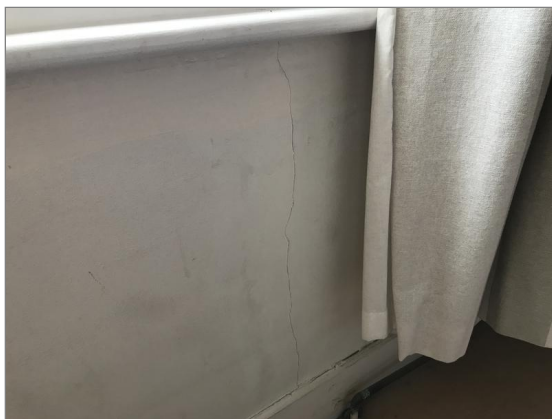
*Photo - 127 Cracking to front bedroom walls.*

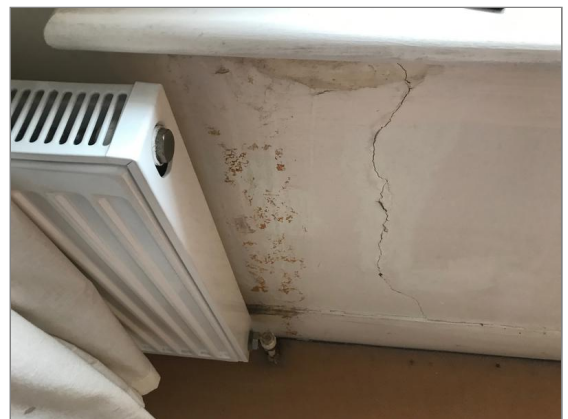
*Photo - 128 Cracking to front bedroom walls.*

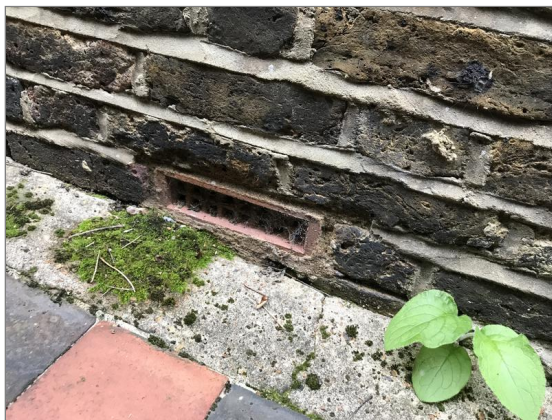
There is a subfloor vent at the rear of the property which is in close contact with the ground. Ideally, the ground level adjacent to this vent should be lowered to remove the risk of water penetration into this element.

*Photo - 133 Sub floor vent close to ground.*

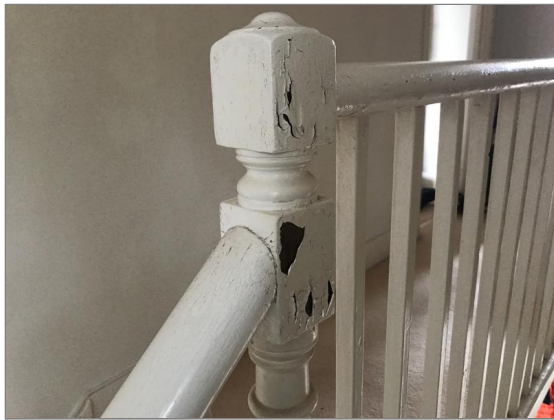
Photo - 153 Failure of decorations to stairs.

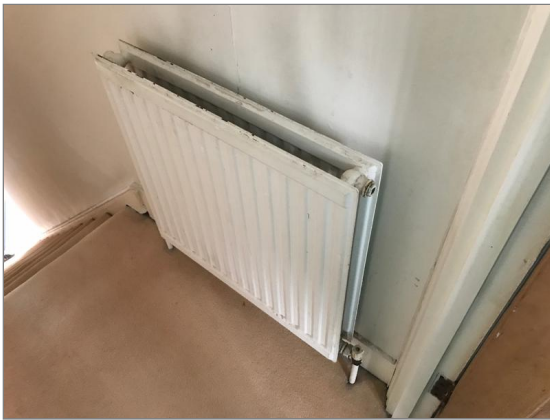
The property is heated by a gas fired boiler in the kitchen and this supplies hot water to the radiators. There is rusting to the radiators and the boiler looks to be nearing the end of its life. We recommend the heating system and boiler are completely renewed in the near future. Due to the high ambient temperature at the time of the inspection, we were unable to test the effectiveness of the heating system.

Photo - 170 Rust to radiator.

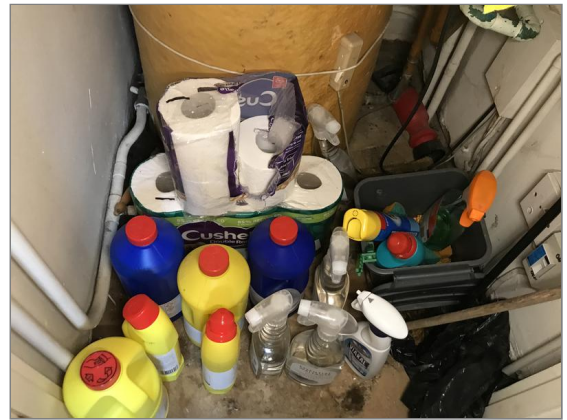
The property features a hot water cylinder located adjacent to the first floor landing. The cylinder has reached the end of its life and water damage to the flooring adjacent to the hot water cylinder was found. We recommend that the cylinder is renewed in the near future. Despite its age, the system was able to supply an adequate volume of hot water.

Photo - 174 Evidence of leaking next to hotwater cylinder.

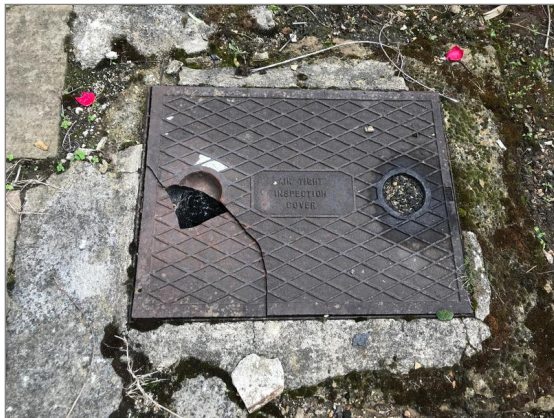
Photo - 176 Crack to inspection chamber lid.

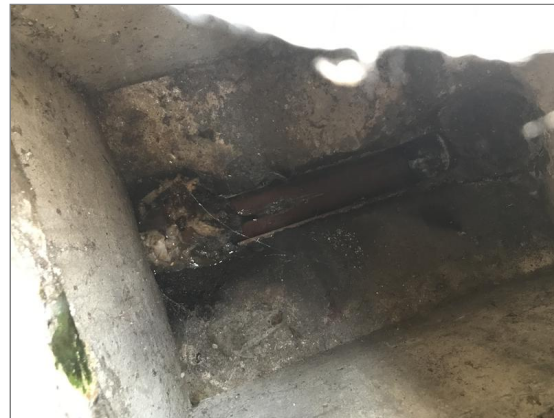
During our examination of the sub-surface drainage, evidence of a blockage was found within the inspection chamber at the front of the property. We recommend that a CCTV survey of this service is carried out.

Photo - 177 Slight blockage to front garden inspection chamber.

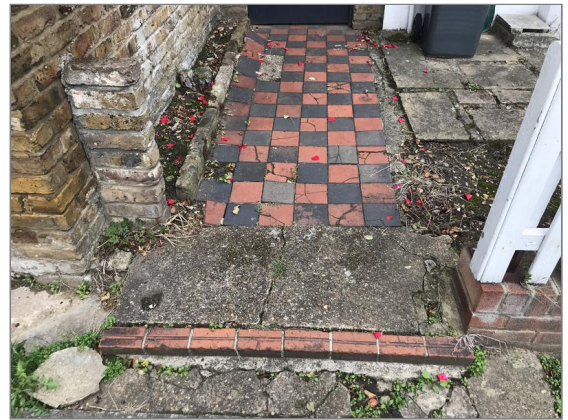
*Photo - 183 Failure of paving in front garden.*

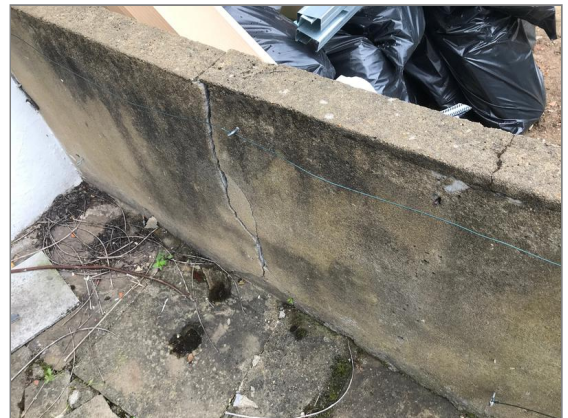
*Photo - 185 Damage to front garden wall.*

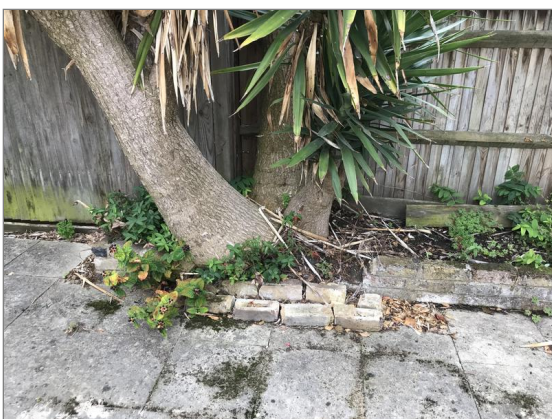
The rear garden area also features paving and this requires re-laying. A low border has been formed around the garden and this comprises a low brickwork wall. Mature plant growth has caused damage to this wall and it requires repair.

*Photo - 192 Damage to wall in rear garden.*
