LEVEL 3

Your survey report

L3 Example Street, London, SW

17th October 2022

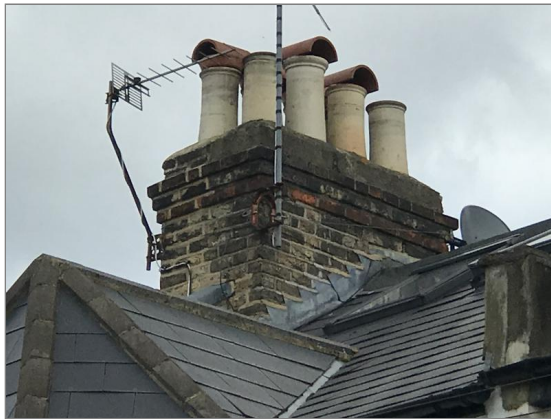
Photo - 11 Main stack

The lead flashings, which weather the abutment at the base of the stack and the adjacent roof coverings, are in fair condition.

Overall, the chimney stack is in fair condition and no current wants of repair were identified with this structure.

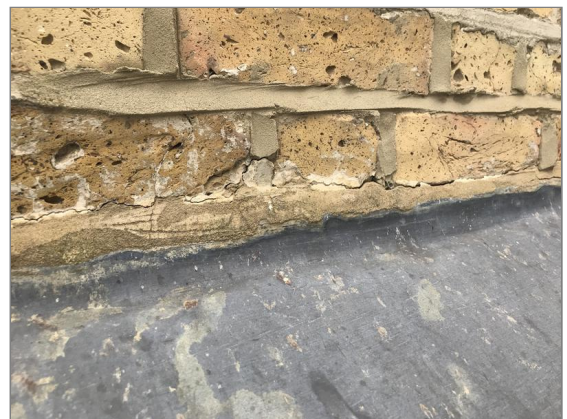
The side extension roof also features a manmade slate covered roof. Slight cracking was noted to the cement holding the flashings in place and we suspect that this will require renewal within the next 2 to 3 years. No current wants of repair were identified during the inspection.

Photo - 22 Slight cracking to cement holding flashings of side addition roof in place

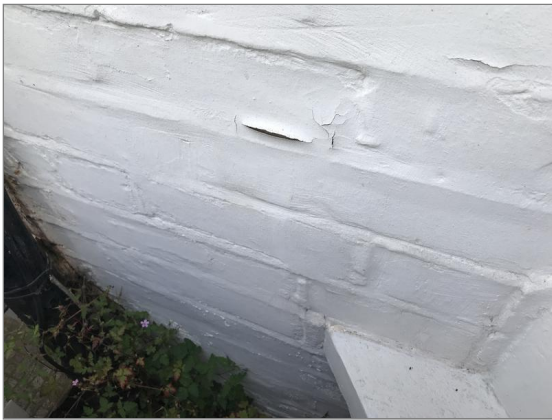
During the inspection, we observed numerous areas of failed decorations. If this is allowed to persist, it could lead to internal dampness in the property. We recommend that the decorations are either renewed or removed using chemical means, and the face of the wall refurbished using heritage materials (lime mortar). These works should occur in the next 12 - 24 months.

Photo - 34 Failure of decorations to front of property

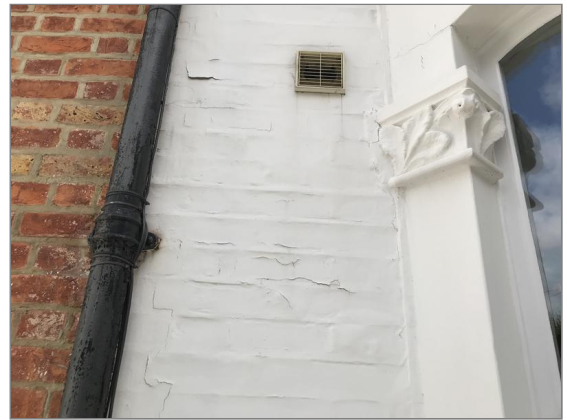
Photo - 35 Failure of decorations to front of property

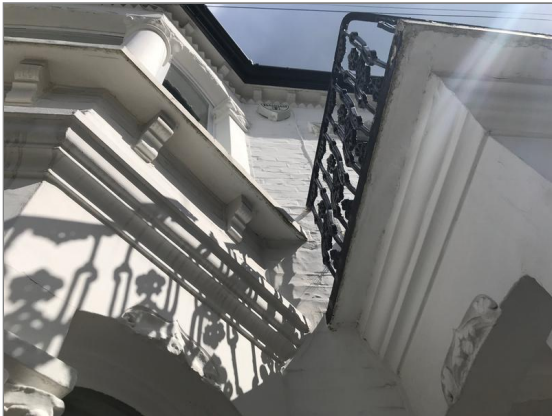
Photo - 36 Failure of decorations to front of property

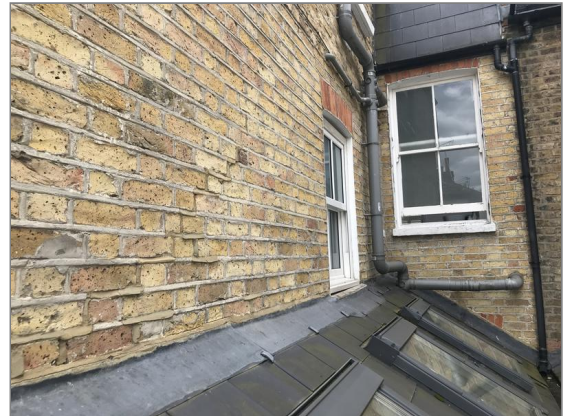
Evidence of cracking repairs was found above the side extension. This cracking likely resulted when the side extension was formed and is typical for this type of work. A cracking repair has also been carried out above the kitchen door. Again, we suspect that this has been necessitated due to the movement that would be associated with the works to form the side extension.

Photo - 37 Cracking repair at rear of property

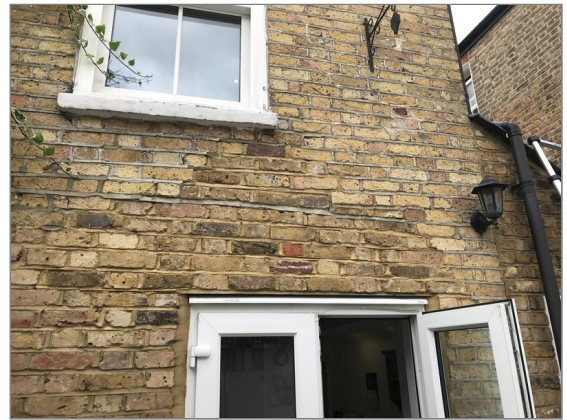
Photo - 41 Cracking repair above kitchen door

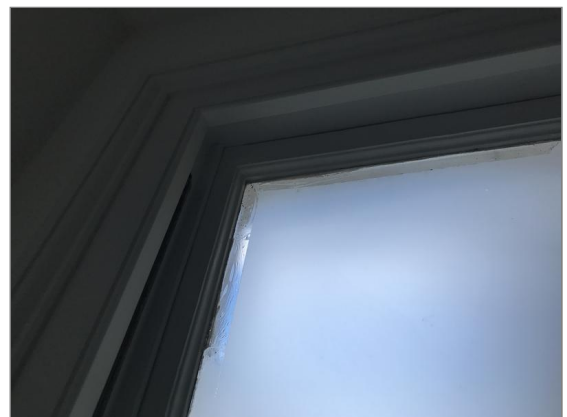
Photo - 51 Slight failure of frosting to en-suite bathroom window

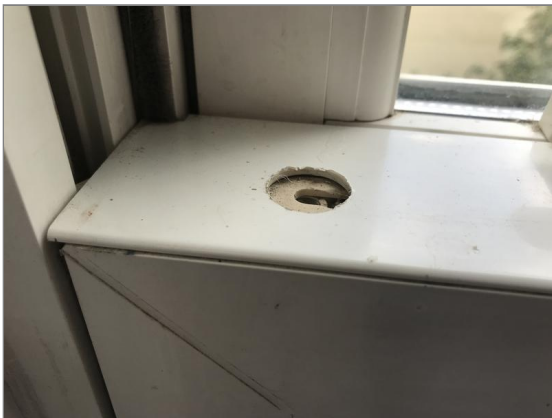
Photo - 54 Minor damage to rear first floor bedroom window

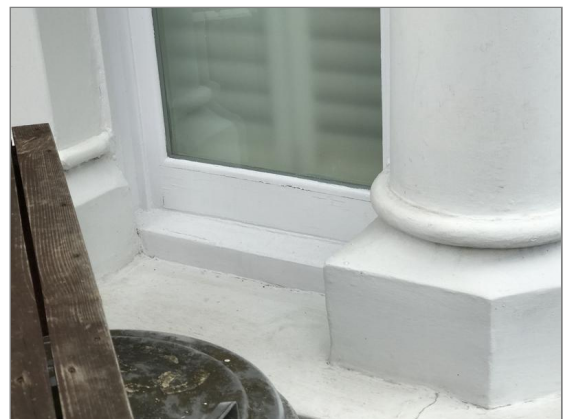
Photo - 57 Slight failure of decorations to front sitting room windows

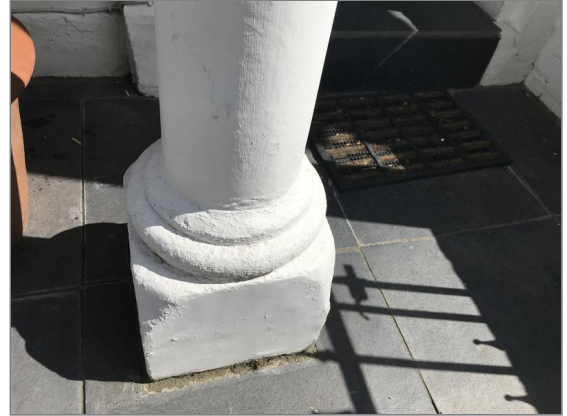
Photo - 69 Failure of decorations to porch

Whilst we have no concerns with the porch structure, evidence of water penetration through the soffit was identified. We recommend that the surface of the soffit is treated with waterproof walkway paint to prolong its life. Redecoration of the steel railings around the balcony is also required and these works should take place within the next 12 months.

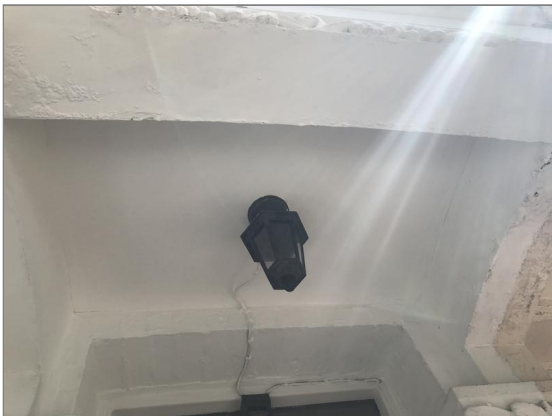
Photo - 70 Slight water damage to porch soffit

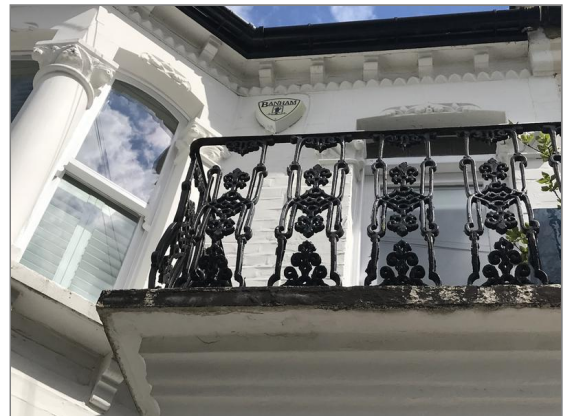
Photo - 71 Damage to metal railings surrounding porch

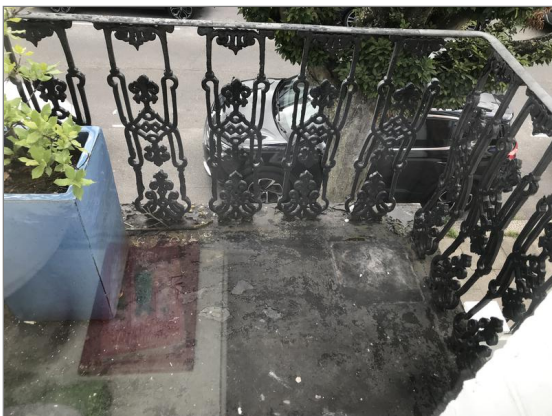
Photo - 72 Failure of waterproofing to porch soffit

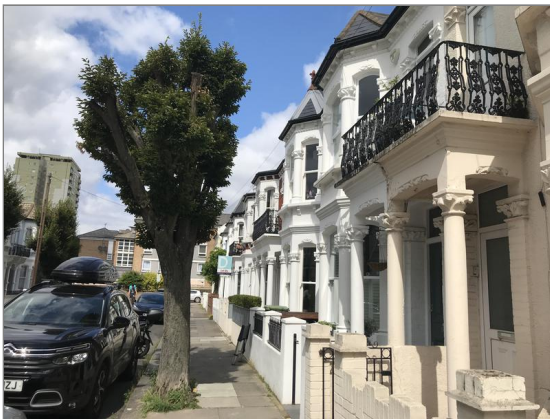
There is a mature street tree adjacent to the property. The dwelling lies within the root zone of this tree and it has the potential to damage the property. The growth of this tree should be managed to mitigate this risk. At the time of the inspection, the tree had been recently pollarded.

Photo - 75 Mature street tree adjacent to dwelling

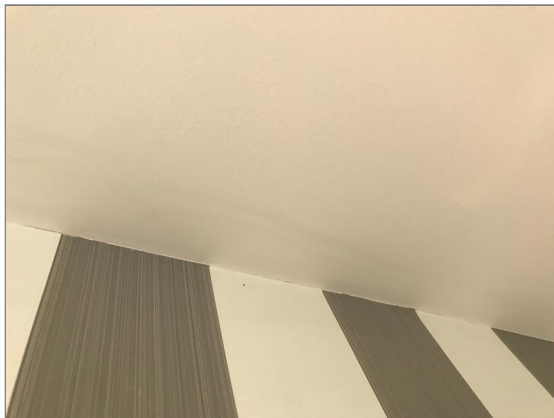
Photo - 88 Water staining to rear second floor bedroom ceiling

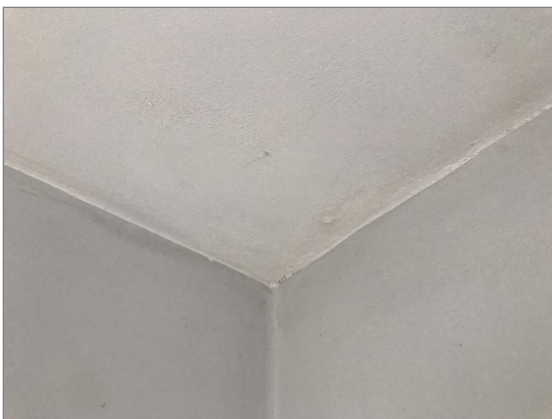
Inside the property, the ceiling and wall surfaces are in slightly better than average condition, less for minor wants of decorative repair. No significant areas of water penetration were identified, however, slight leaking from the rainwater goods adjacent to the rear first floor bedroom has caused minor damp penetration into this room.

Photo - 96 Water damage to rear first floor bedroom ceiling

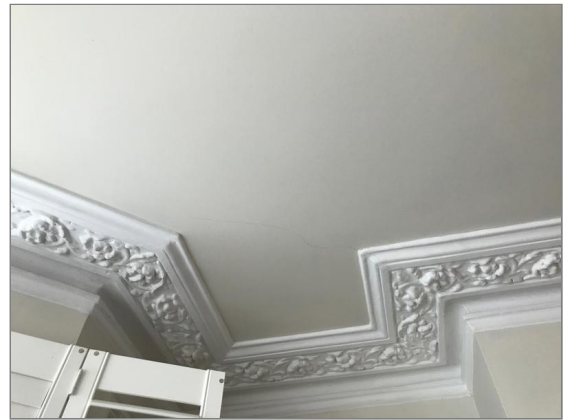
Photo - 99 Hairline cracking to front sitting room ceiling

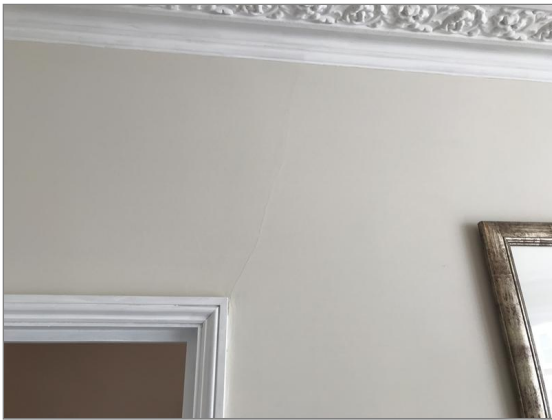
Photo - 108 Cracking to front sitting room walls

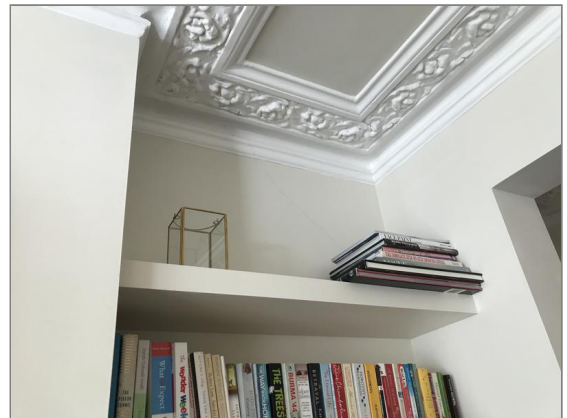
Photo - 111 Minor cracking to front sitting room walls

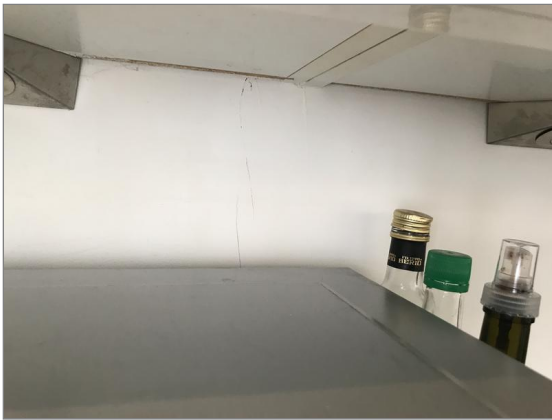
Photo - 120 Slight cracking to kitchen walls

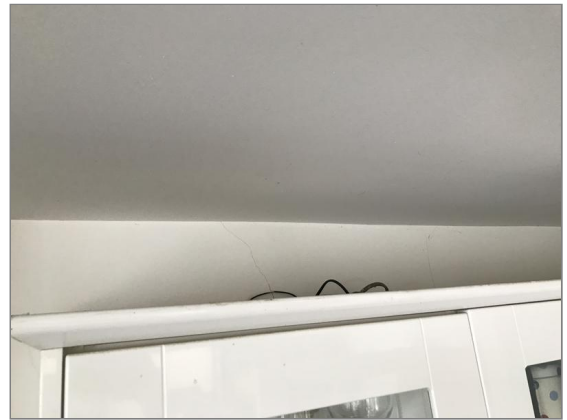
Photo - 121 Slight cracking to kitchen walls

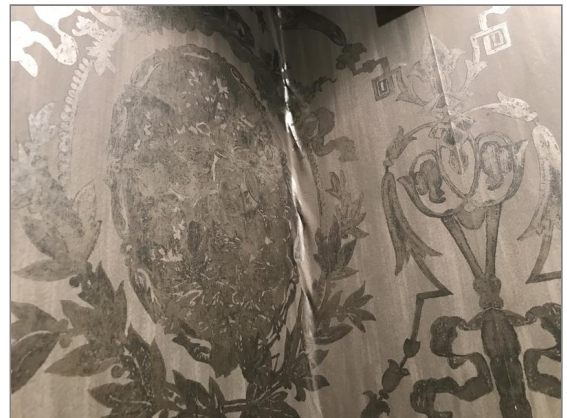
Photo - 123 Failure of decorative lining paper to WC walls

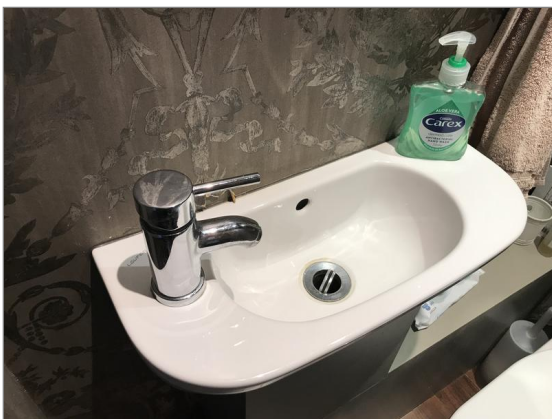
Photo - 124 Lack of splashback to WC walls

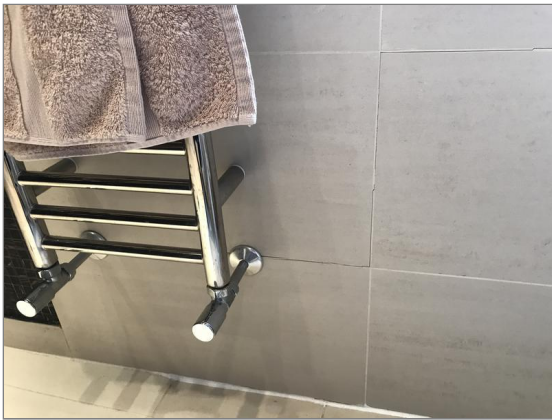
Photo - 132 Cracking to bathroom tiling

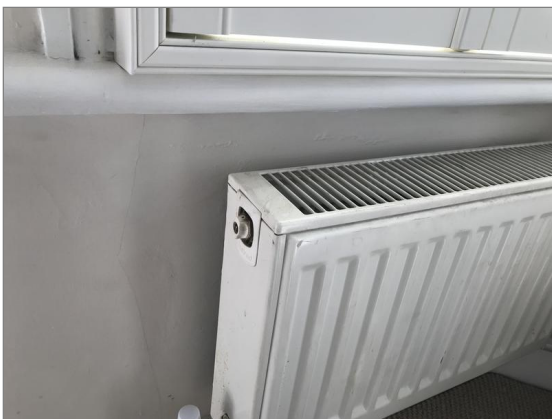
Photo - 136 Decorative damage below master bedroom windows

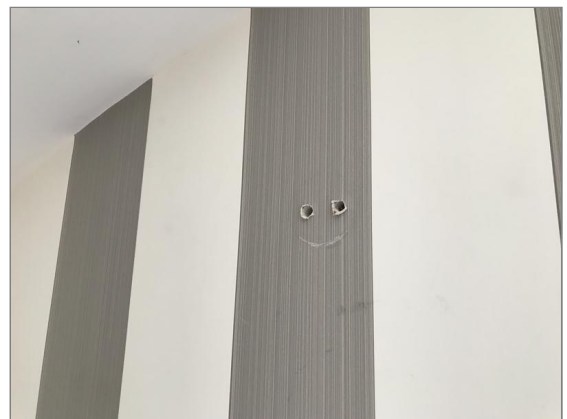
Photo - 143 Mechanical damage to rear second floor bedroom walls

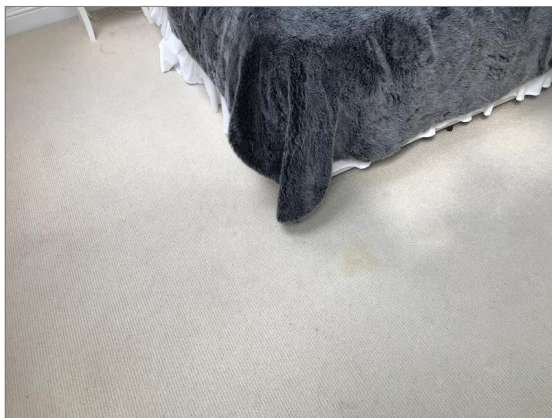
Photo - 152 Staining to larger second floor bedroom carpet

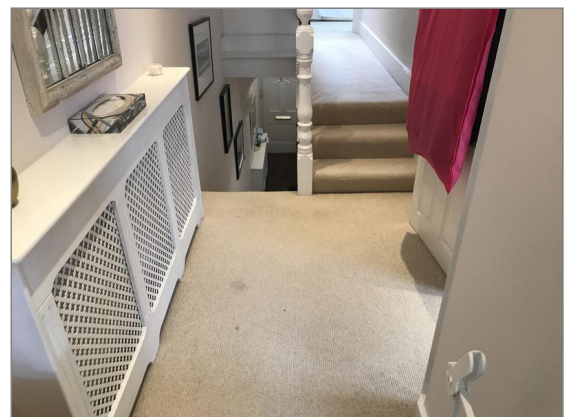
Photo - 155 Staining to first floor landing carpet

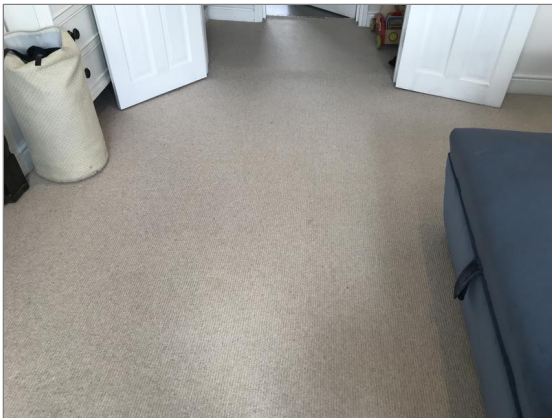
Photo - 156 Unevenness to master bedroom floor

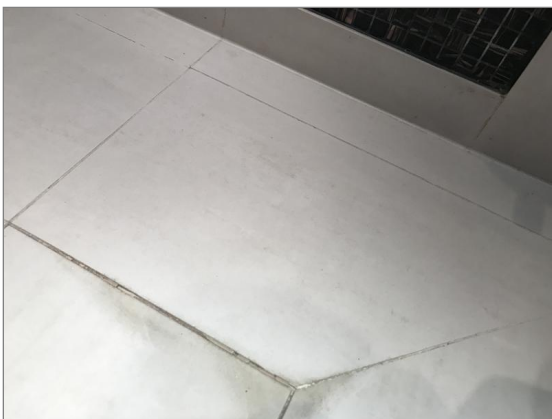
Photo - 160 Loose tiles to shower enclosure

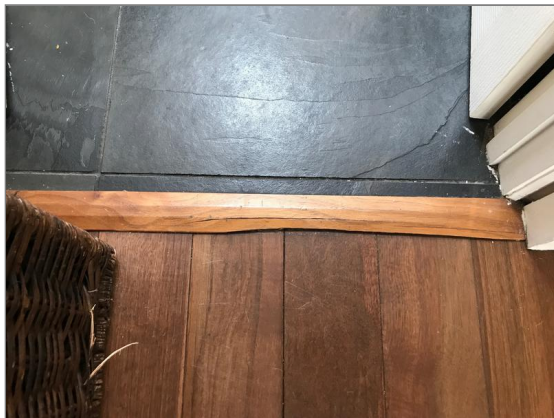
Photo - 164 Damaged threshold strip

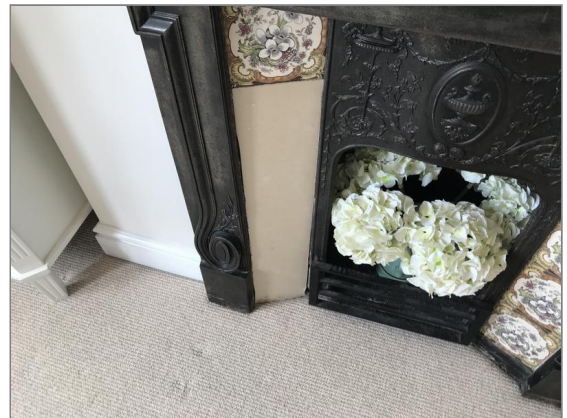
Photo - 169 Missing tiles to side of chimney breast

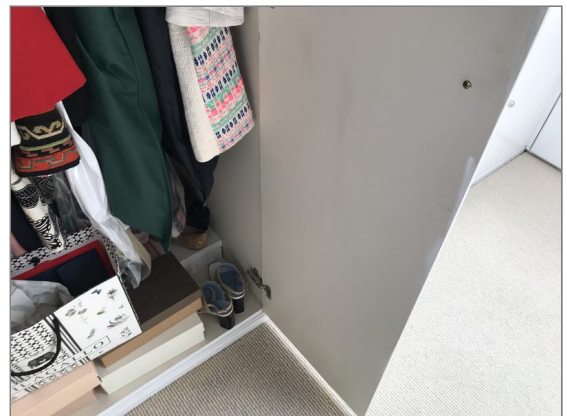
Photo - 175 Decorative condition of built-in fittings

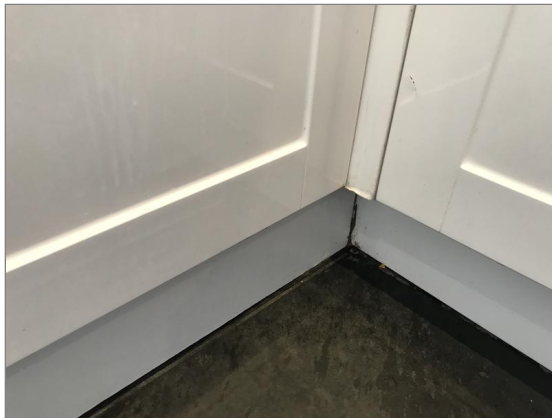
Photo - 182 Water damage to kitchen sink cupboard

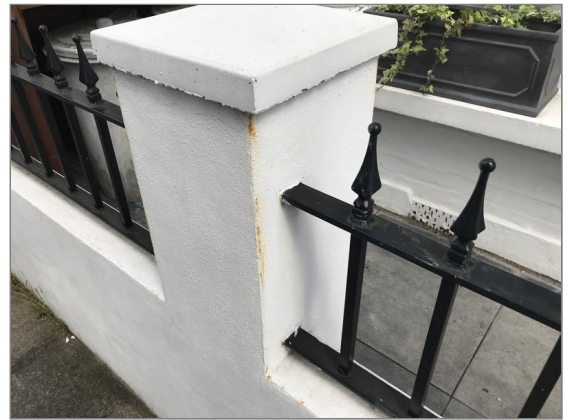
Photo - 224 Failure of decorations to front garden wall
