LEVEL 1

Your survey report

L1 Example Street, London, SW

17th October 2022

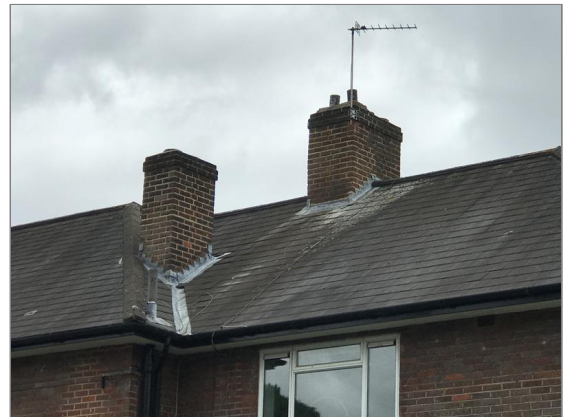
Slight frost damage and minor pointing repairs were noted to the brickwork of both stacks and these structures will require repair within the next 5 years. The flashings weathering the base of the stacks are of lead. No failure of these flashings was noted.

Photo - 5 Main chimney stack located above apex of roof.

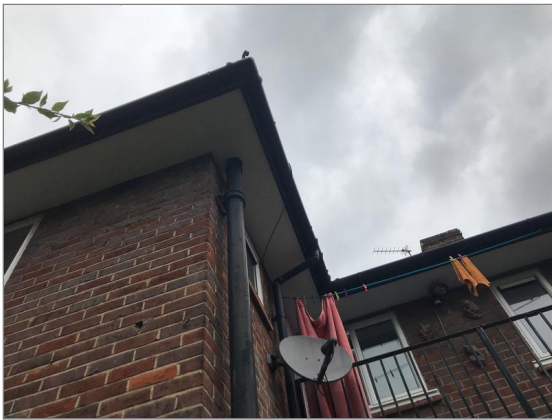
Photo - 11 Rainwater guttering to rear of property.

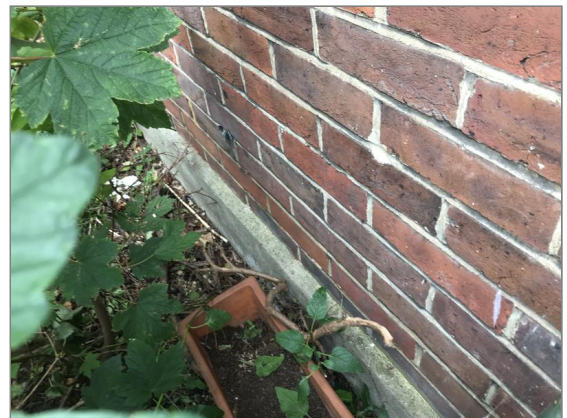
Photo - 13 Render applied to lower part of walls.

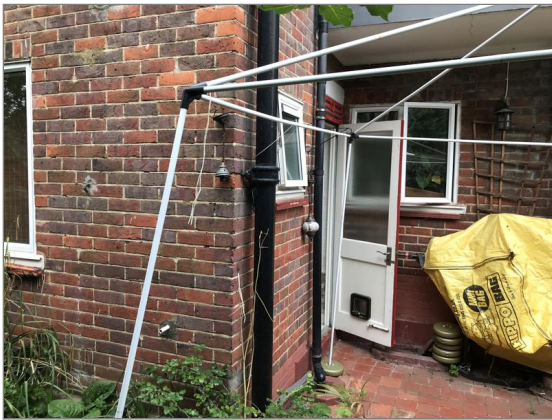
Photo - 14 Paint applied to rear walls.

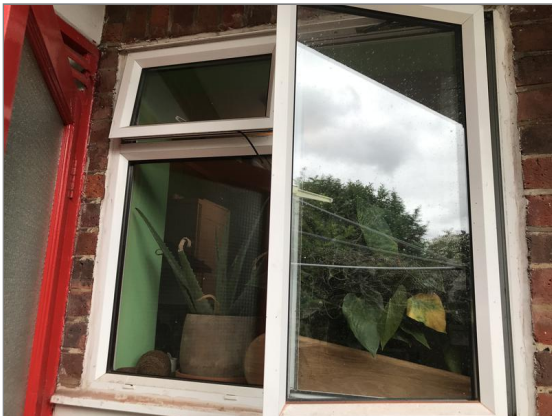
Photo - 16 Kitchen windows.

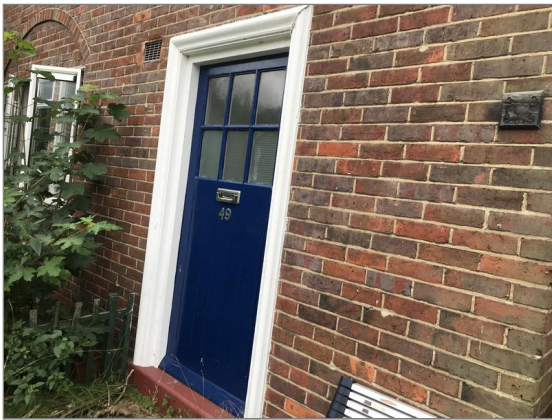
The front door is a timber door set featuring Georgian wired glass. A failure of the decorations to the door frame was identified and these surfaces require redecoration. The door is fitted with a basic night latch and key operated bolt. A new owner may wish to replace these fittings with higher-security furniture.

Photo - 23 Front door.

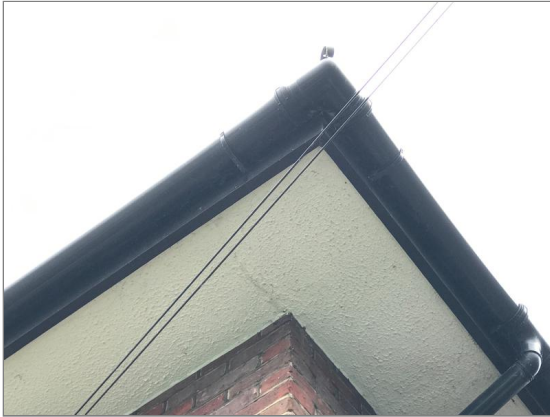
The high level fascias and soffits are in fair decorative condition with no current wants of repair. There is a walkway to the rear of the property. The decorations to the underside of this walkway are beginning to fail and these would benefit from renewal in the next 2-3 years.

Photo - 29 Decorations applied to fascias and soffits around the property.

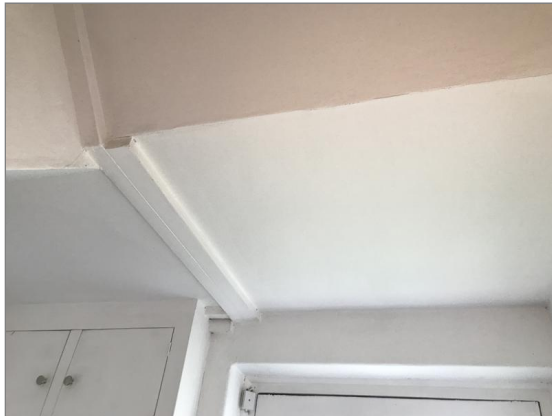
In general, the ceilings are in slightly tired decorative condition and minor areas of cracking were identified to these surfaces. This cracking is not of concern and it can be made good when the ceilings are next redecorated. Otherwise, no significant wants of repair were identified.

Photo - 32 Entrance hallway ceiling.

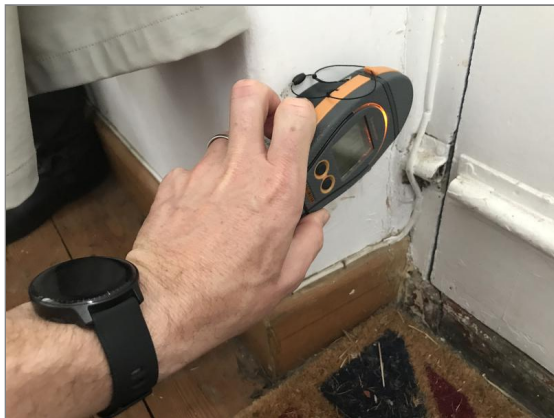
Photo - 43 Damp meter testing to entrance hallway.

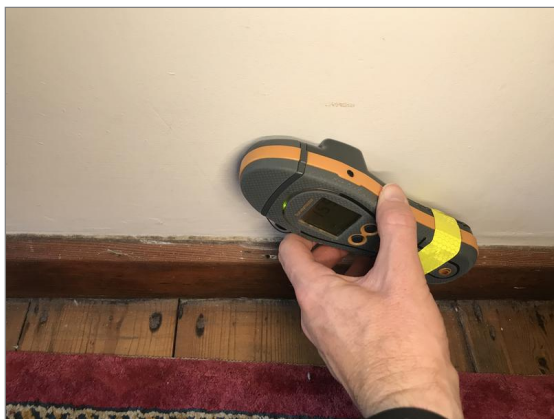
Photo - 45 Damp meter testing to entrance hallway.

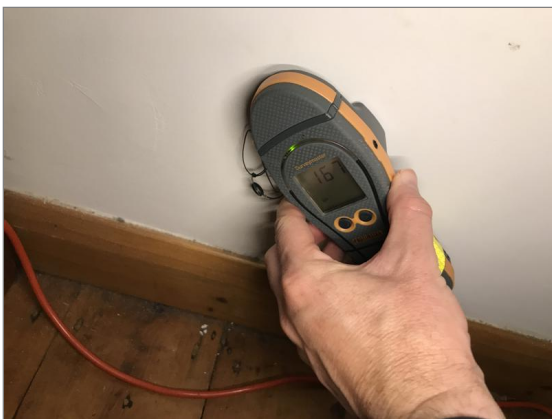
Photo - 51 Damp meter testing to bedroom walls.

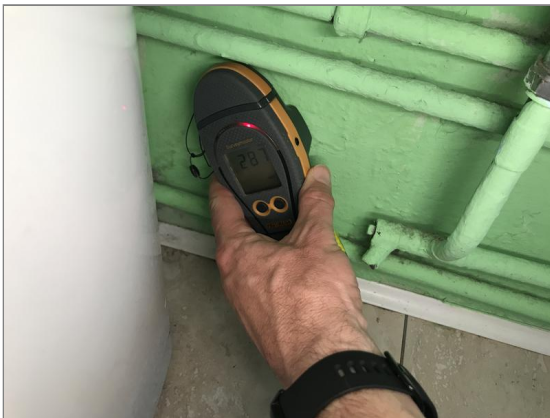
Dampness was recorded to the brickwork adjacent to the rear door. Again, our readings are consistent with high humidity condensing on this surface (as opposed to damp penetration). A new owner may wish to renew the paint film to the adjacent wall to help hold back dampness to this surface.

Photo - 55 Elevated damp meter readings to kitchen walls.

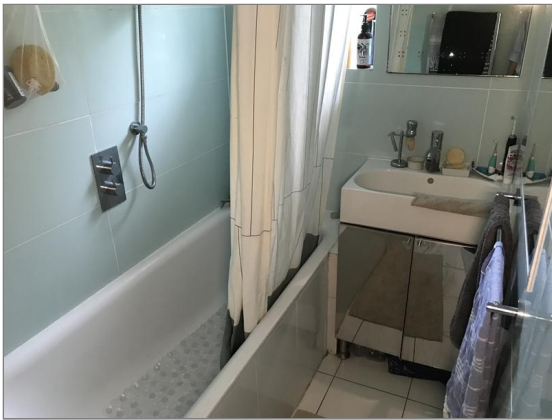
Photo - 59 Bathroom walls.

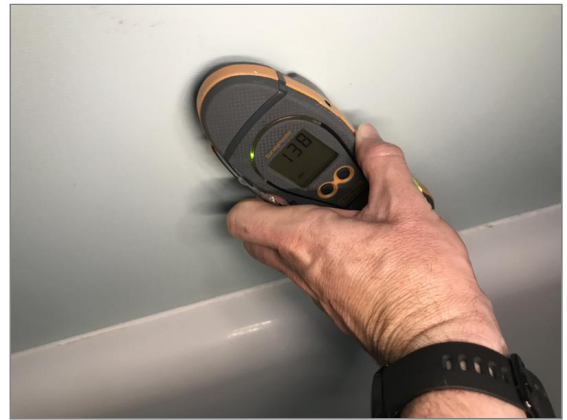
Photo - 60 Damp meter testing to bathroom walls.

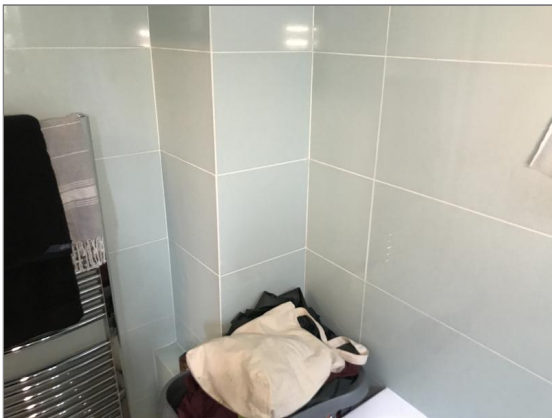
Photo - 61 Bathroom walls.

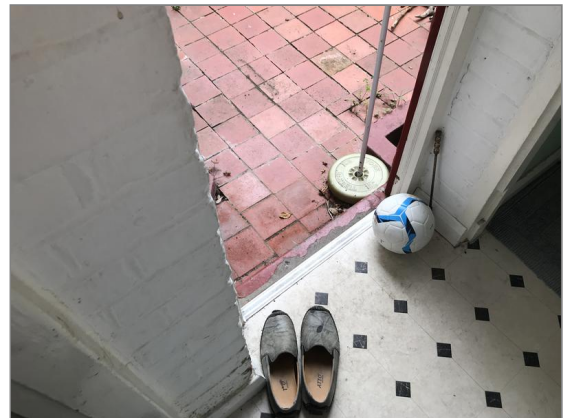
Photo - 62 Rear hallway walls.

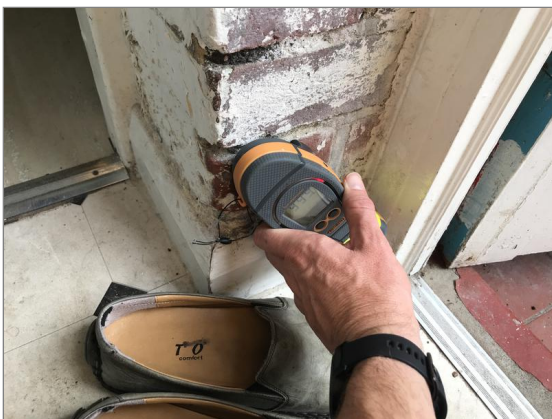
Photo - 63 Damp meter testing adjacent to rear door.

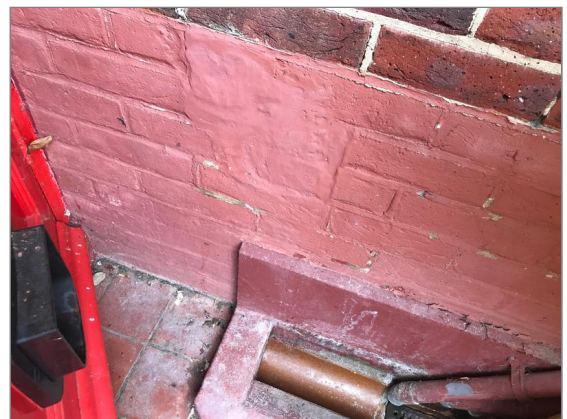
Photo - 64 Decorations applied to external finish walls.

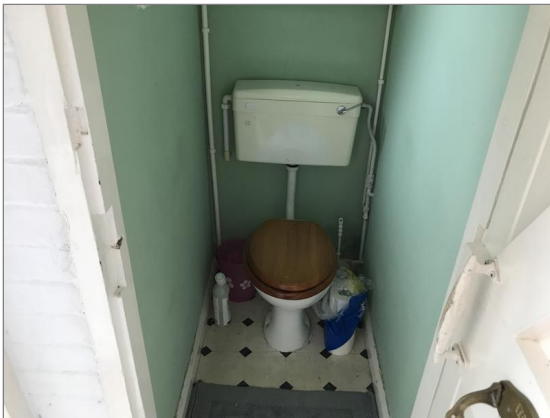
Photo - 65 WC walls.

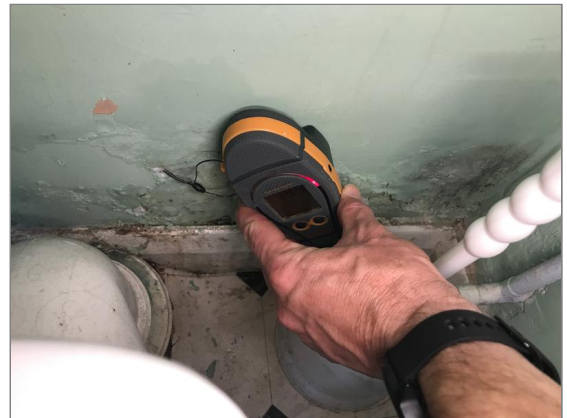
Photo - 66 Water penetration through WC walls.

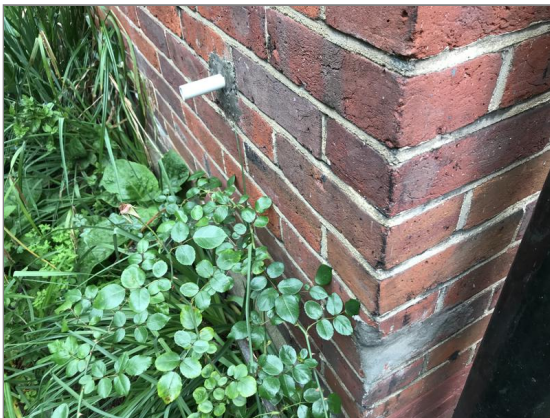
Photo - 67 Plant growth adjacent to area of water penetration.

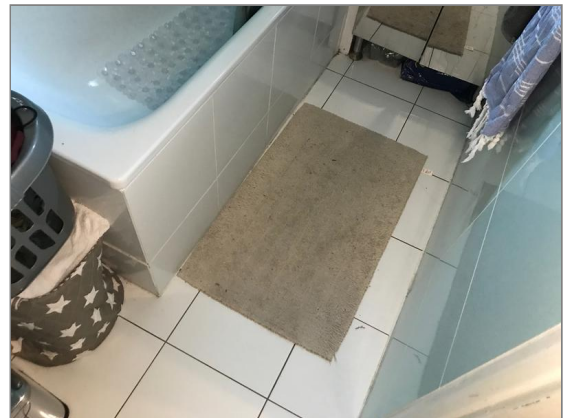
Photo - 71 Tiling in bathroom.

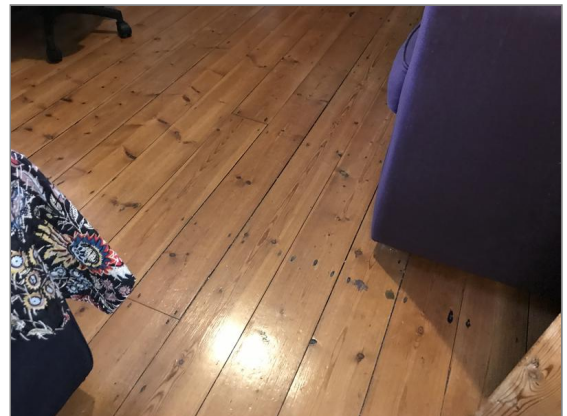
Photo - 77 Living room floor.

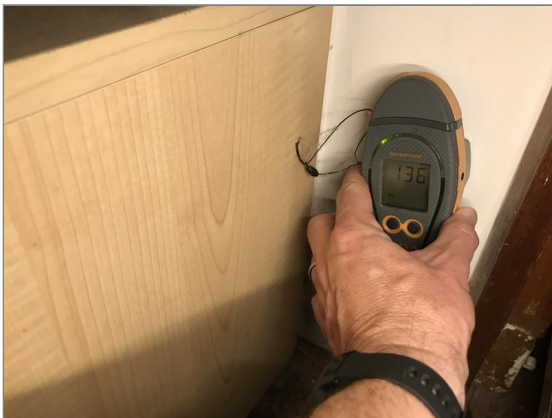
Photo - 80 Damp meter testing to front sitting room fireplace.

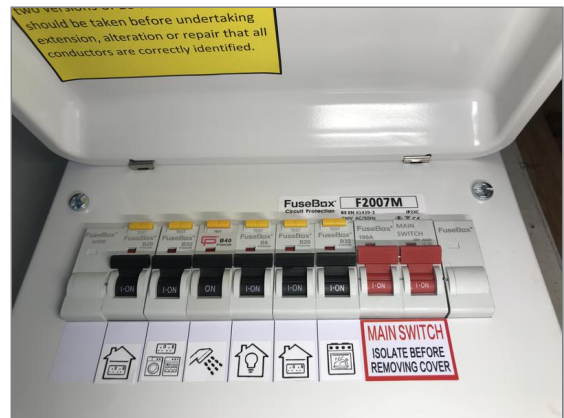
The electricity meter and distribution board are located adjacent to the front door. The property features an RCD protected distribution board. The electrical fittings are dated and they would benefit from renewal. Otherwise, no visual defects were identified with this service. The most recent test certificate for this installation should be sought.

Photo - 103 Distribution board.

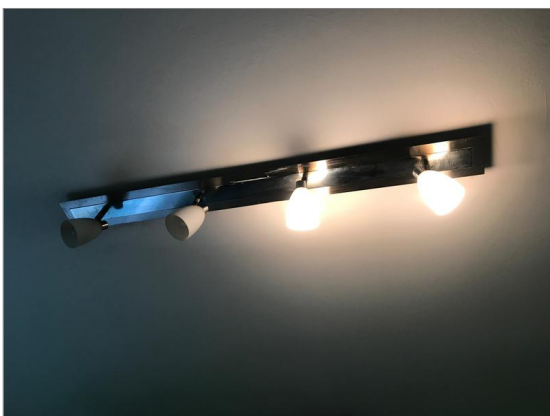
Photo - 104 Bulkhead light fitting in kitchen.

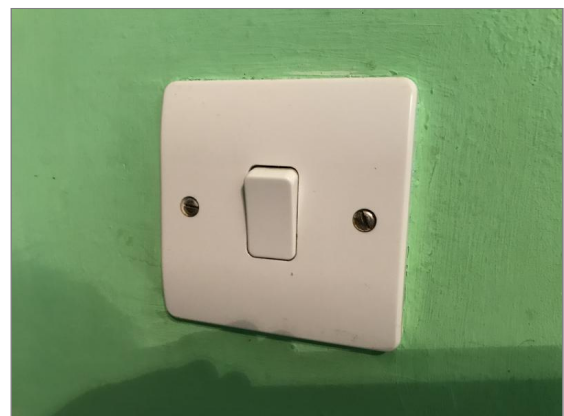
Photo - 105 Single plastic light switch in kitchen.

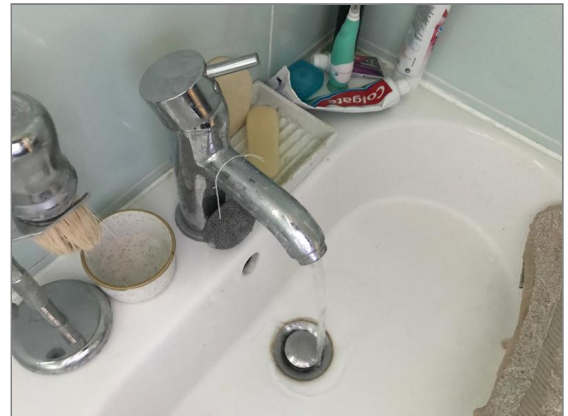
Water is supplied under direct mains pressure. We tested the flow of cold water by opening one and then two outlets and a significant drop in supply pressure was found on opening the second outlet. Despite this, the water pressure is sufficient for a dwelling of this size. The location of the cold water isolation valve should be confirmed by the vendor.

Photo - 107 Testing cold water supply with two outlets open.

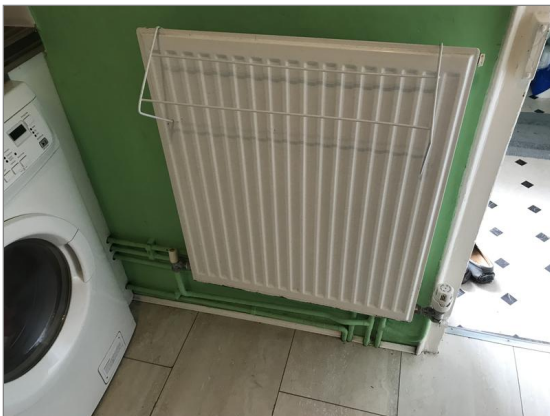
The property is heated by a gas fired combination boiler which is located in the rear WC. This element is nearing the end of its life and rust was identified to some of the radiators. The radiators and boiler will likely require renewal in the next 2-3 years.

Photo - 108 Kitchen radiator.

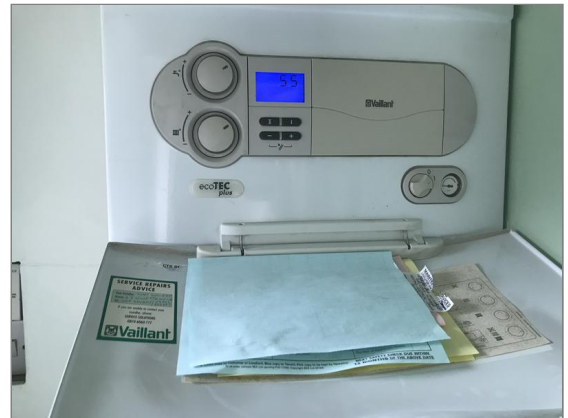
Photo - 111 Combination boiler panel.

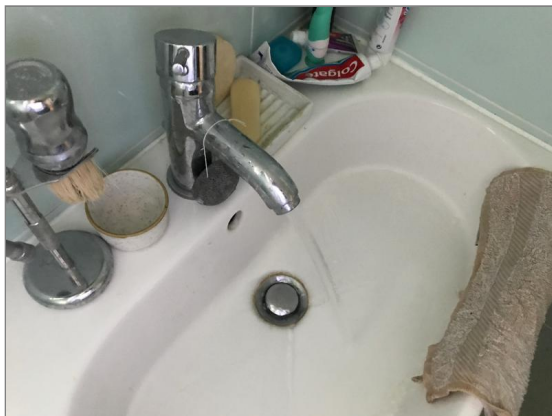
The combination boiler heats hot water on demand. On testing, this was able to provide a fair flow of hot water to one outlet at any one time but a significant drop in supply pressure was experienced when opening more than one outlet.

Photo - 112 Testing hot water supply with one outlet open.

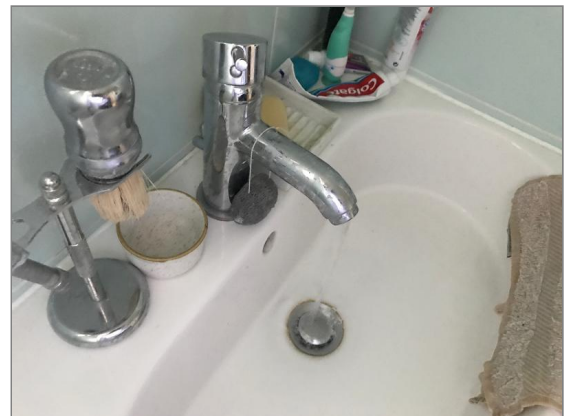
Photo - 113 Drop in hot water supply.

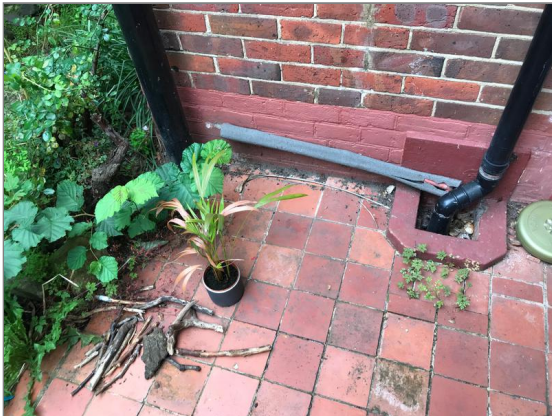
Surface gullies run around the outside of the property and these elements should be cleared. These gullies run to an inspection chamber in the front garden. No visual defects were identified with the drainage and no damage was noted to the cast iron inspection chamber covers.

Photo - 116 Open gully at rear of property.

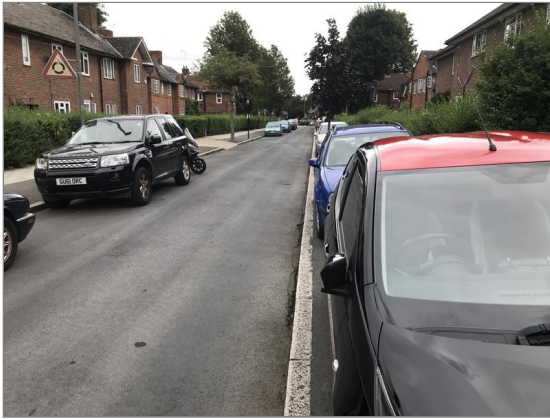
Parking is available on the road to the front of the property. The dwelling does not benefit from a garage. (NI)

Photo - 117 On street parking to front of property.

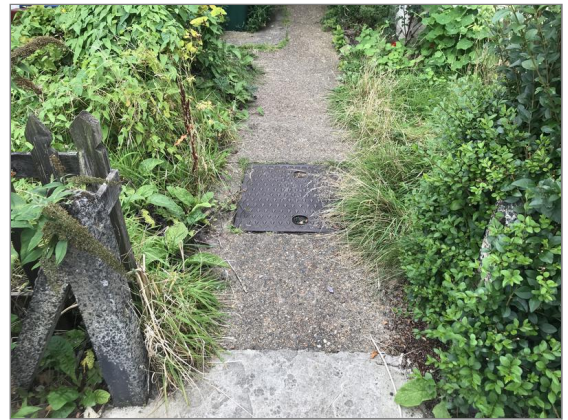
The grounds to the property are overgrown and a new owner will likely wish to have these plants cut back. The front garden is bordered by a low timber fence and this element is tired. In addition, cracking has developed to the oversite concrete path running around the front and side of the dwelling. (2)

Photo - 119 Oversite concrete forming path in front garden.

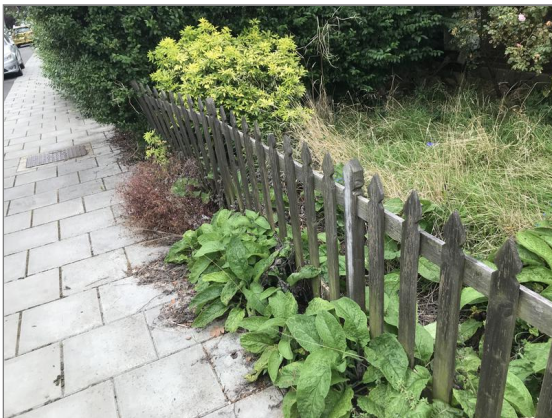
Photo - 120 Deflection of front garden fence.

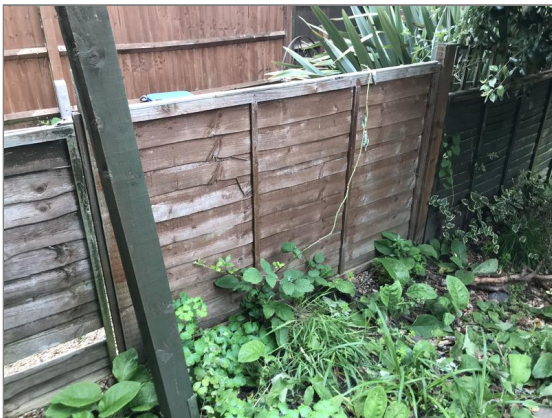
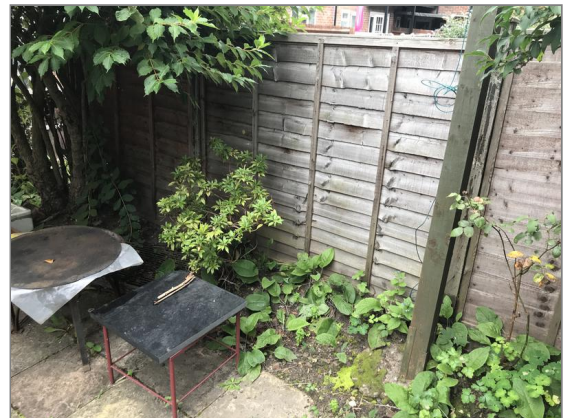
Photo - 126 Fence in rear garden.

Photo - 127 Fence in rear garden.

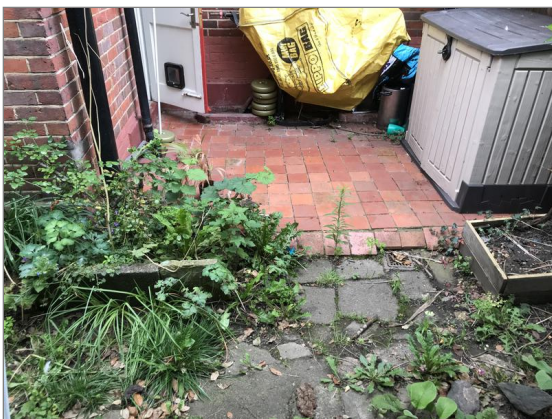
The rear garden has been inexpertly paved and the paving does not look to have been laid onto a suitable sub base. This will require relaying of the paving to resolve. There is a timber shed to the rear of the garden. The roof covering to this shed has failed and this structure requires renewal. The fencing in the rear garden would also benefit from repair. An area of orange quarry tiling is found to the rear of the dwelling. This tiling would benefit from being relaid.

Photo - 128 Orange quarry tiles in rear garden.
