# Your survey report

L2 Example Street, London, SW

17th October 2022

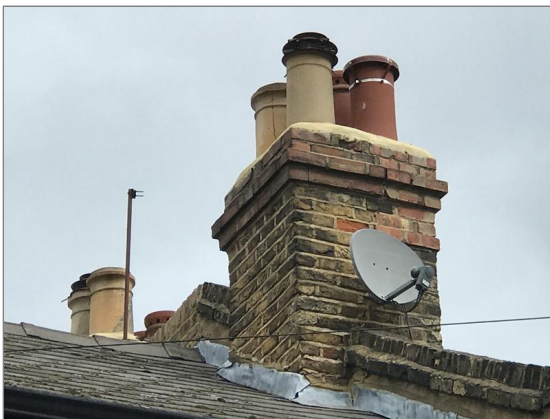
The front chimney stack sits astride the parapet wall and serves this property and the adjacent dwelling. The two chimney pots serving this dwelling are of clay. The rear pot has a vertical crack running through it and this will require replacement of the pot to resolve. In addition, the pot is open and we recommend that a ventilated cover is fitted (to prevent rainwater from entering into the flue). The pot towards the front of the stack has been fitted with a ventilated cowl and this allows for combustion whilst preventing rainwater from entering into the flue. The flaunching to the top of the stack is in fair condition, as is the brickwork. In contrast, the flashings at the base of the stack are tired and a slight failure of the mortar holding the flashings in place was identified. Renewal of the flashings will likely be required in the next 2-3 years.

Photo - 6 Front chimney stack.

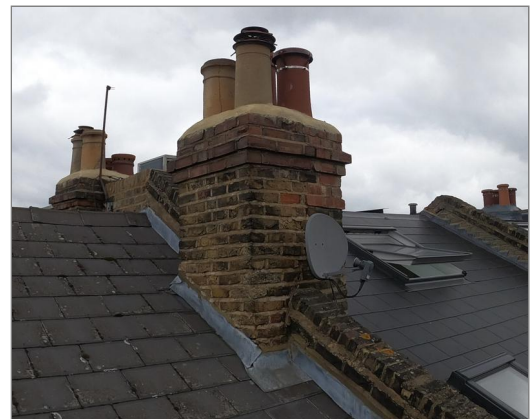
Photo - 7 Elevation view of front stack.

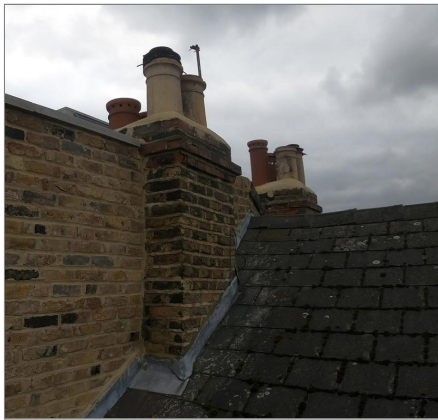
The rear chimney stack has been enclosed in upon by the neighbouring owner's mansard roof conversion. Again, the stack astrides the parapet wall and two chimney pots serve this property. The rearmost chimney pot has been fitted with a ventilated cover whilst the front one is open. We recommend that this is also fitted with a ventilated cover. No structural wants of repair were identified with the chimney stack, although again, the lead flashings at the base of this stack are tired. These elements will require renewal within the next 2-3 years.

Photo - 8 Elevation view of rear chimney stack.

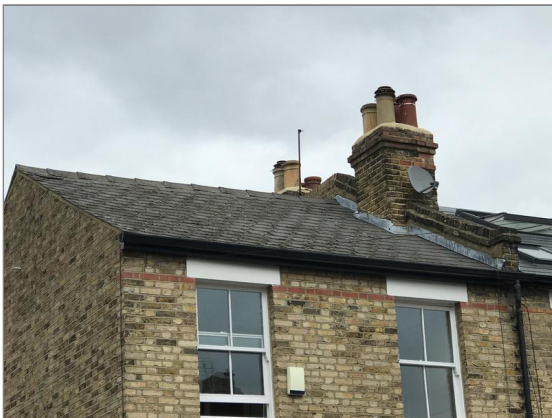
*Photo - 11 Front pitched roof covering.*

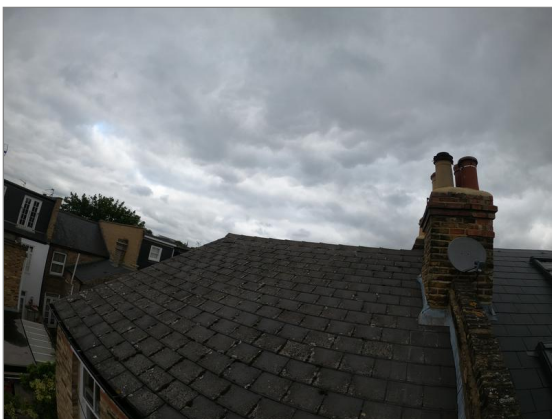
*Photo - 13 Elevated view of front pitched roof.*

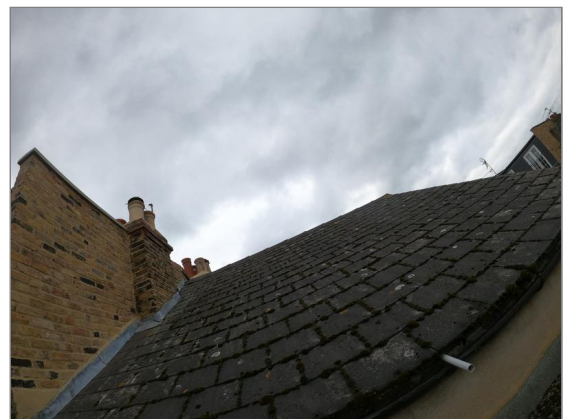
*Photo - 14 Rear pitched roof.*

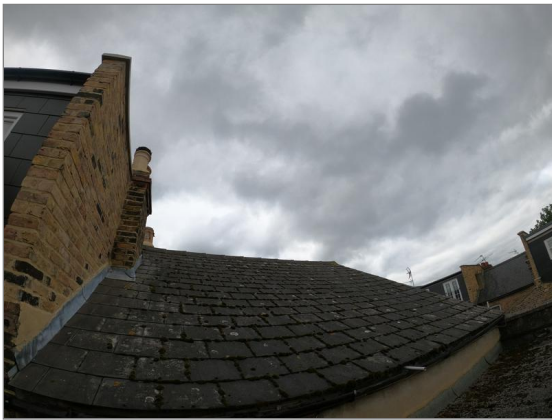
*Photo - 15 Raised parapet wall to side of rear pitched roof.*

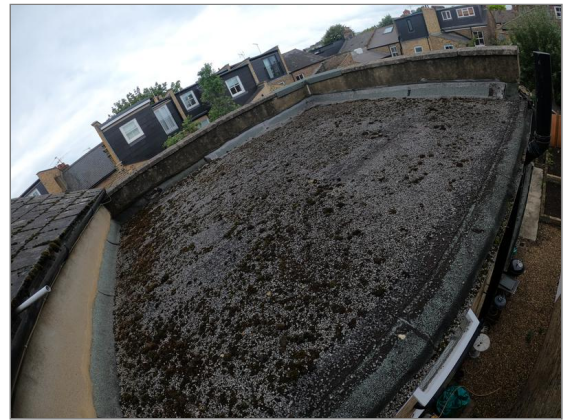
*Photo - 16 Felt roof coverings above first floor extension.*

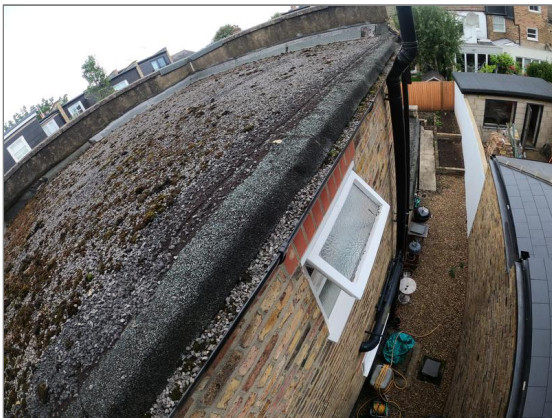
*Photo - 17 Felt roof coverings above first floor extension.*

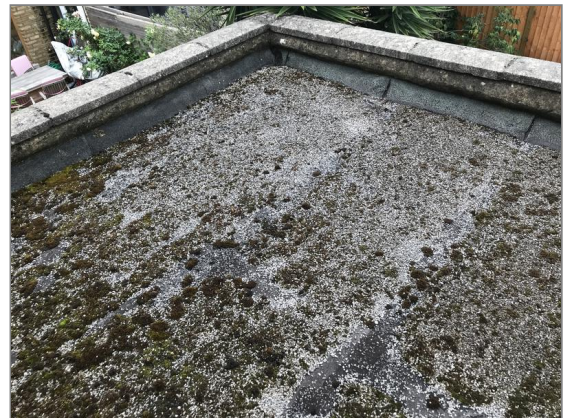
*Photo - 18 Felt roof coverings above ground floor extension.*

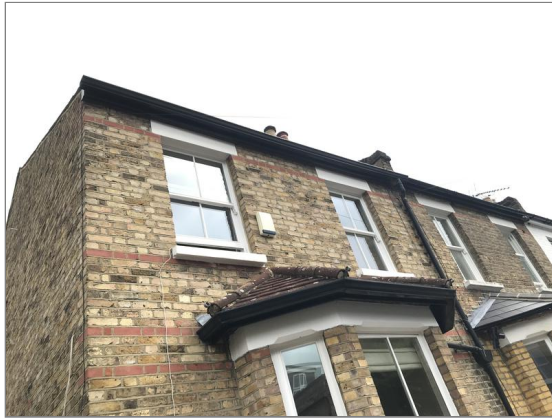
*Photo - 20 Rainwater guttering at the front of the property.*

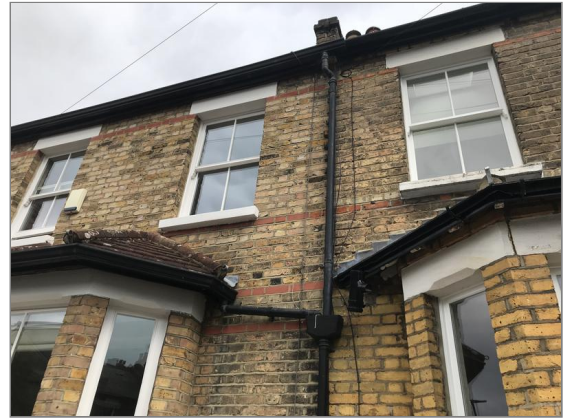
*Photo - 21 Rainwater downpipe at the front of the property.*

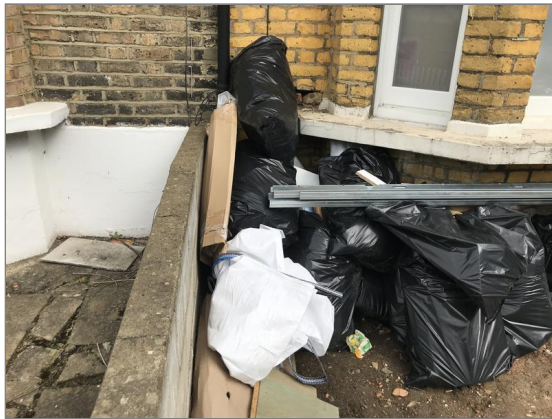
next 2-3 years. The downpipe runs into the neighbouring owner's garden. The method of draining the downpipe could not be determined as the base of the pipe was covered with builder's rubbish at the time of the inspection.

*Photo - 22 Rainwater downpipe running into neighbouring garden.*

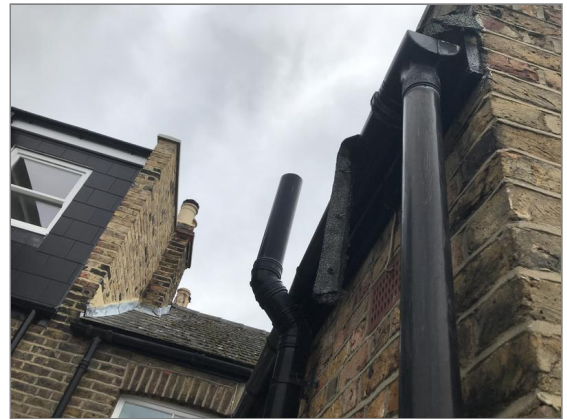
The rainwater goods at the rear of the property feature half round uPVC gutters with circular rainwater downpipes. There is a build up of debris within the gutters and this requires clearance. Water captured by the downpipes runs into gullies at the rear and side of the property. We recommend the gully at the rear of the property is adjusted (so the downpipe runs directly into it) and the debris is removed from the gully at the side of the dwelling (to ensure the free draining of this element).

*Photo - 23 Rainwater goods at the rear of the property.*

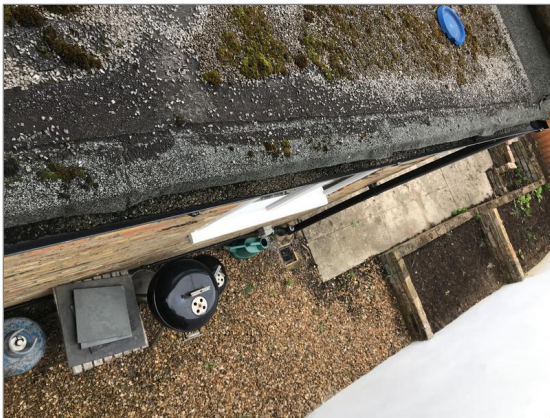
*Photo - 24 Rainwater goods to the rear addition.*

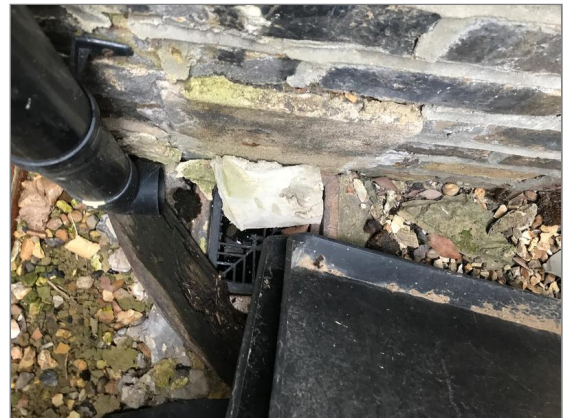
*Photo - 25 Adjustment required to rainwater downpipe.*

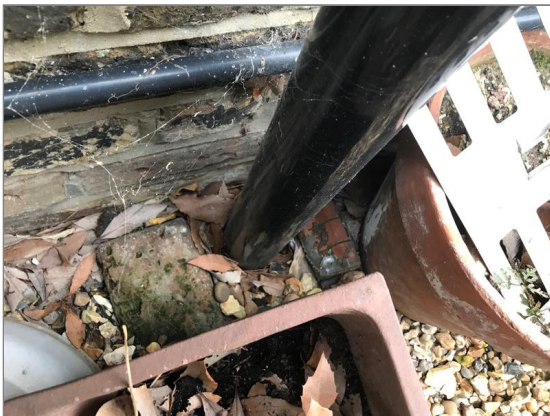
*Photo - 26 Debris in middle gully.*

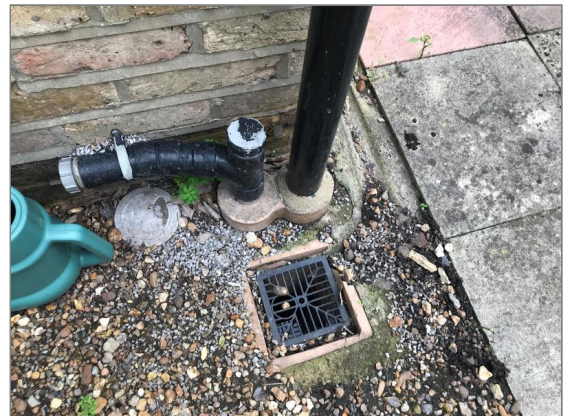
*Photo - 27 Back inlet gully at the back of rear addition.*

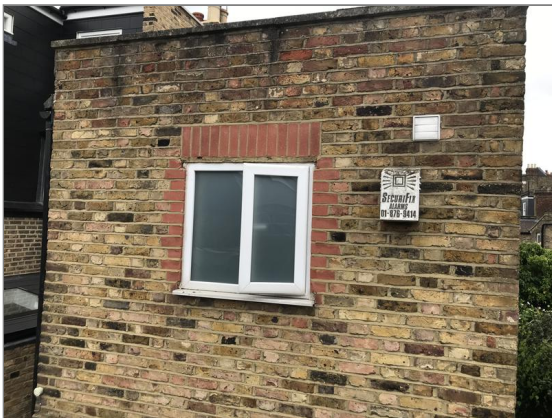
*Photo - 34 Rear bathroom walls.*

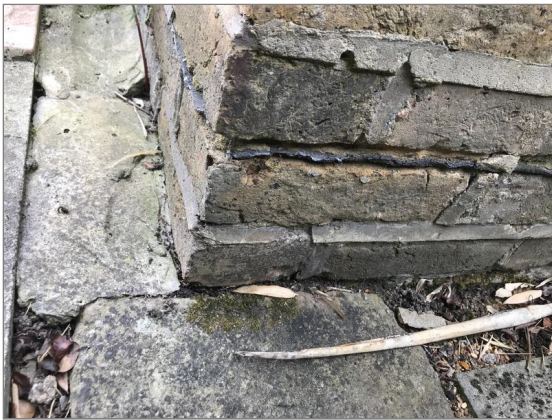
*Photo - 38 Damp proof membrane to rear addition.*

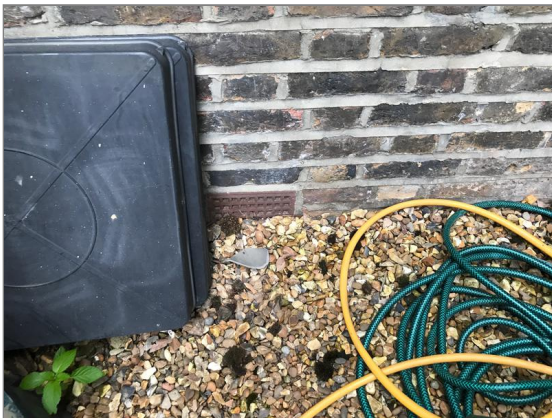
There is a subfloor vent at the rear of the property which is in close contact with the ground. Ideally, the ground level adjacent to this vent should be lowered to remove the risk of water penetration into this element.

*Photo - 40 Sub floor vent to back of the property.*

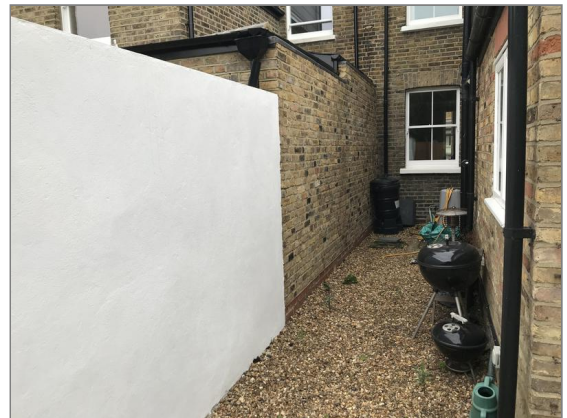
At the time of our inspection, the neighbouring property was being extended. We noted that the new wall to the extension sits on the boundary between the two properties. This could potentially be enclosed in upon by a new owner of this property to form their own side addition (subject to the Party Wall Act).

*Photo - 41 Extension built astride the boundary.*

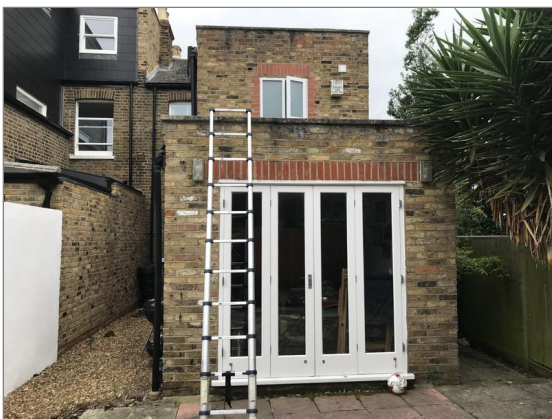
*Photo - 42 Rear elevation of the building.*

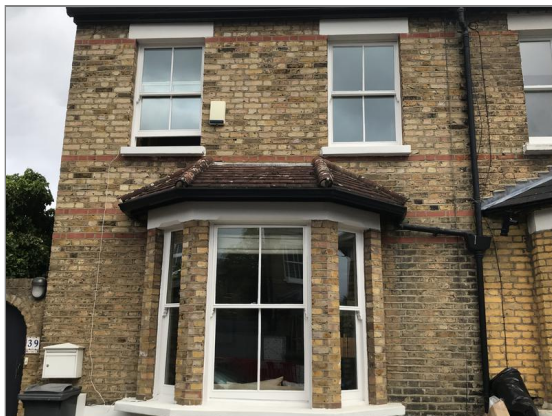
*Photo - 43 Double glazed windows at front elevation of the property.*

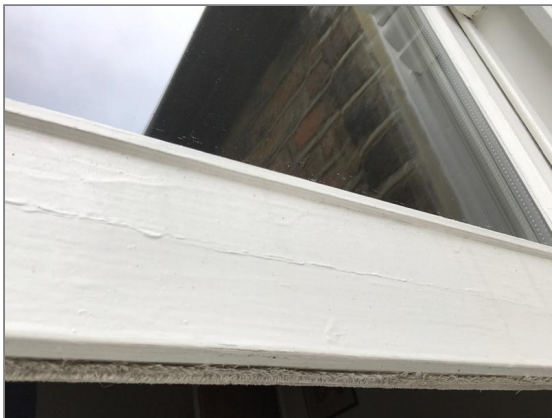
*Photo - 47 Failure of decorations to rear bedroom window.*

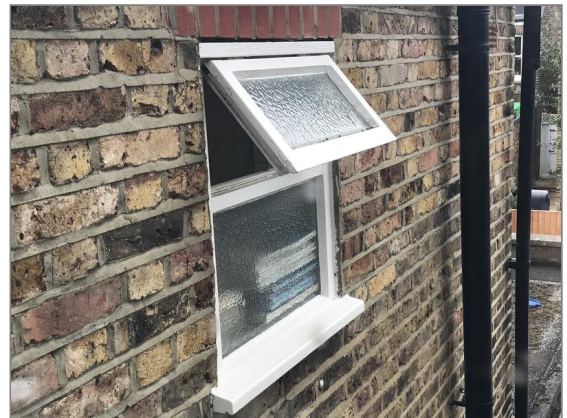
*Photo - 48 WC window.*

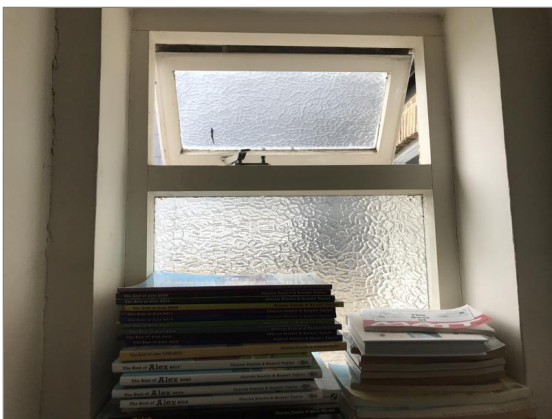
*Photo - 49 WC window.*

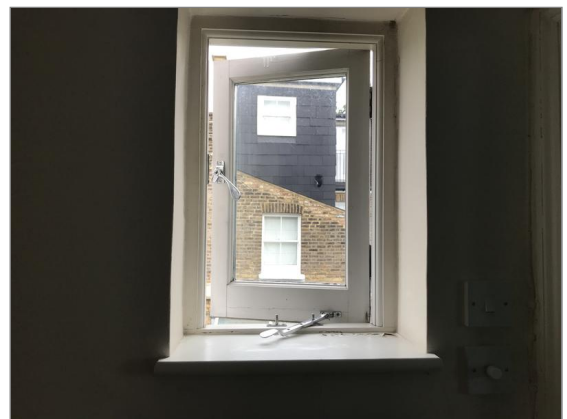
*Photo - 50 Landing window.*

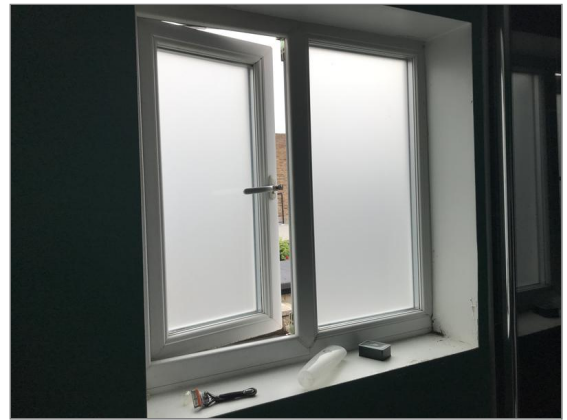
*Photo - 52 Bathroom window.*

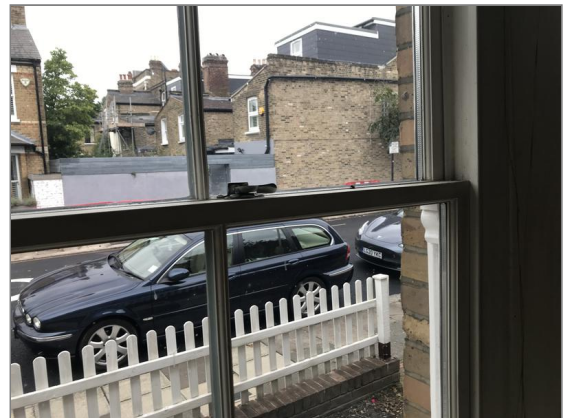
*Photo - 54 Counter-weight mechanism removed from living room window.*

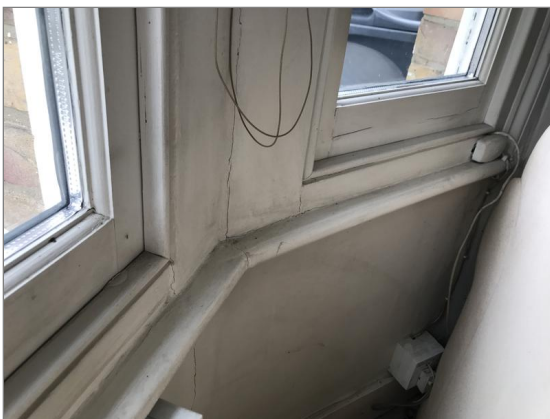
*Photo - 55 Failure of internal decorations to living room window.*

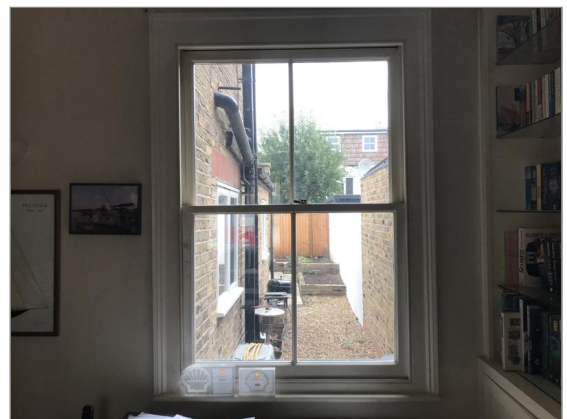
There is a double glazed timber framed sliding sash window at the rear of the living area. Again, the counter-weight mechanisms to this window have been removed and a new owner may wish to have these replaced. Redecoration of this fitting will be required within the next 18 months.

*Photo - 56 Rear living room window.*

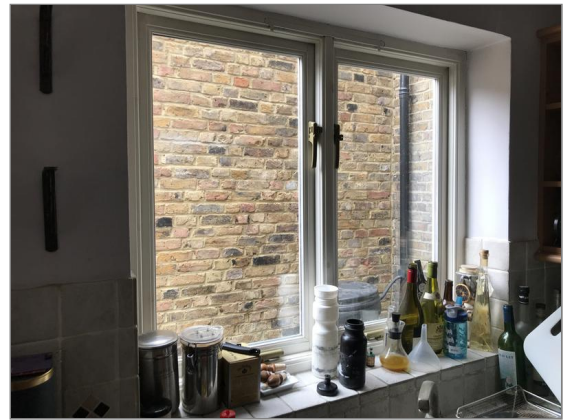
The kitchen features double glazed timber framed casement fittings. These fittings have recently been externally redecorated and no current wants of repair were identified.

*Photo - 58 Kitchen window.*

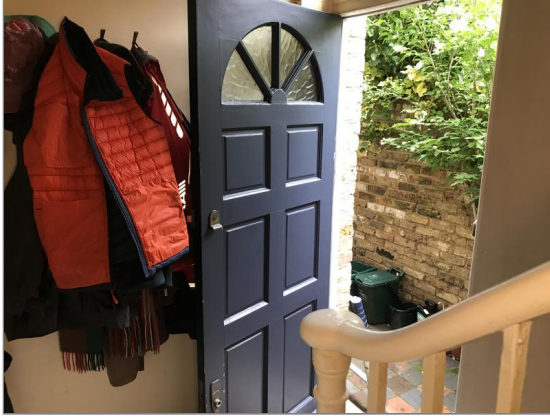
*Photo - 62 Front door.*

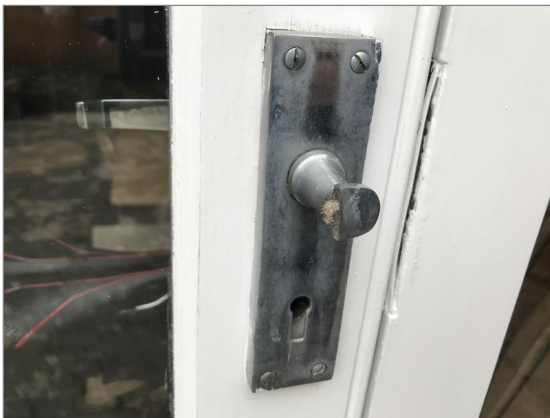
Double glazed timber framed folding doors lead out from the kitchen into the garden. Due to the items stored against the doors, we were unable to open them, however, no failure of the double glazing was identified. The external door handle to these fittings has failed and requires replacement. Redecoration of the doors should not be required for the next 24 months.

*Photo - 66 Damage to folding door handle.*

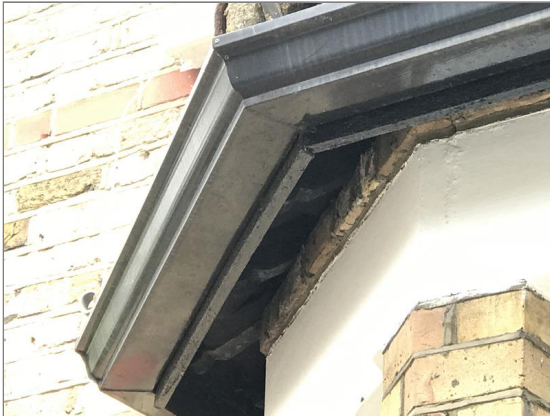
The timber fascias to the bay are in fair decorative condition and they will next require redecoration within the next 3-5 years. We recommend that the decorations to the timber fascias at the rear of the property are renewed when the roof coverings are next replaced. At this time, a new owner could also consider replacing these fascias with uPVC fittings.

Photo - 68 Timber fascias at front of the property.

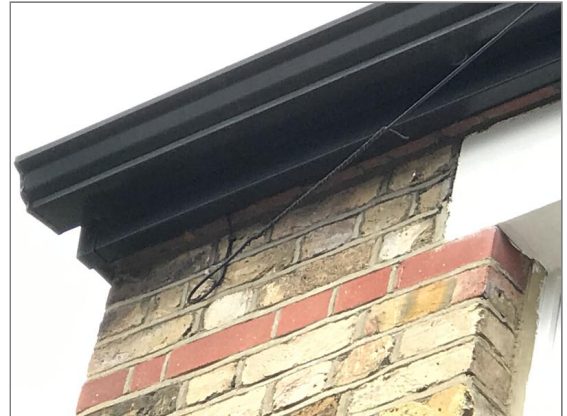
The fascias to the front have been renewed with uPVC fittings and these are in fair condition.

Photo - 69 uPVC fascias at the front of the property.

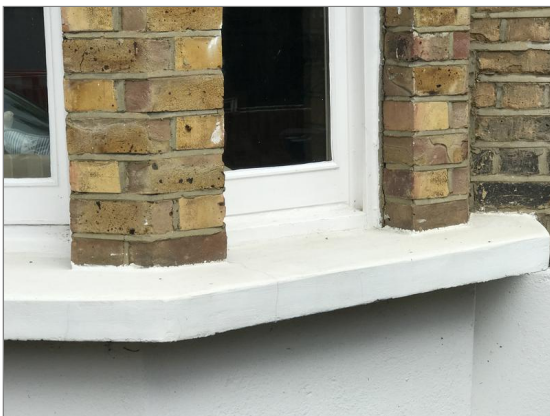
The decorations to the stone window sills are in fair condition with no current wants of repair.

Photo - 70 Decorations of stone window sills.

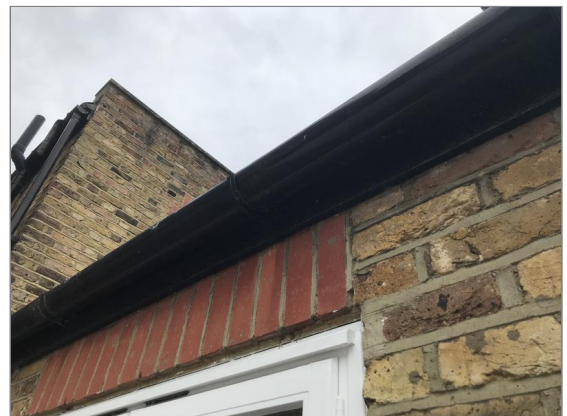
Photo - 71 Timber fascias at the rear of the property.

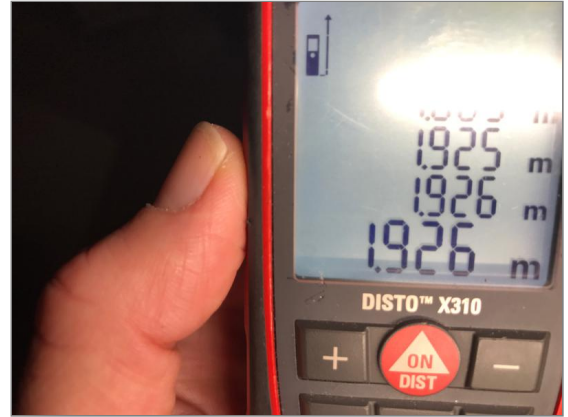
The ridge height of the main pitched roof was measured and this was found to be lower than that required to form a loft conversion. Lowering the ceilings at first floor level and increasing the ridge height will be required to provide sufficient head height in this space.

Photo - 75 Ridge height of pitched roof.

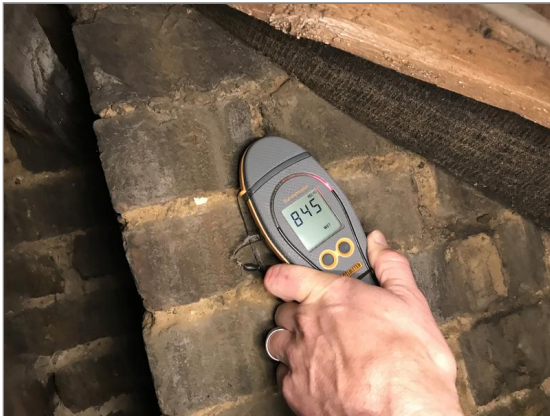
No significant deflection of the roof timbers was noted in this space, however, we did find evidence of water penetration around the chimney stacks. This will require the renewal of the flashings to these elements to resolve. Humidity staining was also noted to the roof timbers, indicating a lack of ventilation to this space. When the roof coverings are renewed, we recommend that they are laid onto a breathable membrane to allow for moisture to more readily escape the void. We also observed the presence of numerous mouse bait traps which indicates an active rodent infestation in the property.

Photo - 76 Elevated damp meter readings to chimney stacks.

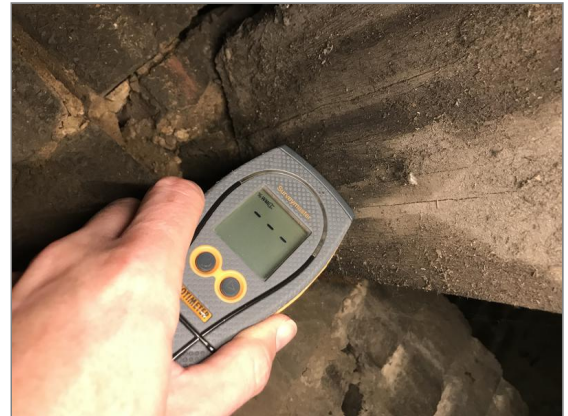
Photo - 77 Damp meter testing to roof timbers.

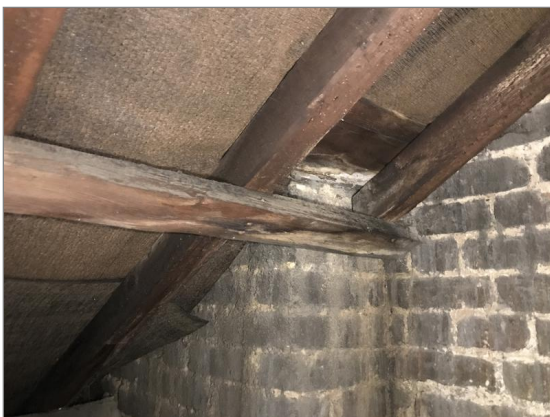
Photo - 78 Water damage to roof timbers in contact with chimney stack.

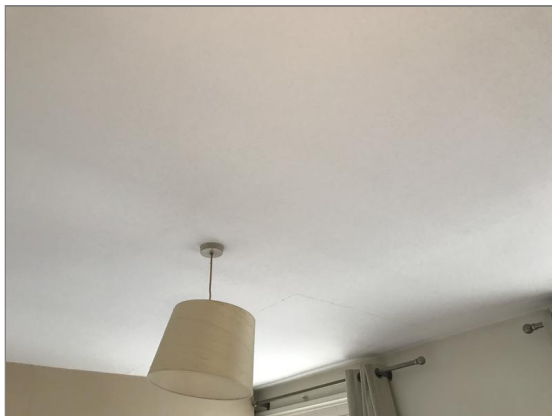
Cracking was found to the ceilings in both bedrooms. This has resulted at the joints of the plasterboard fixed to these ceiling surfaces and is not of concern. Similar cracking was also found to the ceiling above the first floor landing. These surfaces can be made good during the next cycle of decorations.

*Photo - 80 Front bedroom ceiling.*

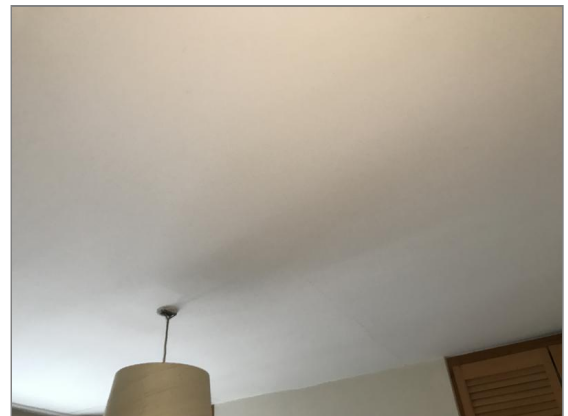
*Photo - 81 Rear bedroom ceiling.*

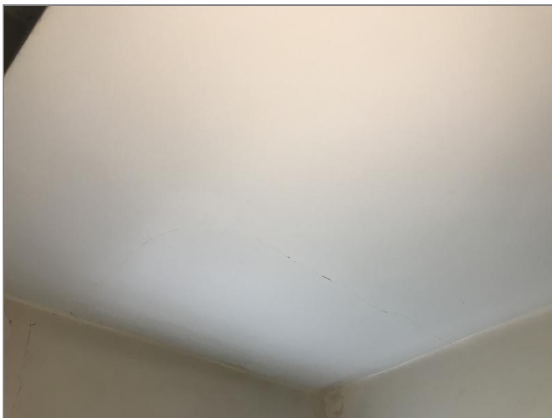
*Photo - 84 Cracking to landing ceiling.*

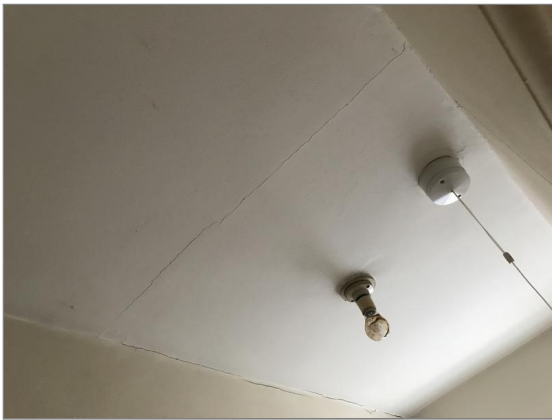
Minor cracking was also found to the ceiling in the WC. This is not of concern and can be made good during the next cycle of decorations.

*Photo - 88 WC ceiling.*

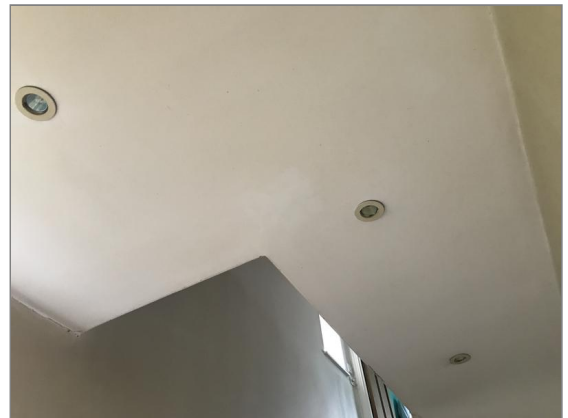
At ground level, cracking was also found to the ceiling in the living area. This has resulted at the joints of the plasterboard and can be made good when these surfaces are redecorated. The ground floor hallway ceiling is in slightly tired decorative condition and would benefit from redecoration

*Photo - 91 Ground floor hallway ceiling.*

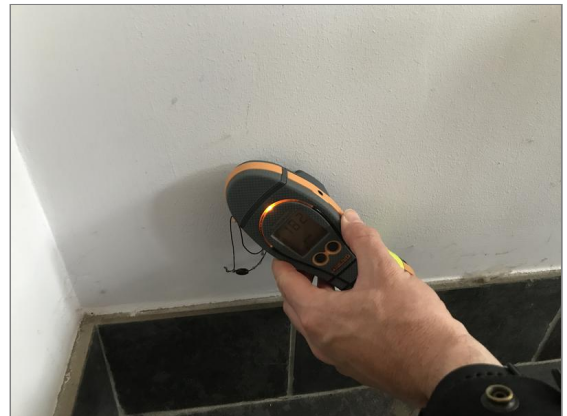
The rear dining area walls are in tired decorative condition. Cracking has developed to the surface of the walls, indicating slight movement of the back left hand corner of this structure. If an extension is to be carried out, then the depth of the foundations should be examined and reinforced as required. No significant areas of damp penetration through these walls were identified, however, the surfaces have been affected by high humidity. We recommend that a humidity activated extract fan is fitted in this space to improve the control of humidity in this area.

*Photo - 96 Damp meter testing to dining area walls.*

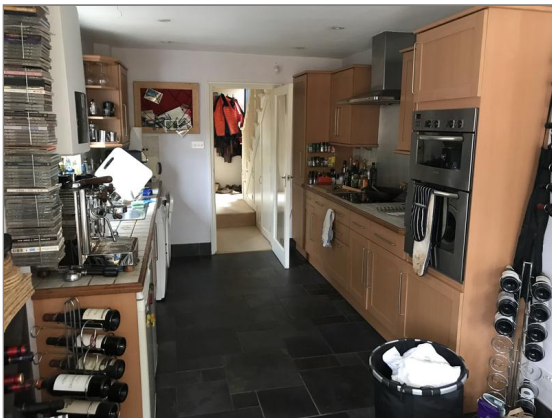
A limited inspection of the kitchen wall surfaces could be carried out due to the built-in fittings in this space. Elevated damp meter readings were recorded to the face of the partition walls separating this area from the dining room. We suspect that this has been caused by bridging of the damp proof course by the floor structure in this area. Renewal of the damp proof course and damp proof membrane laid beneath the floor should be carried out (if significant extension works are planned).

Photo - 101 Kitchen walls.

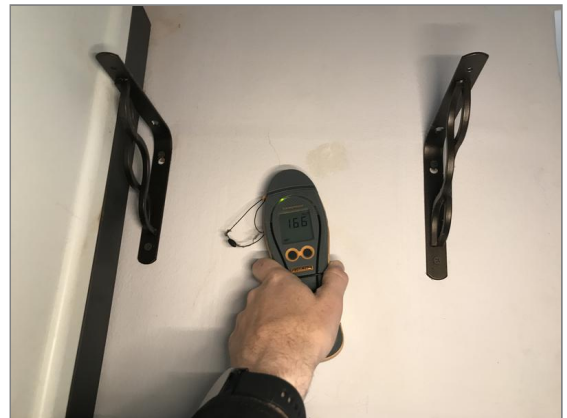
Photo - 102 Damp meter testing to kitchen walls.

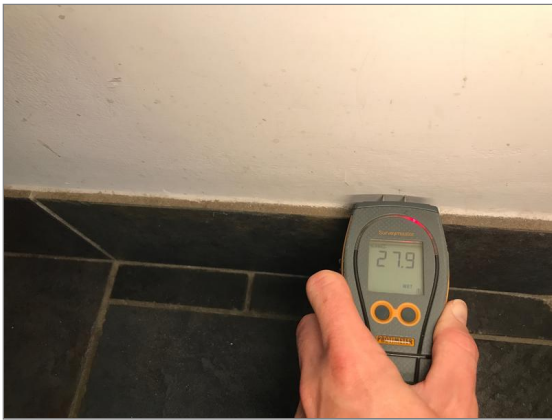
*Photo - 105 Dampness to kitchen walls.*

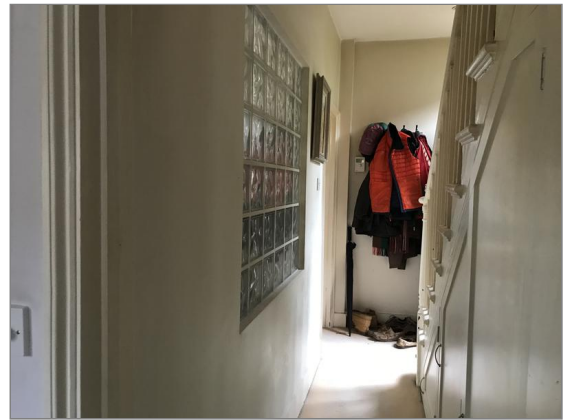
The entrance hallway walls are in tired decorative condition and they have been subject to scuffing and minor mechanical damage. Elevated damp meter readings were also recorded to these wall surfaces, likely due to drafts (causing humidity to condense upon these surfaces).

*Photo - 106 Entrance hallway walls.*

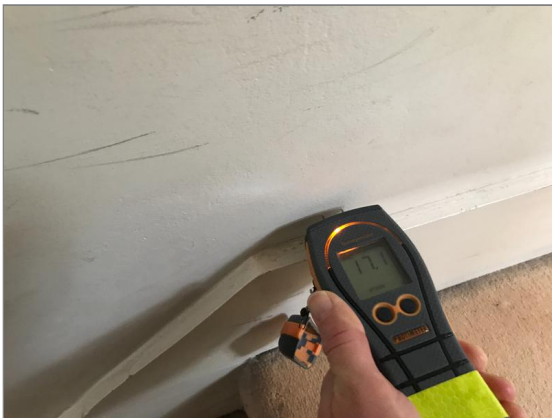
*Photo - 107 Damp meter testing to entrance hallway walls.*

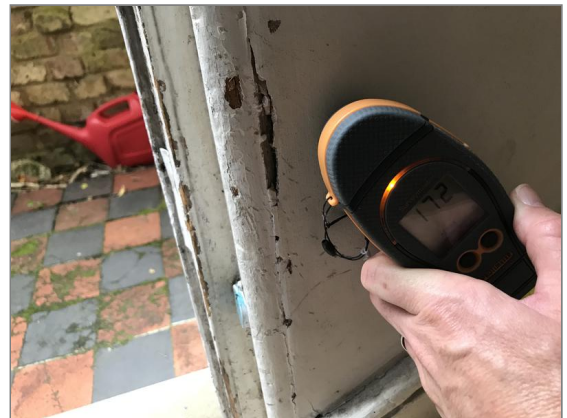
*Photo - 108 Damp meter testing to entrance hallway walls.*

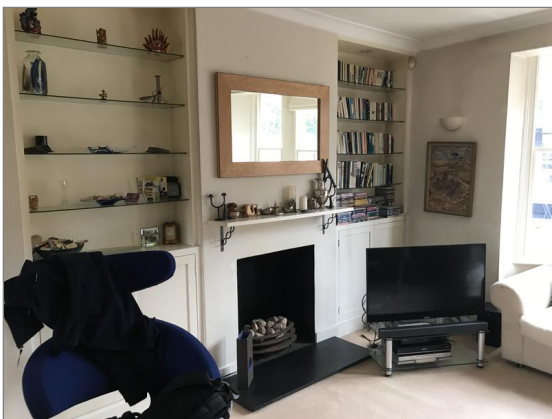
*Photo - 109 Front sitting room walls.*

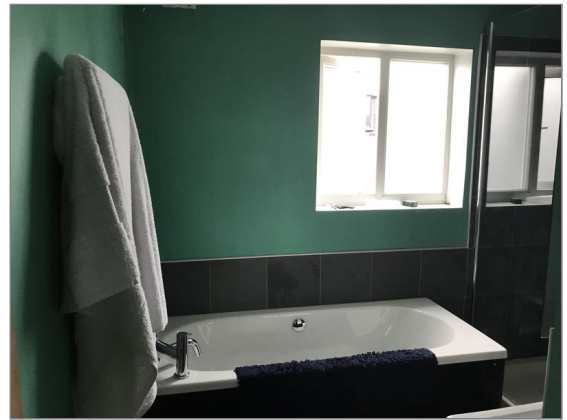
The bathroom walls are in tired decorative condition and they have been affected by high humidity. Water penetration was also evidenced as a result of a failure of the roof coverings above this area. The tiling within the shower enclosure was found to have failed and water penetration is occurring through the tiles. This will require re-tiling of this space to resolve and these works should occur in the near future (in order to preserve the supporting wall behind). It should be noted that any

damage that has occurred to the adjacent walls and floors is concealed by the built-in fittings in this space.

*Photo - 118 Bathroom walls.*

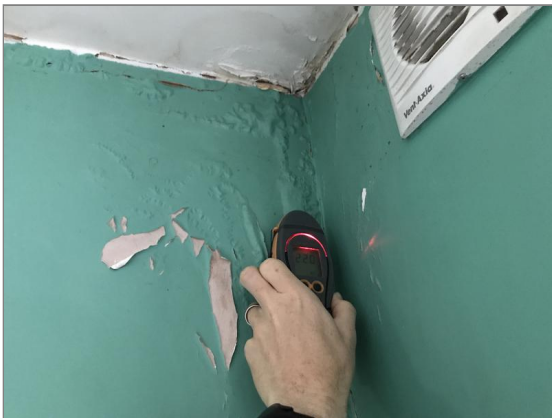
*Photo - 119 Damp meter testing to bathroom walls.*

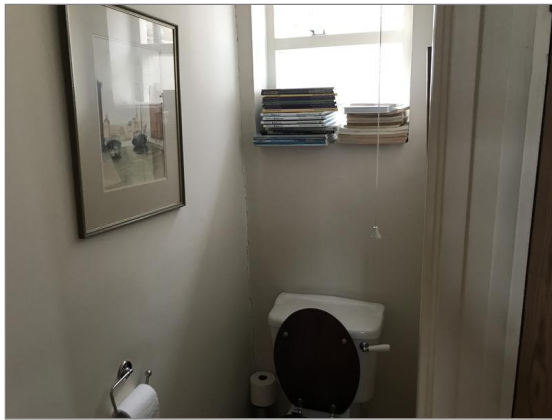
Cracking was found at the wall abutments within the WC. This has resulted due to differential movement of the external walls and the internal partitions (which is typical for dwellings of this type).

*Photo - 124 Cracking to WC walls.*

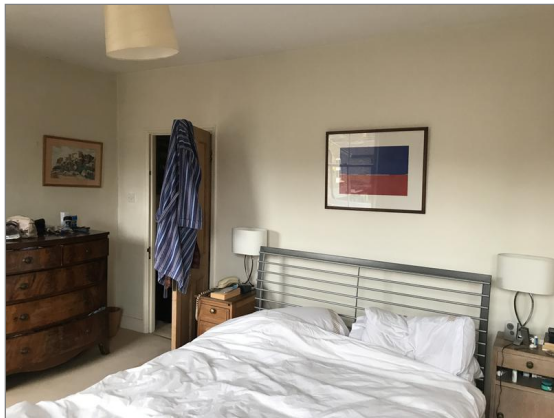
The front bedroom walls are in poor decorative condition and they require redecoration. Cracking was observed below both windows in this room. This has been caused by movement of the bay and will require crack stitching repair and redecoration to resolve. This area of cracking should be monitored, as repairs to the lintel above the bay and the foundations of the bay may be required. Slight hairline cracking was also found to the corner and above the door of this room. This is not of concern and can be made good when these surfaces are next redecorated.

Photo - 129 Front bedroom walls.

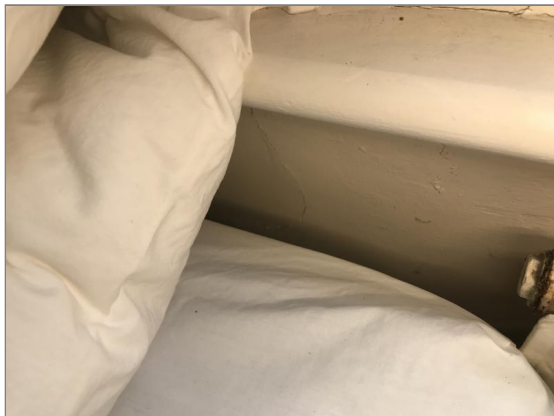
Cracking has developed below the window in the rear bedroom, again, due to differential movement between the front and rear of the property. This can be made good as described above.

Photo - 131 Cracking to rear bedroom walls.

Overall, the internal walls are in tired decorative condition throughout and require crack stitching repairs, plaster repairs and redecoration. We recommend that the cracking to the rear addition and front bedroom is monitored for any further movement. In addition, external repairs are required to remedy the damp penetration this is occurring and the tiling within the bathroom requires renewal.

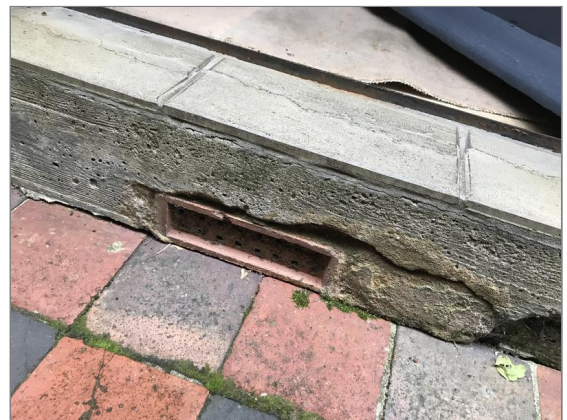
Ground floor suspended timber floor structures require ventilation to remove humidity from the void beneath them. Subfloor vents have been provided around the building for this purpose, however, some of these lie in close contact with the ground. We recommend that a channel drain (or gravel filled French drain) is introduced around the perimeter of the property to prevent water from entering into them.

*Photo - 134 Sub floor vent in contact with ground.*

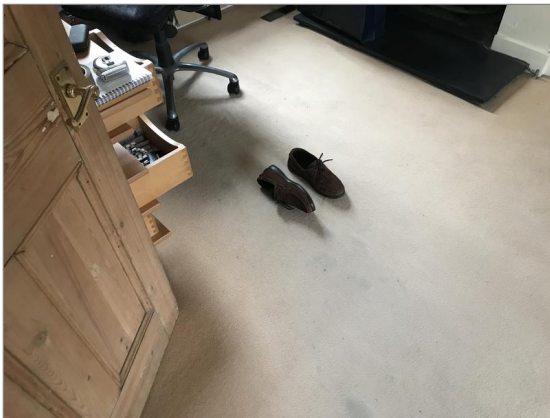
*Photo - 137 Living carpet in tired condition.*

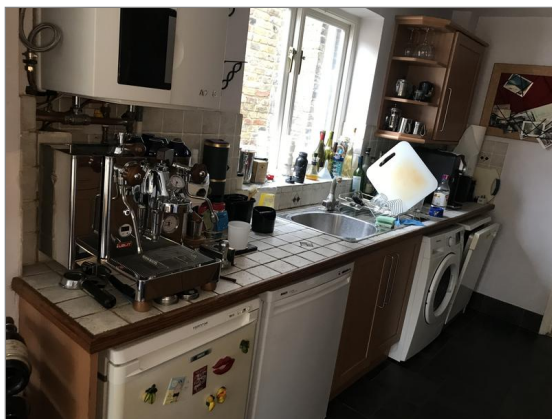
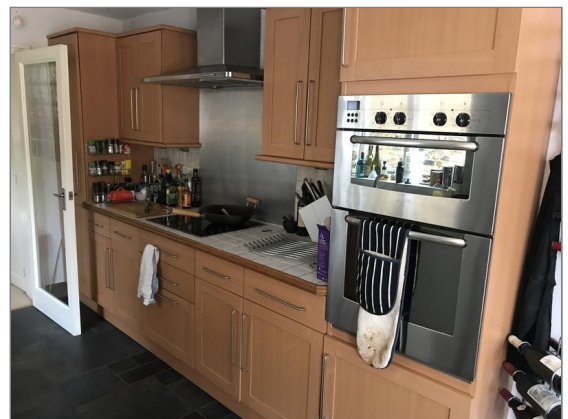
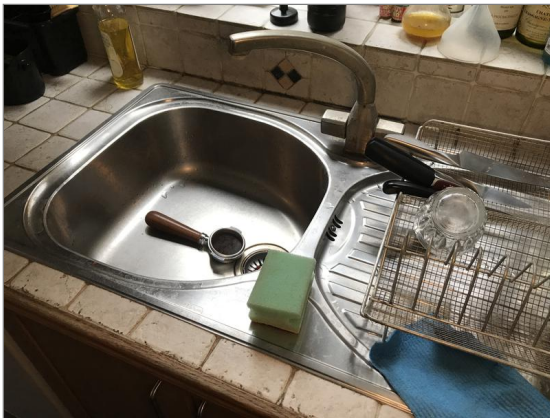
The kitchen features foil faced MDF cabinetry with a tiled worktop. These fittings have reached the end of their life and we recommend that they are completely renewed.

*Photo - 148 Kitchen fittings.*

*Photo - 149 Kitchen fittings.*

*Photo - 150 Kitchen fittings.*

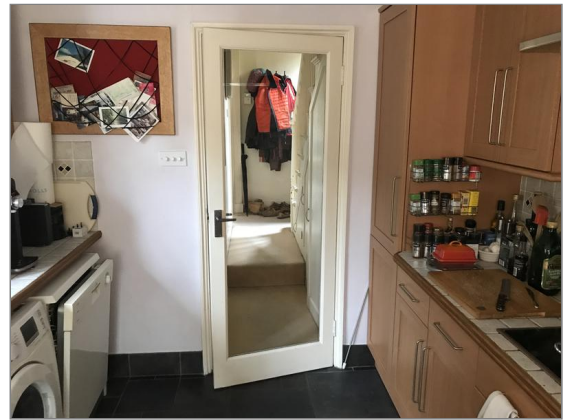
The internal doors are simple timber door sets; it should be highlighted that these are non fire rated fittings. If a loft conversion is formed, then fire rated doors should be installed throughout. The kitchen door is fully glazed, however, there is no Kitemark on the glazing to indicate that toughened glass has been installed (or the door is fire rated). We recommend that this door set is renewed with a fire rated door set with safety glass (to protect occupants who may fall against the door).

Photo - 154 Glazed door to kitchen.

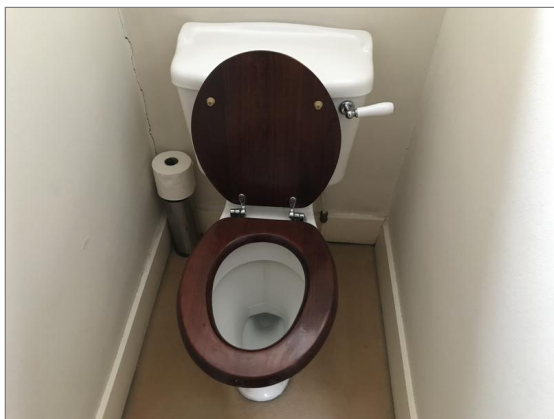
The property features a WC and a separate bathroom. The fittings in these spaces are tired and we recommend that these suites are renewed in the near future. As mentioned in E2, evidence of previous leaking from the shower tray was identified.

Photo - 156 WC fittings.

Photo - 157 Bath fittings.

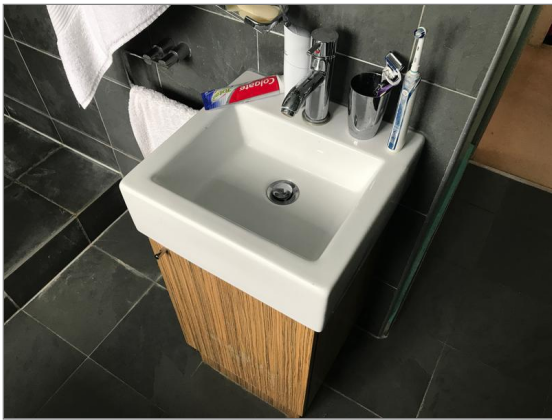
*Photo - 158 Basin fittings.*

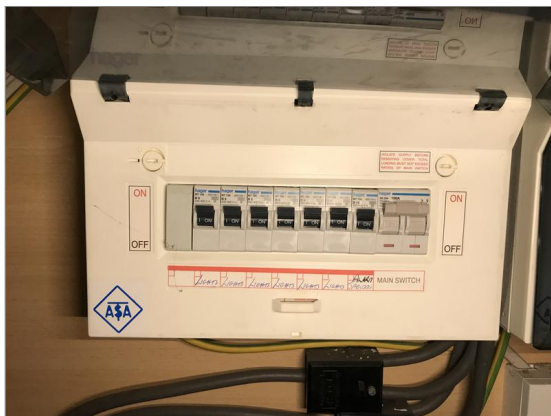
The electrical distribution boards and meters are located beneath the stairs. The property features a part RCD protected distribution system, indicating the system is likely to be in excess of 20 years old. The electrical fittings in the property are tired and would benefit from renewal. If significant works are intended, we recommend the property is completely rewired and a fully RCD protected distribution board is fitted. No visual wants of repair were identified during the survey.

Photo - 163 Non RCD protected light circuits.

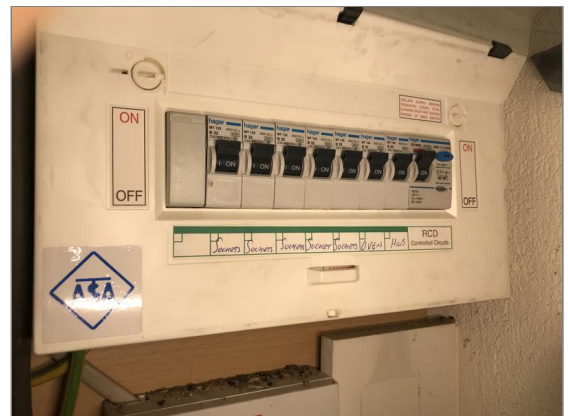
Photo - 164 RCD protected distribution board.

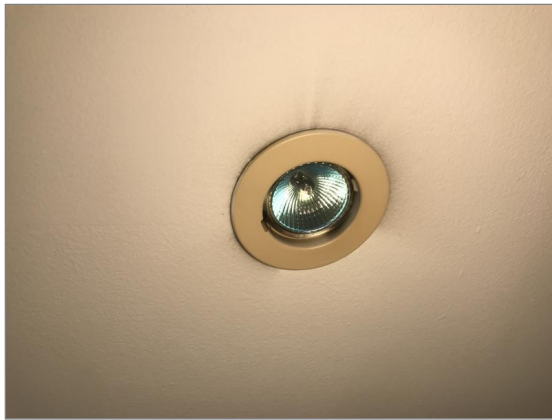
Photo - 165 Dated light fitting.

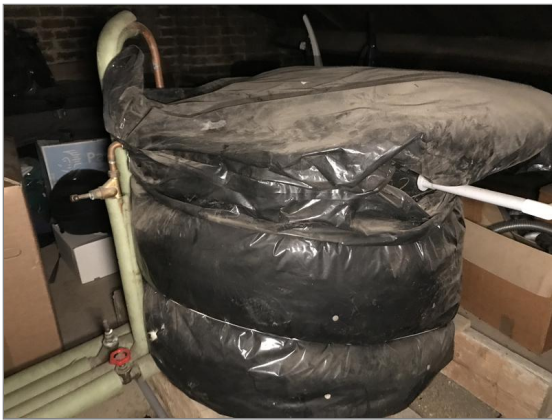
Photo - 167 Cold water tank in the loft.

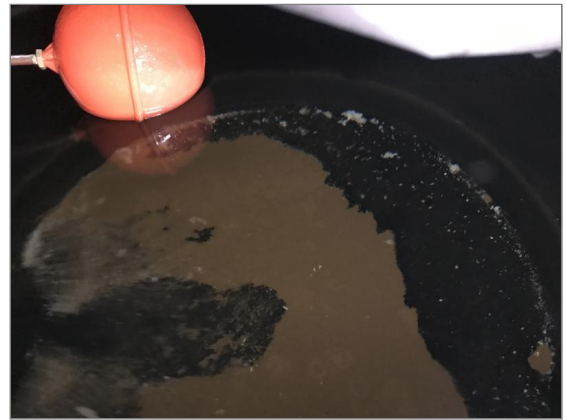
The property features a cold water tank in the loft which supplies cold water to the boiler and bathroom fittings. There is a build up of sediment within the tank and this should be cleaned and properly sealed. It should be noted that if tank fed water supplies are not properly maintained, they pose a risk of Legionella. If a loft conversion is intended, then we recommend that the property is re-plumbed so that all outlets are provided under direct mains pressure. As part of these works, we recommend that a large capacity cold water main is brought into the dwelling. We were informed that the cold water isolation valve of the incoming main is located within the kitchen. During the inspection, a sufficient flow of cold water was provided by this system.

Photo - 168 Sediment build up in tank.

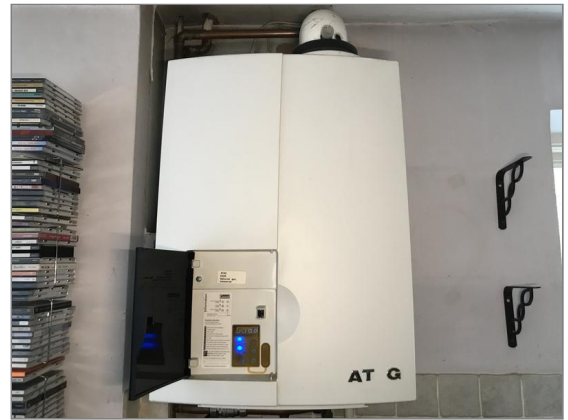
The property is heated by a gas fired boiler in the kitchen and this supplies hot water to the radiators. There is rusting to the radiators and the boiler looks to be nearing the end of its life. We recommend the heating system and boiler are completely renewed in the near future. Due to the high ambient temperature at the time of the inspection, we were unable to test the effectiveness of the heating system.

Photo - 171 Boiler in the kitchen.

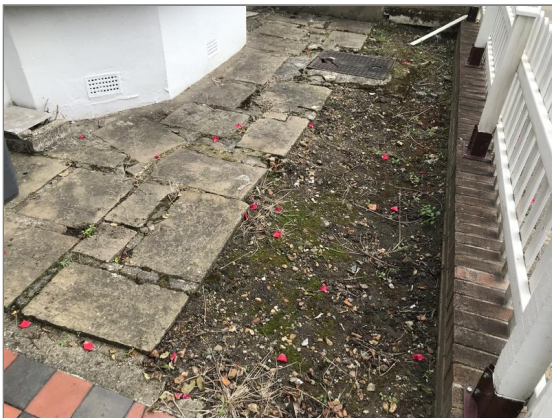
The front garden is bordered by a low picket fence and this element is in fair condition. In contrast, the paving in the front garden has failed and requires complete renewal. There is a single skin blockwork wall to the right hand side of the garden. This is also in poor condition and a new owner should consider having this replaced.

*Photo - 184 Failure of paving in front garden.*

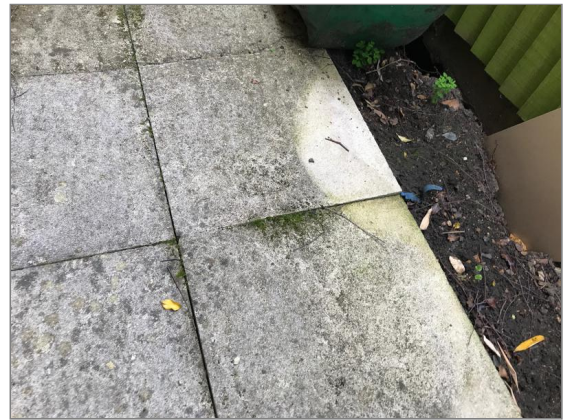
The paving to the side passageway is in poor condition and requires renewal. The paving slabs have been laid directly onto the soil (with a suitable sub-base).

*Photo - 189 Paving slabs require re-laying to the side of the property.*

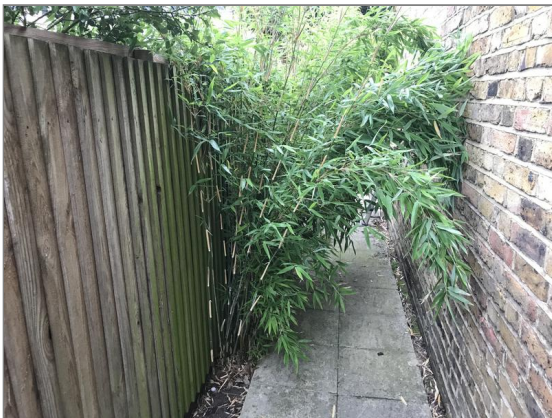
There is bamboo growth in the side passageway. It should be highlighted that bamboo can pose a risk to the foundations of a property and we recommend that this plant is completely removed.

*Photo - 190 Mature bamboo growth at the side of the property.*

The bamboo at the side of the property should be cut back to prevent damage to the foundations of the building.
