# Your survey report

L2 Example Street, London, SW

17th October 2022

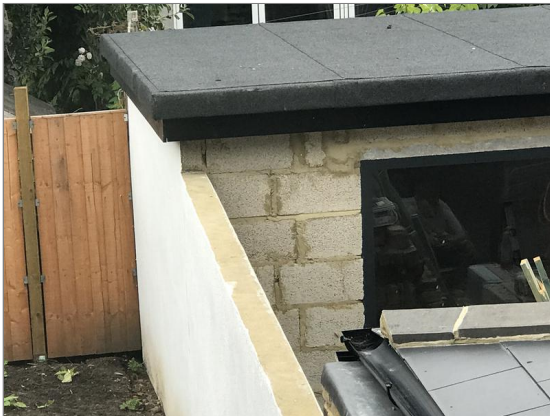
We noted that the eaves of the roof to the neighbour's garden building oversail the boundary. A new owner may wish to request that the neighbour removes this structure back to the boundary.

*Photo - 195 Roof structure oversailing boundary wall.*
