LEVEL 3

Your survey report

L3 Example Street, London, SW

17th October 2022

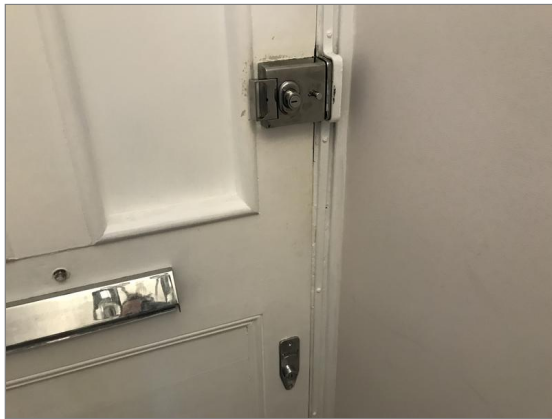
Photo - 2 Locking furniture to front door

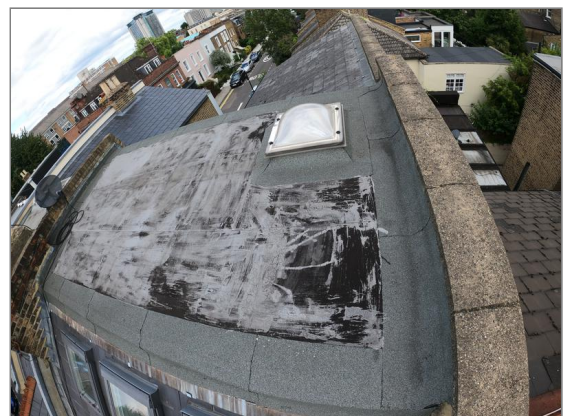
Overall, the main roof coverings are in fair condition and should not require renewal for the next 10 to 15 years. The flat roof coverings above the mansard will require renewal within the next 2 to 3 years.

Photo - 16 Elevated view of flat mansard roof

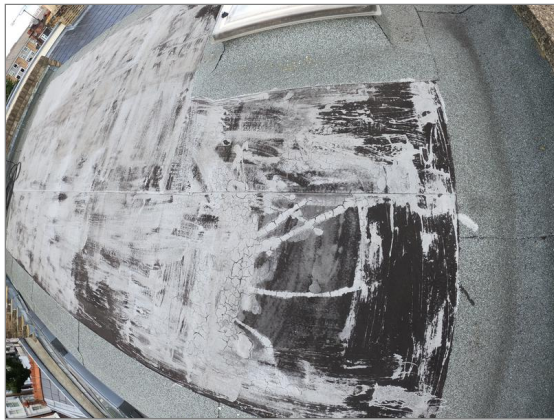
Photo - 17 Waterproof paint used to prolong the life of flat mansard roof

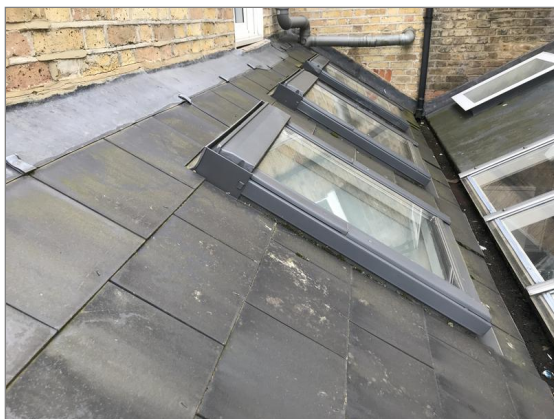
The side extension roof also features a manmade slate covered roof. Slight cracking was noted to the cement holding the flashings in place and we suspect that this will require renewal within the next 2 to 3 years. No current wants of repair were identified during the inspection.

Photo - 21 Side addition roof

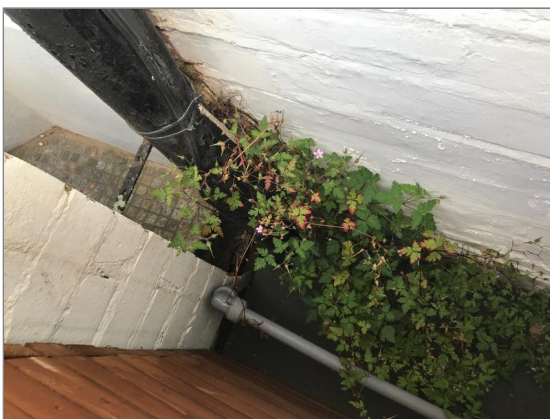
Photo - 25 Debris build up in open gully at front of property

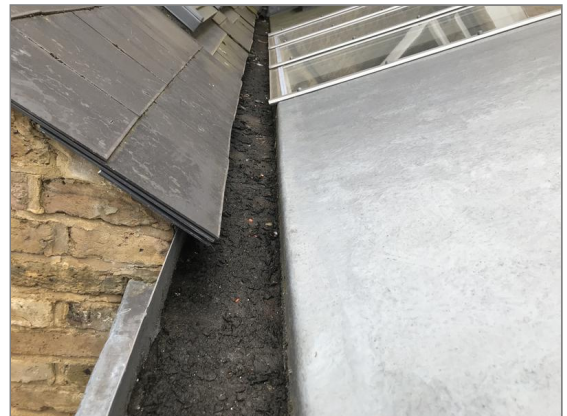
Rainwater running off the flat mansard roof is captured by guttering at the rear of this structure. From here, the water is discharged into a valley gutter serving the side extension roof. This gutter is shared with the neighbouring property. Water captured by this element runs into the subsurface dwelling of the neighbouring property. There is a build up of debris within this gutter and this requires clearance.

Photo - 30 Debris build up in valley gutter

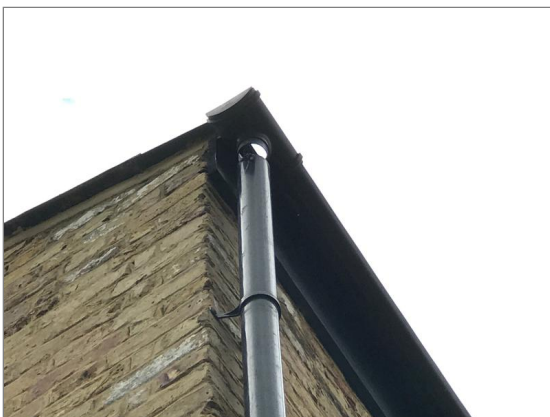
Rainwater running off the rear outrigger roof is captured by a gutter running along the edge of this roof. This gutter is drained by a downpipe that runs into the subsurface drainage at the rear of the property. The connection between the guttering and the downpipe has failed and this requires re-fixing. At present, water is escaping at this junction and leading to dampness in the rear bedroom at first floor level. The build up of moss and debris in the gutters should also be cleared.

Photo - 31 Downpipe detached from guttering serving rear outrigger roof

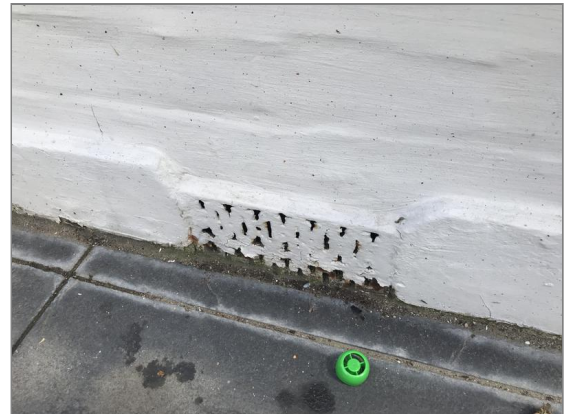
Photo - 33 Sub-floor vent in contact with ground

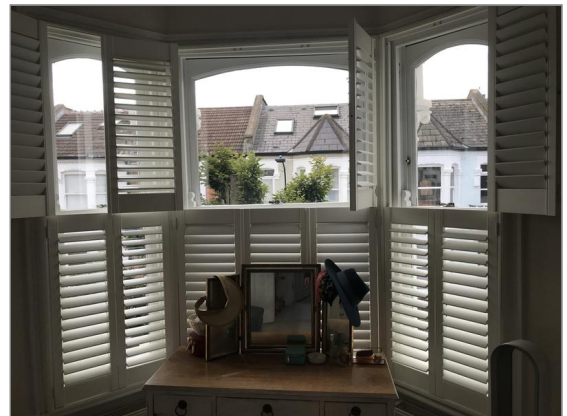
The first floor master bedroom features three sliding sash windows set into the bay. These windows have been recently internally decorated, however, the decorations are relatively inexpert. Going forward, external redecoration of these fittings will be required within the next 2 years and we recommend that the windows are eased and adjusted at that time. No failure of the double glazing was identified during the inspection. The windows feature factory finished MDF shutters and these elements are in fair condition.

Photo - 49 First floor master bedroom window

We recommend that the external decorations to the windows are renewed and these works should occur within the next 2-3 years.

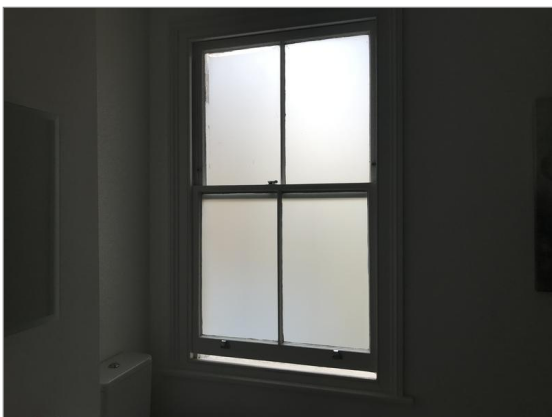
The en-suite bathroom also features double glazed, timber-framed windows which have been recently internally decorated. As before, external redecoration of these fittings will be required within the next 2 years. A slight failure of the obscured film to these windows was observed and this would require replacement of the affected glazing pane to resolve.

Photo - 50 First floor en-suite bathroom window

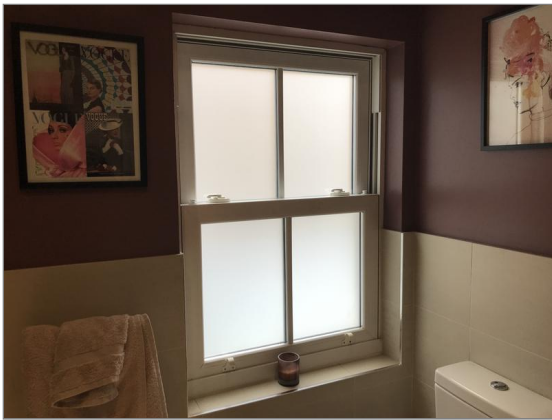
Photo - 52 First floor bathroom window

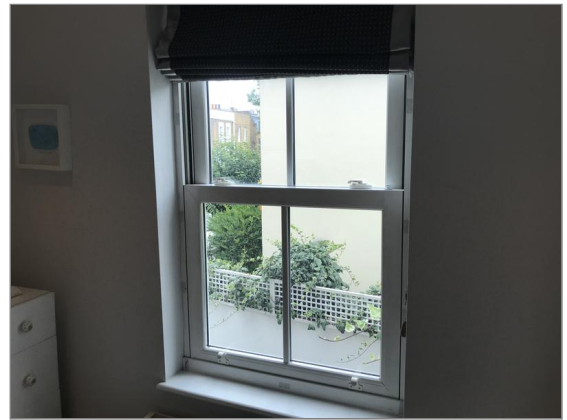
The rear first floor bedroom also features a double glazed, uPVC framed window. Renewal of this window will be required within the next 3 years. Minor damage was noted to the frame of this window, however, this does not affect its performance.

Photo - 53 Rear first floor bedroom window

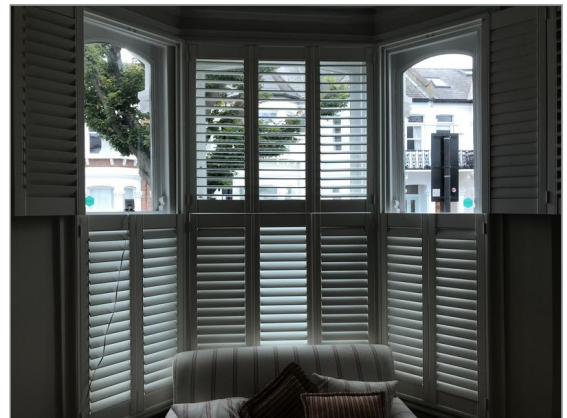
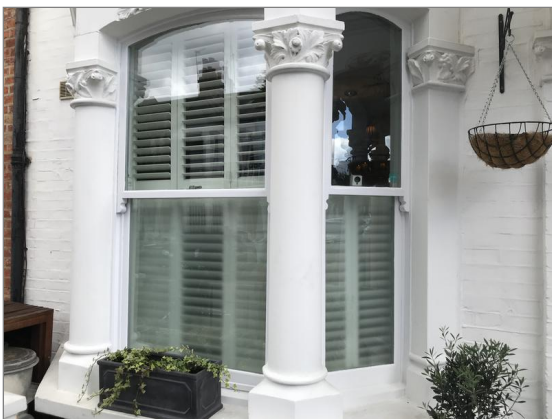
The front sitting room features three double glazed, timber-framed windows. These fittings have been inexpertly decorated and we recommend that they are redecorated within the next 2 to 3 years. All of the windows have been painted shut and cannot be opened. The counterweight mechanisms have also been removed from the outer windows, although they have been retained to the central sliding sash. These windows have been fitted with factory finished MDF shutters and these elements are in fair condition.

Photo - 55 Front sitting room windows

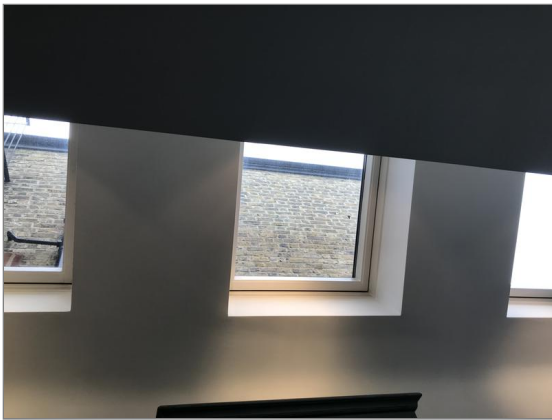
The side addition features three centre pivot roof windows. These elements have been recently redecorated to improve their appearance and they should not require renewal for the next 5 years. The kitchen also features a fixed double glazing pane, set within a uPVC frame. This unit is in fair condition.

Photo - 58 Side addition windows

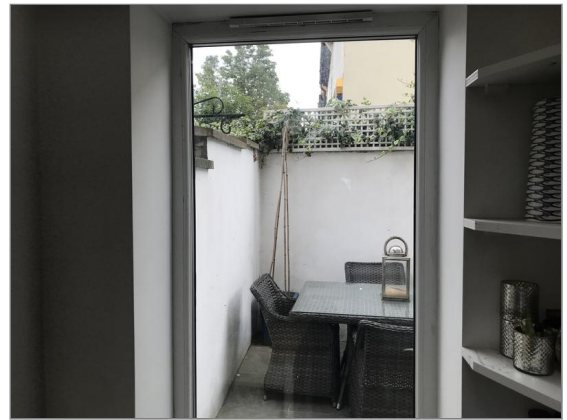
Photo - 59 Fixed glazing pane at rear of side addition

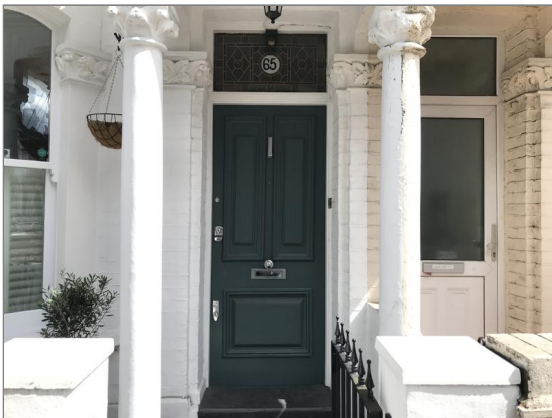
The front door is a hardwood timber door set featuring a leaded overhead light (that has been fitted with secondary glazing). Overall, the door is in fair condition less for tarnish to the door fittings. 2

Photo - 60 Front door

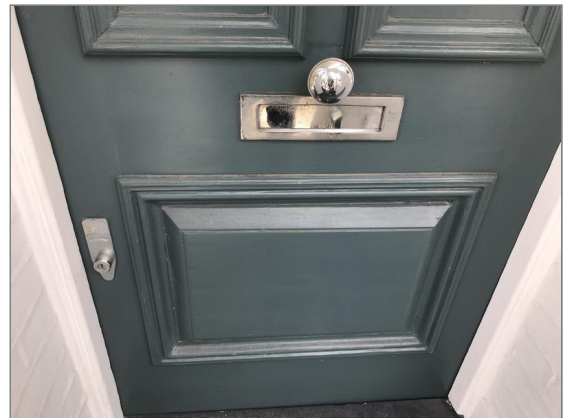
Photo - 61 Slight tarnish to front door fittings

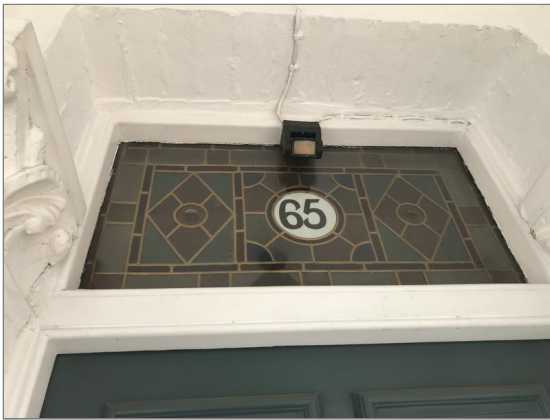
Photo - 62 Leaded overhead light

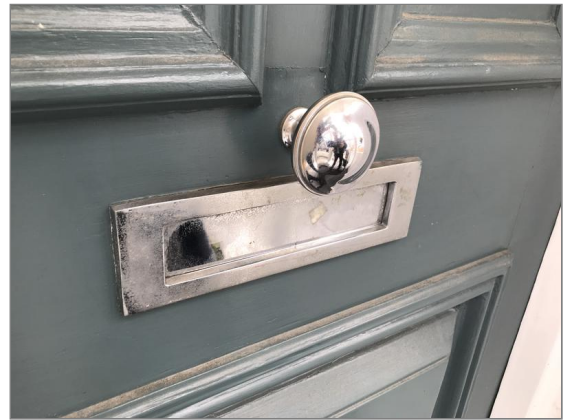
Photo - 63 Front door fittings

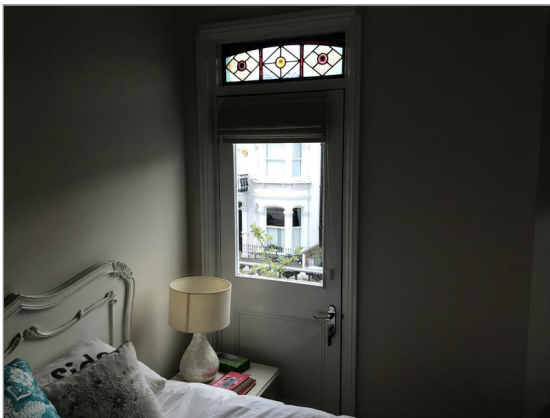
Photo - 64 Master bedroom door

A timber door leads out from the master bedroom onto the soffit of the porch. This door set was unable to be opened and external redecoration, easing, adjustment and minor repair of this fitting is required.

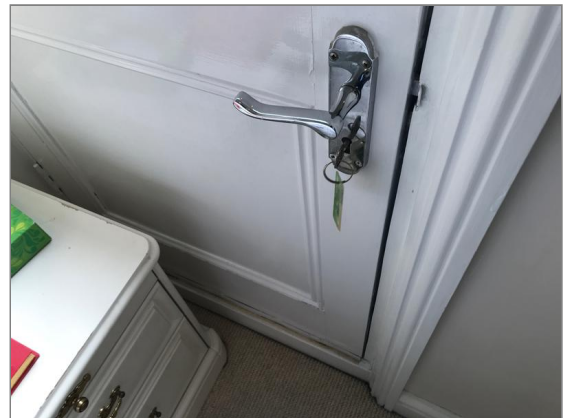
Photo - 65 Master bedroom door requiring adjustment

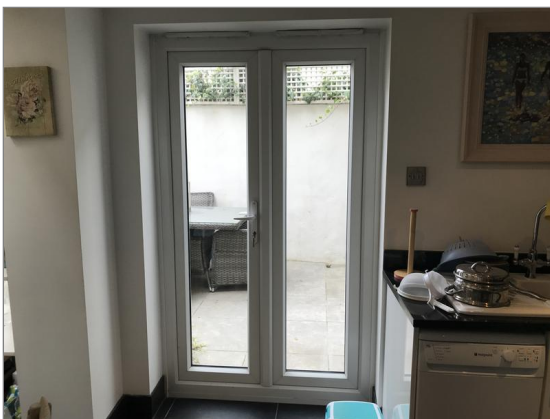
Double glazed, uPVC framed doors lead out from the kitchen into the rear garden area. These doors are in fair condition, however, the right hand door rubs along its frame and it would benefit from minor adjustment.

Photo - 66 Double doors leading to rear garden

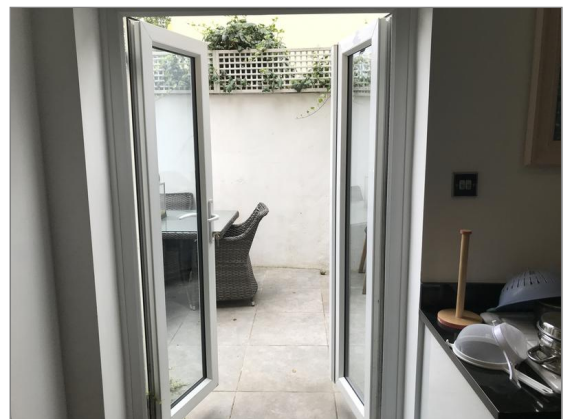
Photo - 67 Testing double doors leading to rear garden

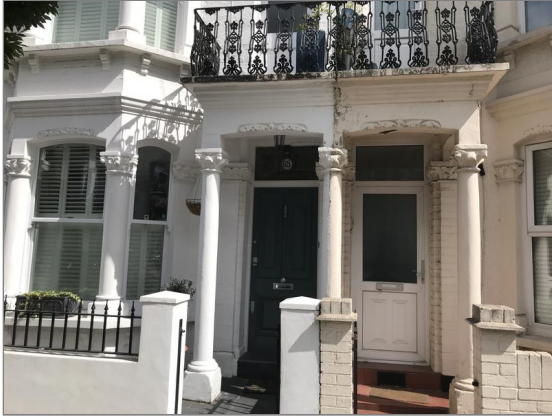
The property features a stone porch structure. The decorations to this element are failing and would benefit from renewal within the next 2 to 3 years. Evidence of water penetration through the soffit above this element was identified during the inspection. We recommend that the surface of

Photo - 68 Porch structure

the soffit is treated with waterproof walkway paint to prolong its life. Redecoration of the steel railings around the balcony is also required. These works should be carried out within the next 6 to 12 months. No structural instability of the porch was identified during the survey.

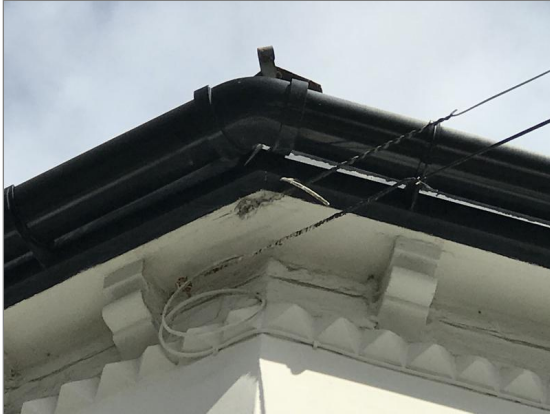
The decorations to the painted timberwork are in fair condition and they should not require renewal for the next 3 years.

Photo - 73 Timber fascias and soffits

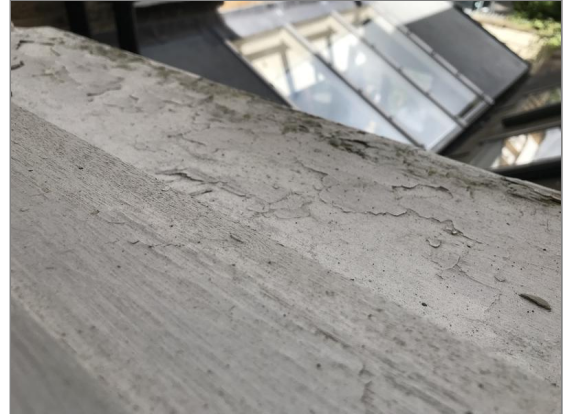
The decorations to the stone window sills are failing and they should be renewed within the next 12 months. At present, a failure of the decorations is leading to water penetration into the master bedroom.

Photo - 74 Decorative condition of window sills

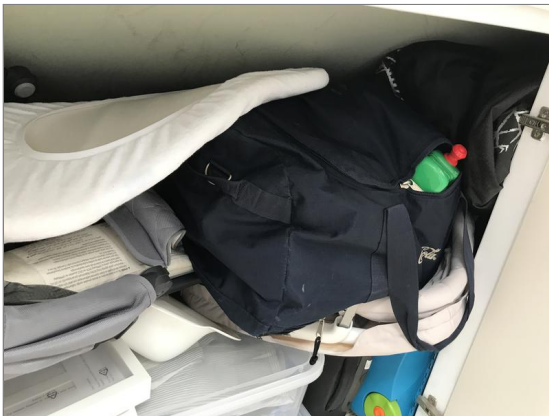
Photo - 76 Front pitched roof void boarded out

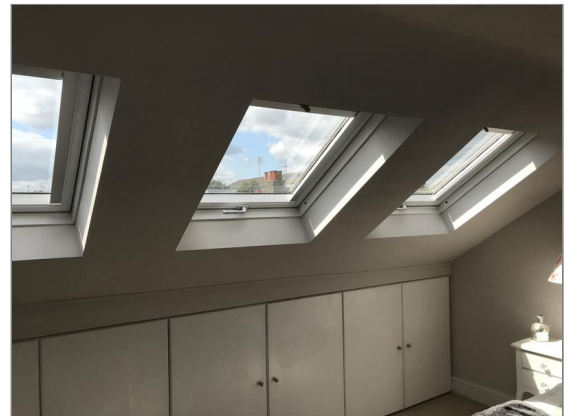
The front pitched roof structure has been boarded out to provide additional storage. Deflection has occurred to this structure, however, this is not unusual for structures of this type. Typically, this type of movement results when the loft structure is initially converted.

No signs of progressive movement were noted and we have no significant concerns regarding these elements.

Photo - 77 Deflection of front pitched roof structure

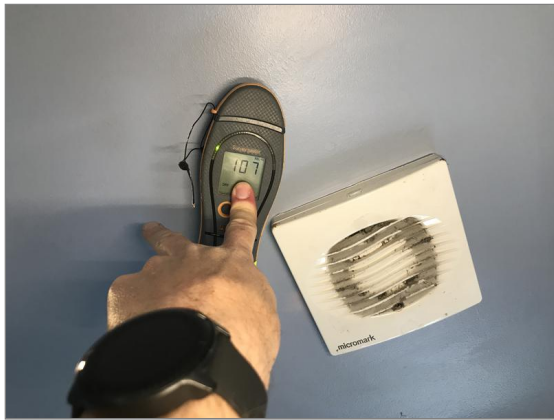
At second floor level, we found water staining to the surface of the ceiling in the bathroom. This is consistent with high humidity condensing upon this surface (and then running down the ceiling). A new owner may wish to replace the extract fan in this space with a humidity activated extract fan to improve the ventilation in this room.

Photo - 86 Damp meter testing to second floor bathroom ceiling

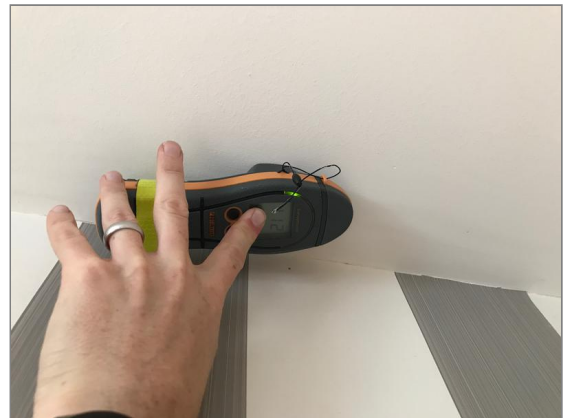
Water staining was also observed to the ceiling above the rear second floor bedroom. This is consistent with a failure of the flashings above this area (and it has led to water penetration to the rear of the pitched roof above). No currently elevated damp meter readings were recorded in this area, indicating the source of the leak has likely been resolved. No other significant wants of repair

Photo - 89 Damp meter testing to area of water staining

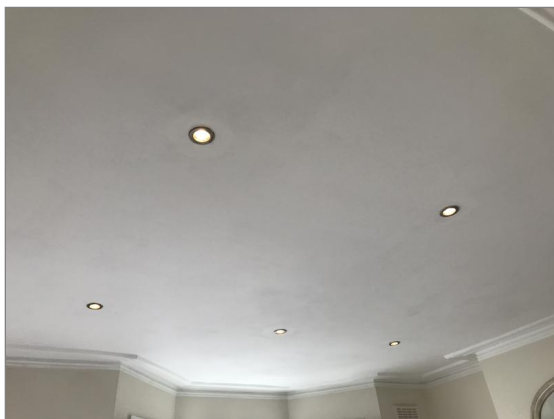
The first floor master bedroom ceiling is of lath and plaster construction. Slight cracking has developed to the coving around the edge of this ceiling due to a minor failure of the plaster in these areas. This is typical for ceilings of this type and the cracking is not of concern.

Photo - 90 First floor master bedroom ceiling

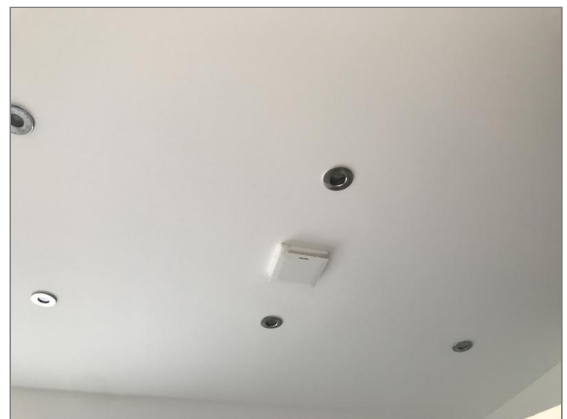
The en-suite shower room ceiling is of plasterboard. This surface is in fair condition, as is the ceiling to the adjacent changing area.

Photo - 91 First floor master en-suite ceiling

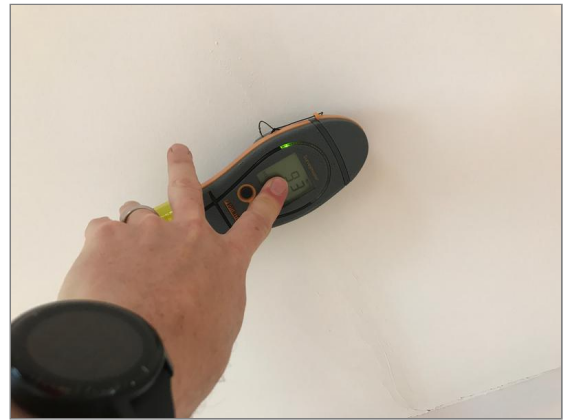
Photo - 93 Damp meter testing to area of cracking repair on first floor landing

A minor repair has been made to the surface of the first floor landing ceiling adjacent to the bathroom. This can be made good by sanding down and redecorating this area.

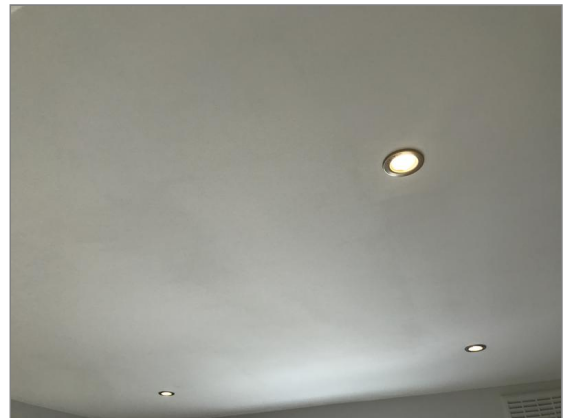
The rear first floor bedroom ceiling is of plasterboard. The corner of this ceiling has become damp, due to water escaping from the rainwater downpipe adjacent to this area. As mentioned previously, the downpipe requires repair.

Photo - 95 Rear first floor bedroom ceiling

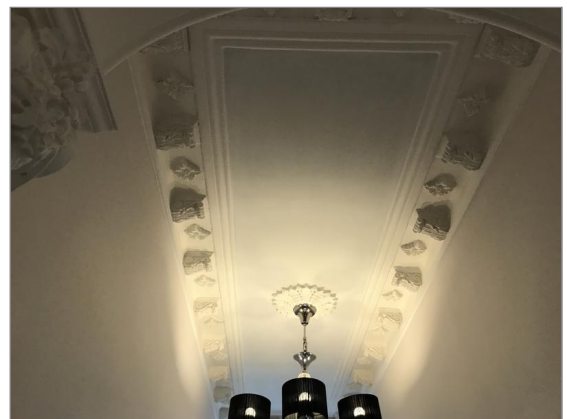
At ground floor level, the entrance hallway features an original lath and plaster ceiling with decorative plaster elements. This ceiling is in fair condition.

Photo - 97 Entrance hallway ceiling

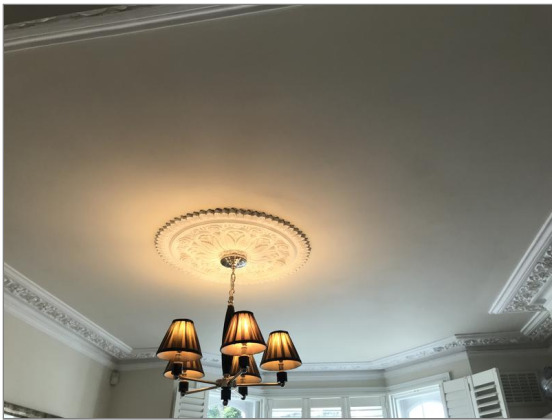
Minor cracking was found to the ceiling in the front sitting room, adjacent to the bay. This has resulted due to differential movement between the bay and the front facade of the property. Such cracking is typical for dwellings of this age and type and is not of concern.

Photo - 98 Front sitting room ceiling

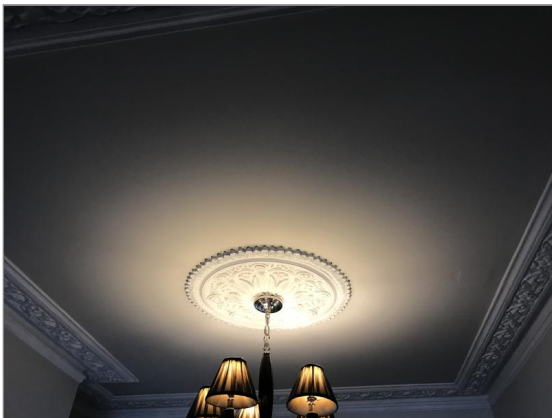
Photo - 100 Rear sitting room ceiling

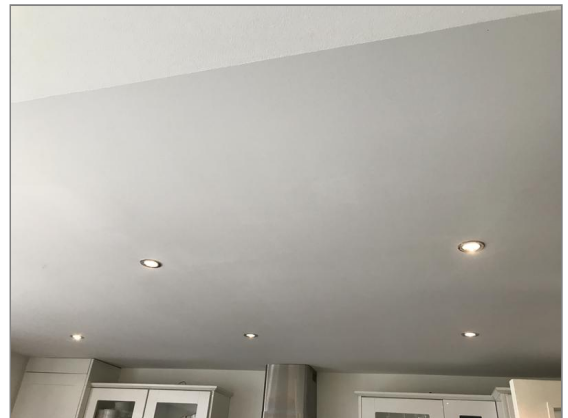
Photo - 101 Kitchen ceiling

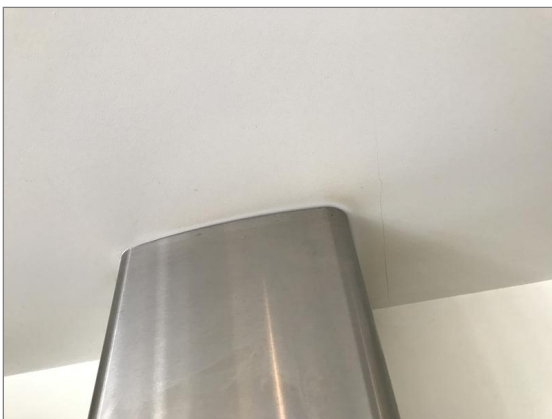
Photo - 102 Kitchen ceiling

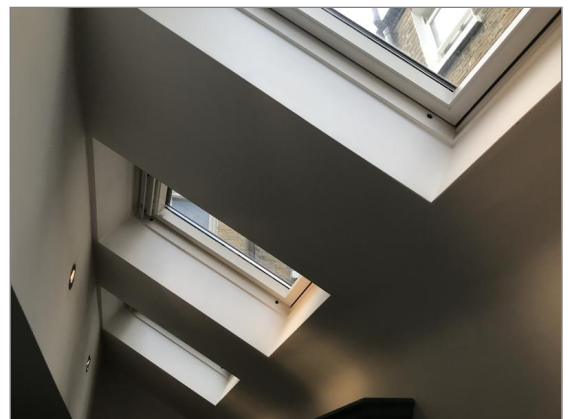
Photo - 103 Side addition ceiling

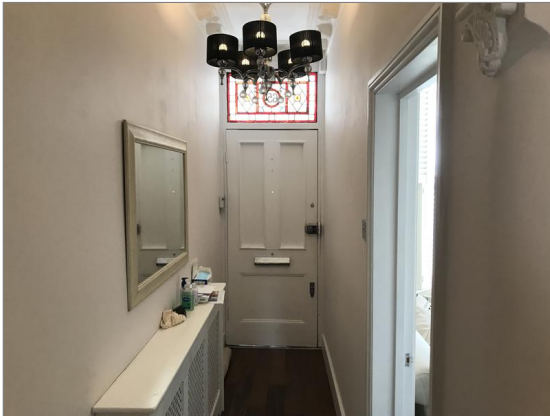
Minor scuffing was found to the walls in the entrance hallway. Otherwise, these surfaces are in fair condition.

Photo - 104 Entrance hallway walls

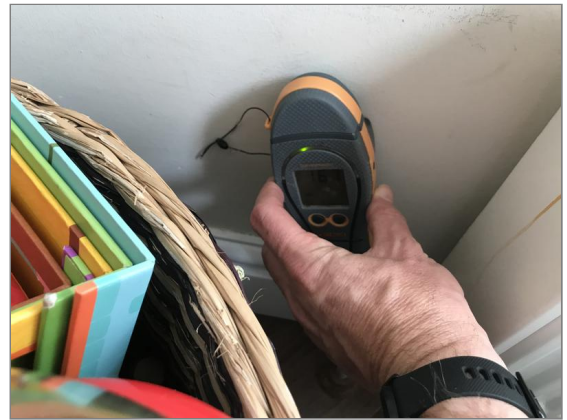
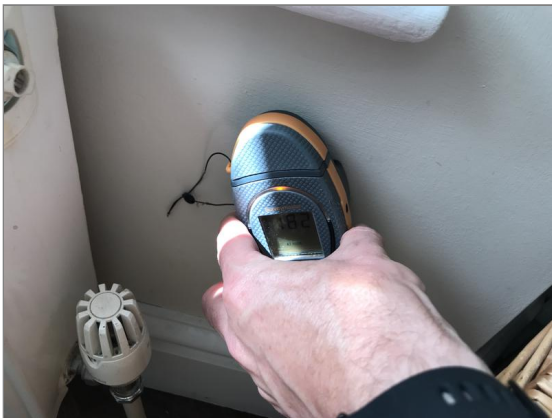
Elevated damp meter readings were recorded to the external face of the bay in the front sitting room. Our readings are consistent with high humidity condensing upon this colder external surface (rather than damp penetration).

Photo - 109 Damp meter testing to front sitting room walls

Photo - 110 Damp meter testing to front sitting room walls

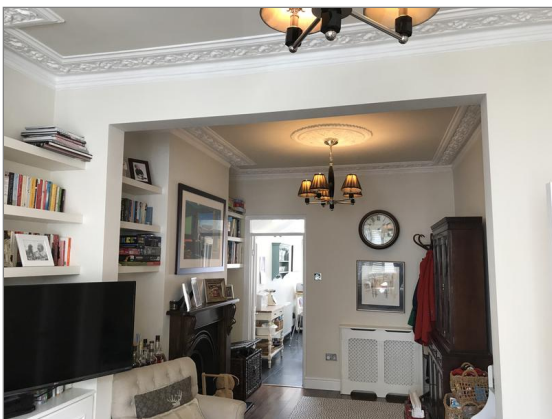
Slight cracking was found to the party wall adjacent to the opening leading from the front to the rear sitting area. This is consistent with normal seasonal movement of the dwelling. The opening formed between the front and rear sitting rooms is likely to be supported by a beam. The Structural Engineer's details relating to the design of this element should be sought from the vendor (if available). No signs of structural insufficiency and/or other wants of repair were identified with this element.

Photo - 112 Opening through to rear sitting room

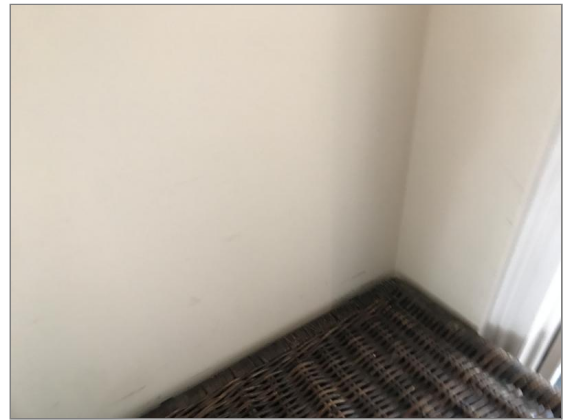
Minor scuffing was noted to the walls in the rear living area. Otherwise, these surfaces are in fair condition.

Photo - 115 Slight scuffing to rear sitting room walls

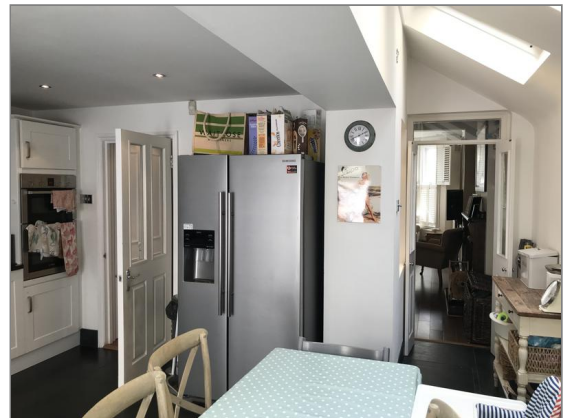
An opening has been formed between the side addition and the kitchen area. This opening will be supported by a steel beam and the Structural Engineer's details for this method of support should be sought from the vendor (if available). No structural insufficiency with this element was noted.

Photo - 117 Opening through to side addition

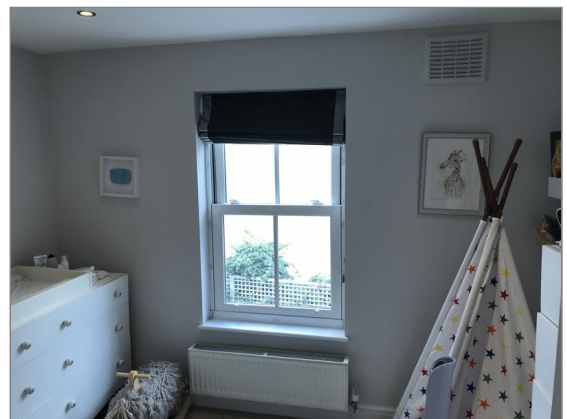
The rear first floor bedroom walls have been affected by water penetration due to leaking from the rainwater goods adjacent to this area. As mentioned, this requires external repair to resolve. The walls also feature decorative stickers and removal of these elements will cause slight damage to the decorations (which will necessitate localised decorative repair).

Photo - 125 Rear first floor bedroom walls

Overall, the walls in the property are in fair condition. That said, a new owner will likely wish to redecorate these surfaces upon occupation of the dwelling. In addition, we recommend that the leaking rainwater goods are repaired and the window sills are redecorated.

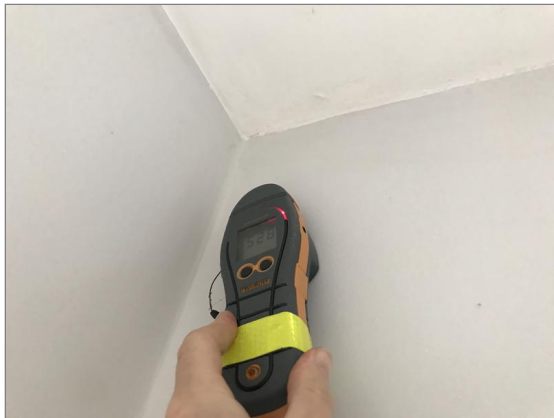
Photo - 126 Dampness to rear first floor bedroom walls

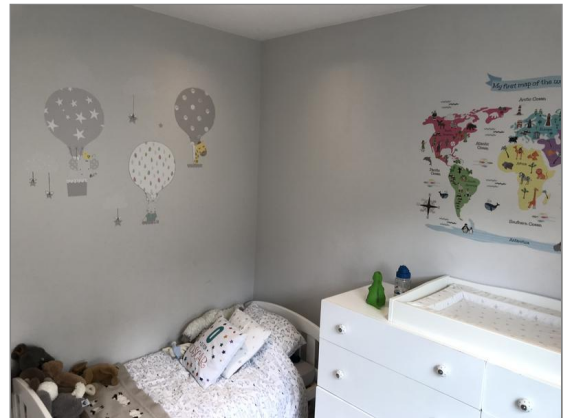
Photo - 127 Decorative decals affixed to rear first floor bedroom walls

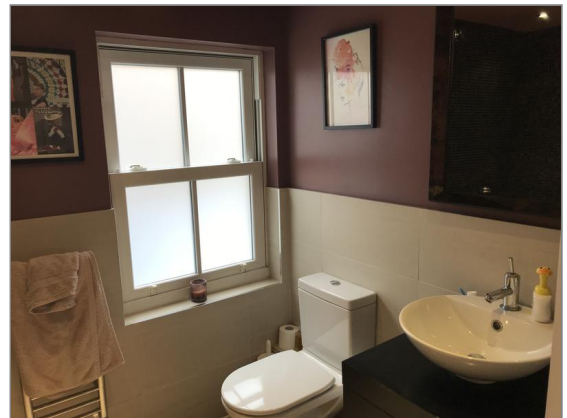
The first floor bathroom walls have been part tiled; mosaic tiles are found within the shower enclosure. No failure of the tiling within the shower enclosure was noted, however, slight movement of the property has caused cracking to grout of the larger format tiles adjacent to the WC. These tiles require re-grouting.

Photo - 129 First floor bathroom walls

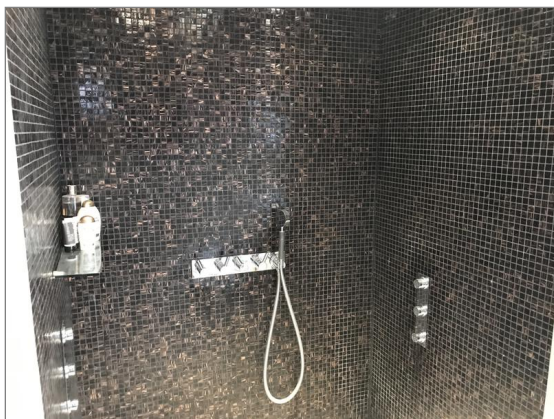
Photo - 130 Tiling to shower enclosure walls

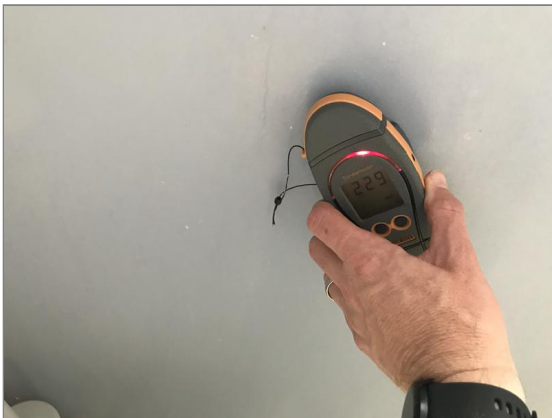
The second floor bathroom walls have been affected by high humidity and we recommend that a humidity activated extract fan is fitted in this space. No failure of the tiling adjacent to the bath fittings was identified.

Photo - 146 Elevated damp meter readings to second floor bathroom walls

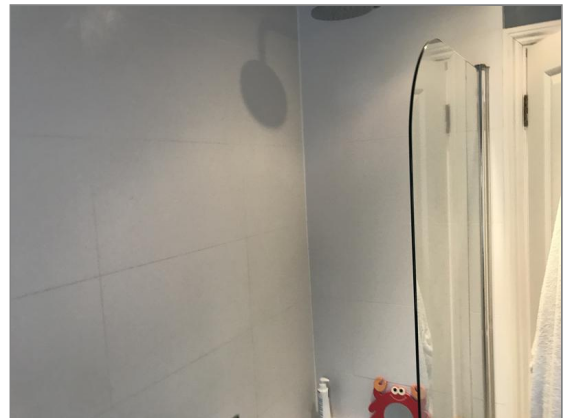
Photo - 147 Tiling within second floor bathroom

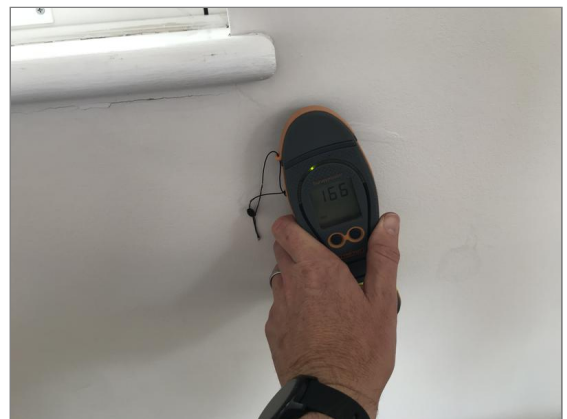
Photo - 149 Damp meter testing to rear second floor bedroom walls

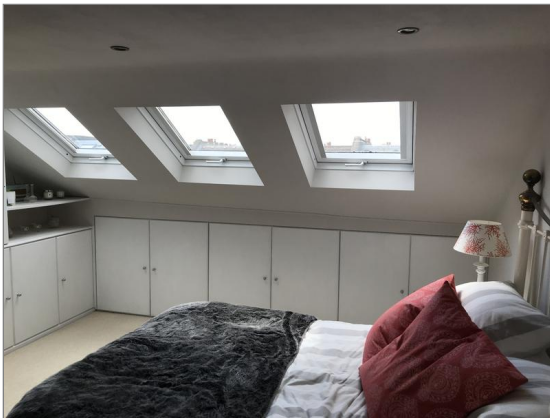
Photo - 150 Larger second floor bedroom walls

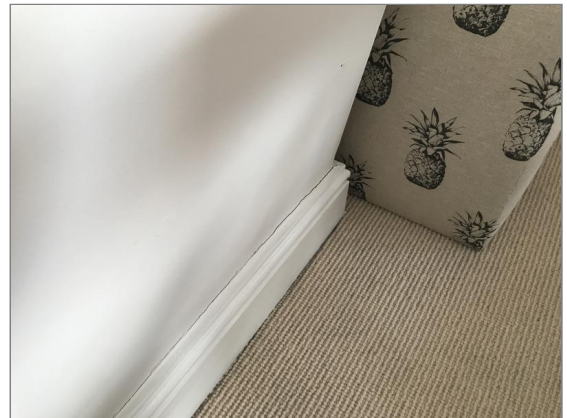
Photo - 151 Larger second floor bedroom walls

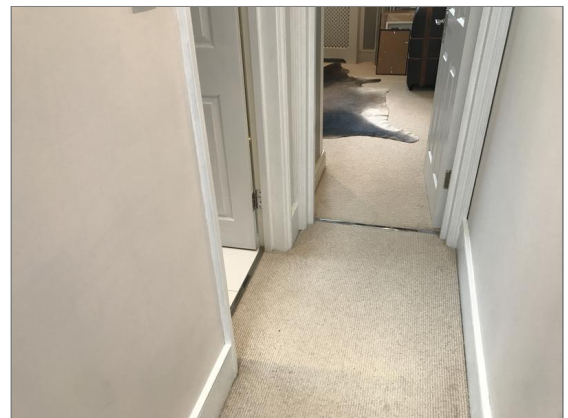
The lower second floor landing features an original suspended timber floor. Slight deflection was noted to this surface and creaking was observed when trafficking the floor (due to deflection of the floorboards). This is typical for a floor of this age and type and can be made good by repairing and replacing the floorboards when the carpet is renewed. The carpet to the landing would benefit from renewal.

Photo - 153 Lower second floor landing level

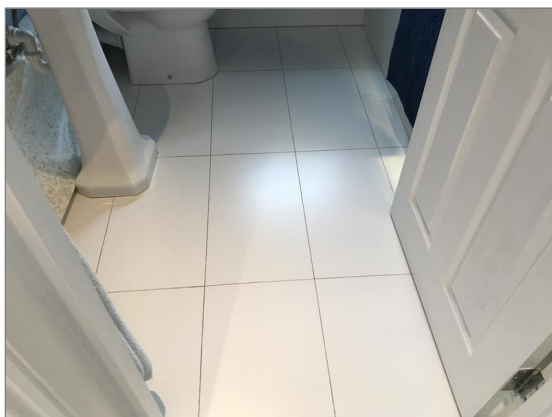
The bathroom at this level features a tiled floor. Slight cracking has developed to the grout between the tiles and this requires raking out and renewal to resolve.

Photo - 154 Tiles to second floor bathroom

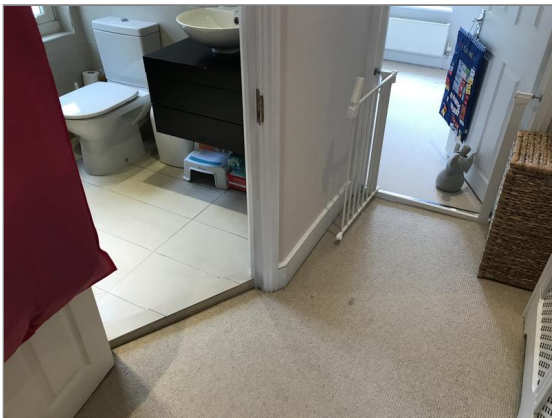
The shower room floor adjacent to the landing has been tiled. There is a failure of the grout to the tiles and a number of loose tiles were found within the shower enclosure. This would require relaying of these elements to resolve.

Photo - 159 Tiling to second floor shower room floor

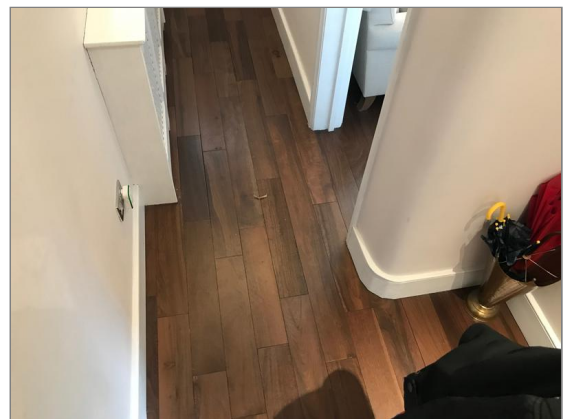
Photo - 161 Entrance hallway tiling

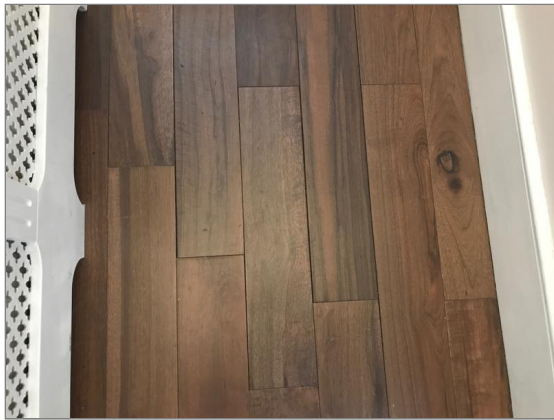
The suspended timber ground floor has been laid with engineered timber flooring. Slight expansion and contraction of the floor has caused some of the floor joists to open up and minor mechanical damage was observed to the surface of the floor. In addition, damage was noted to the threshold strip at the abutment of the living room and kitchen area and this would require replacement of the strip to resolve. Otherwise, no significant wants of repair were found.

Photo - 162 Joints opening up between timber boards to entrance hallway

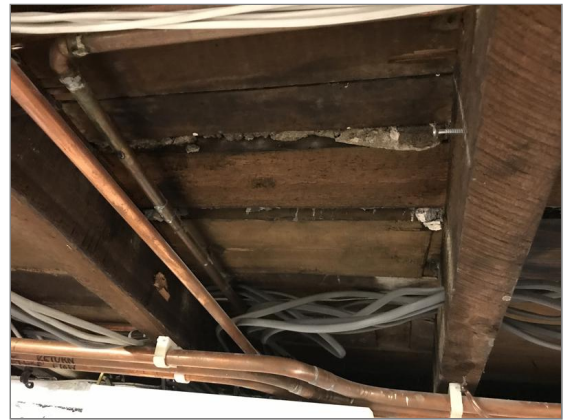
At ground floor level, the living area and entrance hallway feature a suspended timber floor. Ventilation is provided to the sub-floor void through floor vents at the front of the property and via the presence of a basement below this area. As mentioned, the vents lie in close proximity to the external ground and we recommend that a channel drain is introduced at this abutment. No significant deflection or bounce was noted to the floor structure which would indicate a significant structural want of repair.

Photo - 163 Suspended timber floor at ground floor level

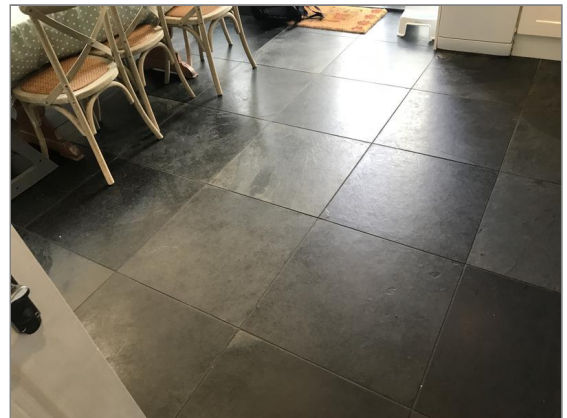
The kitchen and side addition features a solid floor that has been laid with stone tiles. These elements are in fair condition.

Photo - 165 Tiles to kitchen area

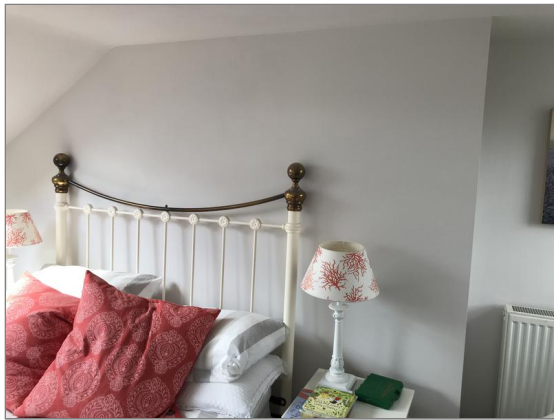
Photo - 166 Chimney breast enclosed in upon at second floor level

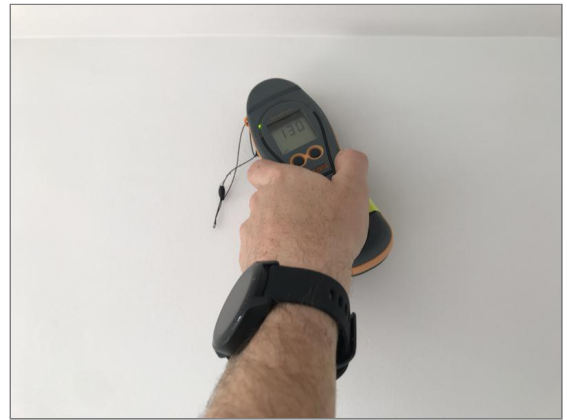
Photo - 167 Damp meter testing to chimney breast at second floor level

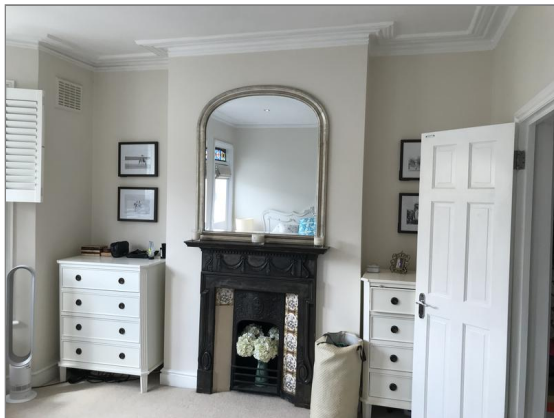
The front master bedroom features an original fireplace. An opening has been formed above the fireplace to allow for ventilation of the flue. A number of the tiles are missing from the side of the chimney breast and a new owner may wish to have these replaced. No structural wants of repair were identified with this element.

Photo - 168 Chimney breast to master bedroom

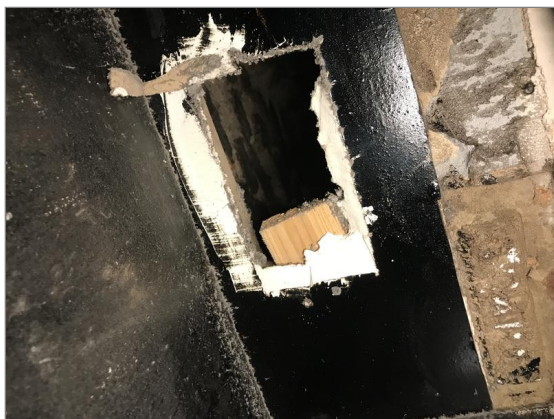
Photo - 170 Ventilation to fireplace in master bedroom

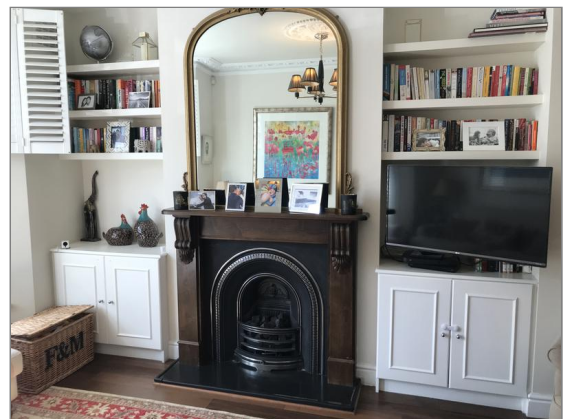
The chimney breasts in the ground floor living areas feature gas fireplaces. These appliances should be tested by a Gas Safe engineer prior to use, however, no significant wants of repair were identified.

Photo - 171 Front sitting room fireplace

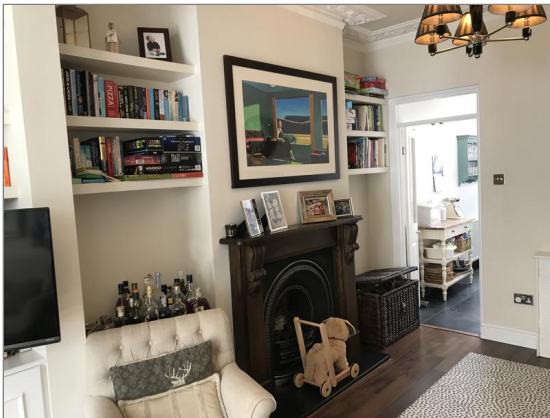
Photo - 172 Rear sitting room fireplace

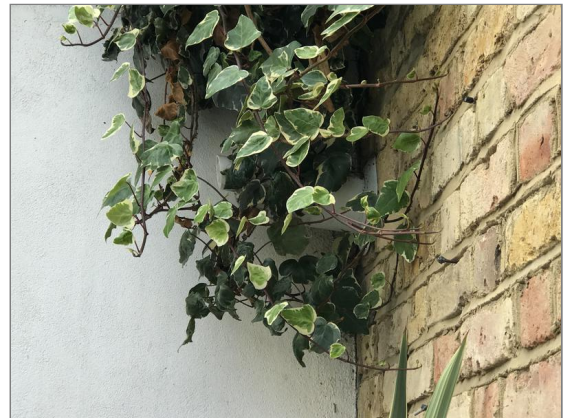
The boiler flue penetrates through the rear wall of the kitchen. There is mature ivy growth around the flue and this should be cut away to allow for adequate ventilation of this element.

Photo - 173 Boiler flue obscured by plant growth

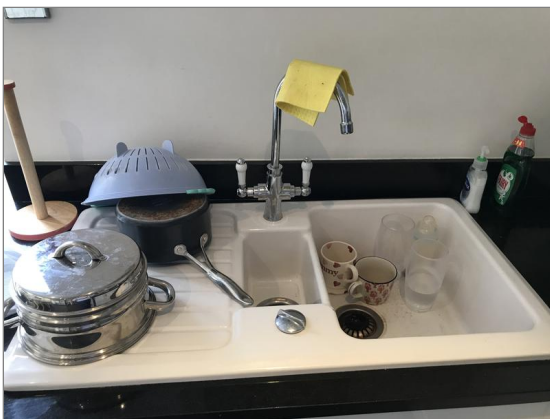
The kitchen features foil faced MDF cabinetry with a manmade stone worktop. The cabinets have been fitted with magnetic child catches (which a new owner may wish to have removed). Minor mechanical damage has been incurred at the edge of some of these fittings and slight water damage was observed to the sink unit. In addition, scuffing has caused staining to the ceramic sink. This will require replacement of these elements to resolve. Otherwise, no significant wants of repair were identified. Going forward, a new owner will likely wish to replace these fittings within the next 2 to 3 years.

Photo - 180 Kitchen sink

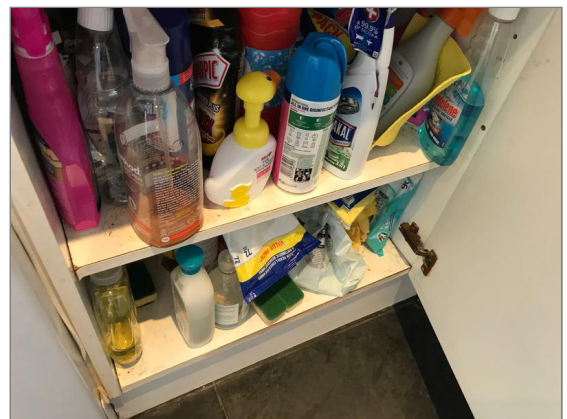
Photo - 181 Kitchen sink cupboard

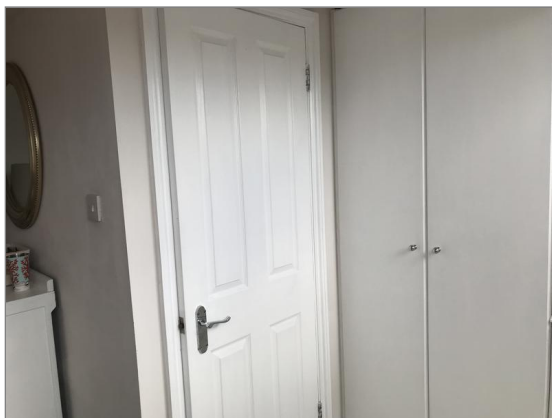
Photo - 183 Bedroom door at second floor level

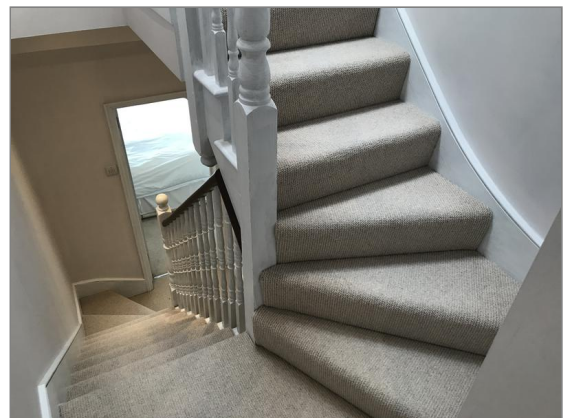
Slight deflection was noted to the stairs due to historic settlement of the building. This does not significantly affect these structures. Minor squeaking was also observed to some of the treads and these can be locally repaired when the floor coverings are next renewed. In addition, the decorations to the spindles are relatively inexpert and a new owner may wish to have these professionally redecorated.

Photo - 184 Stairs going down to first floor level

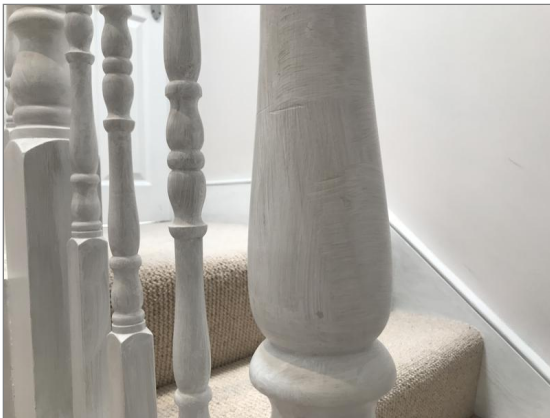
Photo - 185 Inexpert decorations to stairs
