LEVEL 3

Your survey report

L3 Example Street, London, SW

17th October 2022

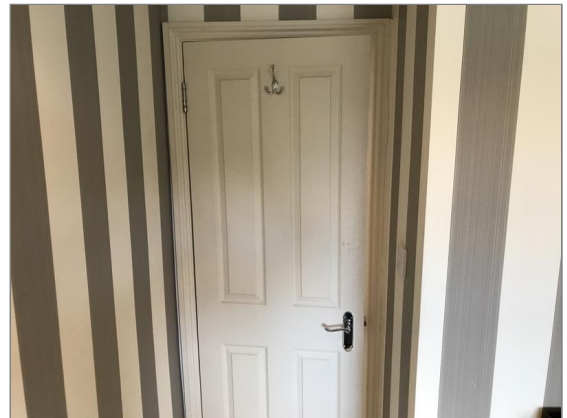
The internal doors are simple timber panelled door sets. The quality of the decorations to these surfaces is relatively inexpert, as is the quality of the decorations to the architraves and skirtings. The rear second floor bedroom door was also found to bind upon its frame. This requires easing of this fitting to resolve. 2

Photo - 186 Door binding upon frame to rear second floor bedroom

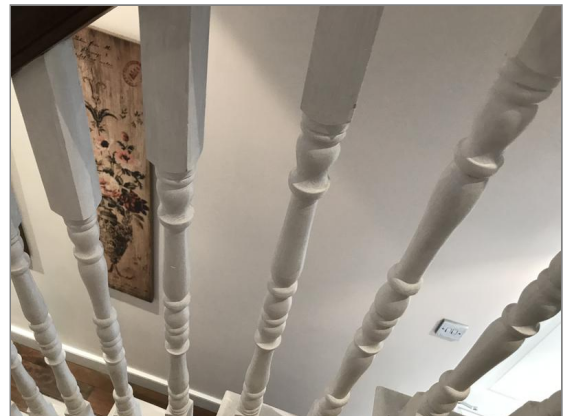
Slight deflection was noted to the stairs due to historic settlement of the building. This does not significantly affect these structures. Minor squeaking was also observed to some of the treads and these can be locally repaired when the floor coverings are next renewed. In addition, the decorations to the spindles are relatively inexpert and a new owner may wish to have these professionally redecorated.

Photo - 188 Inexpert decorations to stairs

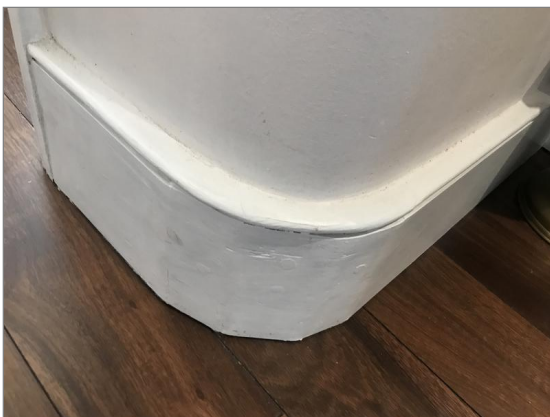
Photo - 189 Scuffing to skirtings at ground floor level

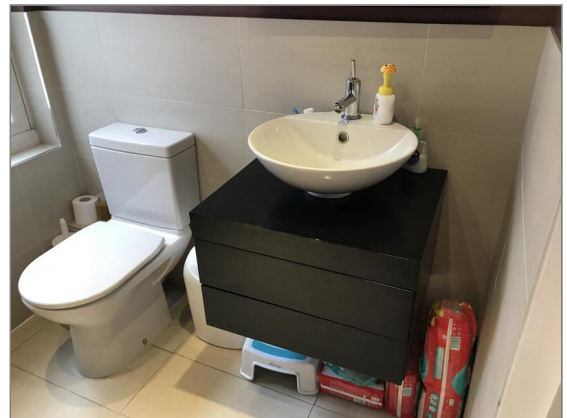
Photo - 197 First floor shower room fittings

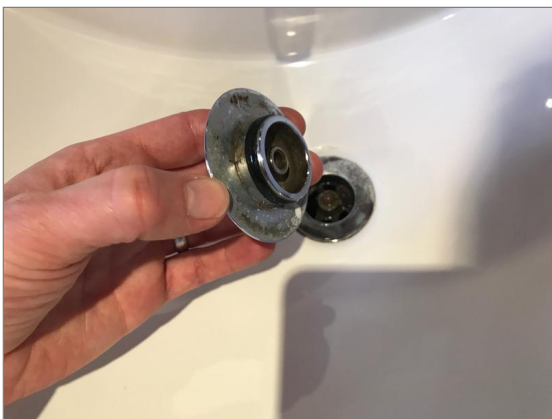
Photo - 198 First floor shower room fittings

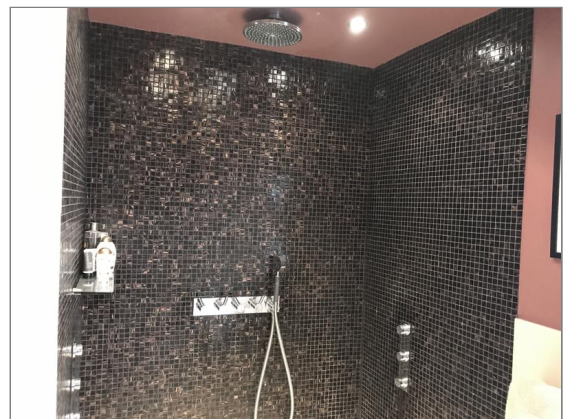
Photo - 199 First floor shower room fittings

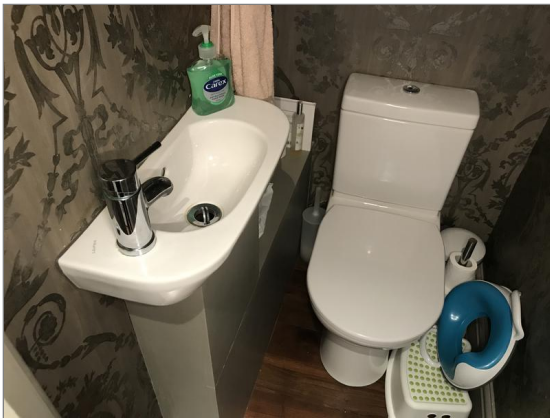
Photo - 200 Ground floor WC fittings

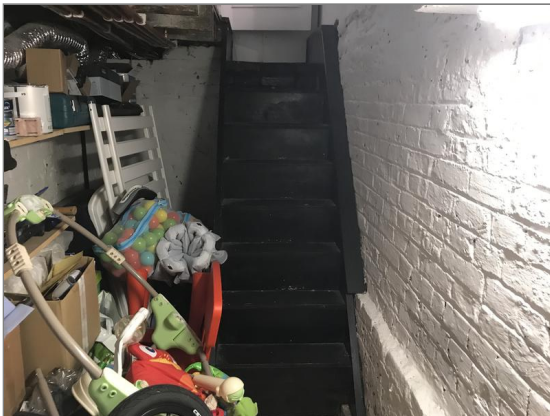
The property features a basement which is accessed via stairs from the entrance hallway. The stairs are relatively steep and uneven and a new owner may wish to have the staircase renewed. Despite this, no structural wants of repair were identified.

Photo - 201 Stairs leading down to basement

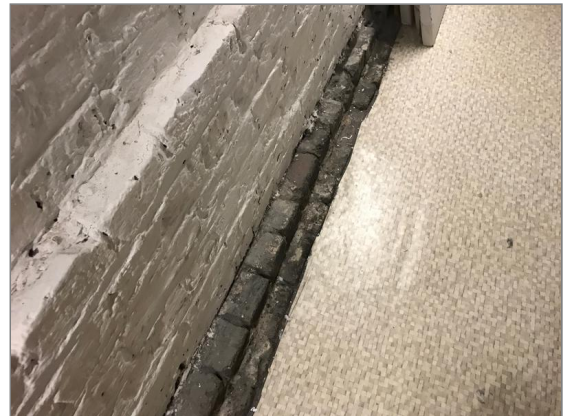
The floor of the basement has been covered with cement and overlaid with vinyl. The exposed brickwork walls have been painted. Whilst the basement does not benefit from a tanking system, no significant areas of water penetration through the walls were identified and the basement is drier than normal for a basement of this type.

Photo - 202 Exposed brickwork walls in basement

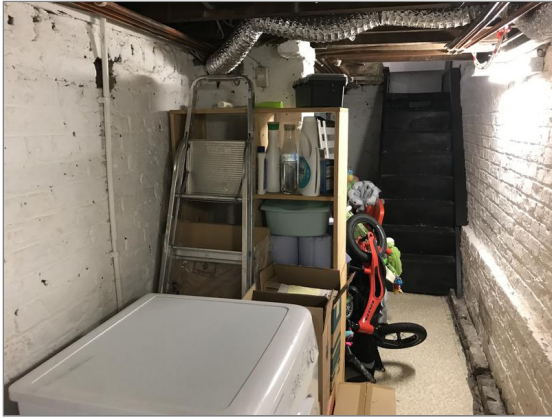
Photo - 203 Basement

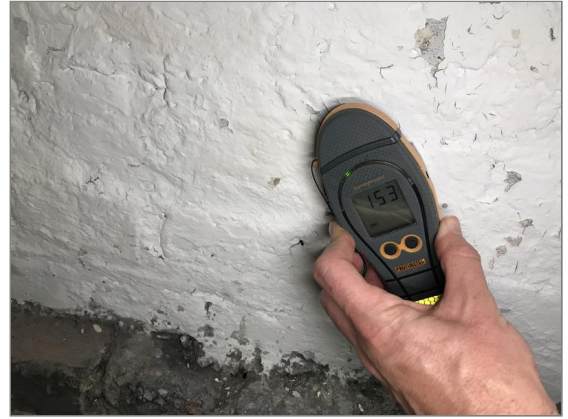
Photo - 204 Damp meter testing to walls in basement

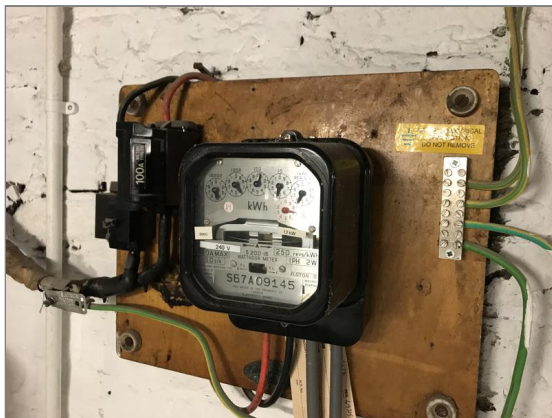
The property benefits from a 100amp incoming main which is sufficient for a dwelling of this size. The property features a part RCD protected distribution board. Going forward, a new owner may wish to replace this with a fully RCD protected device to provide optimum protection from fire and shock.

Photo - 205 Incoming main and meter

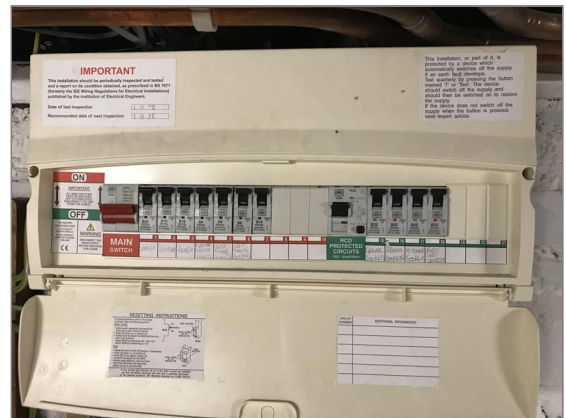
Photo - 206 Distribution board

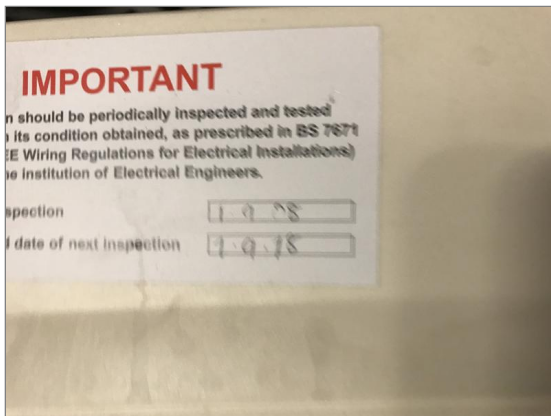
Photo - 207 Date of installation of distribution board

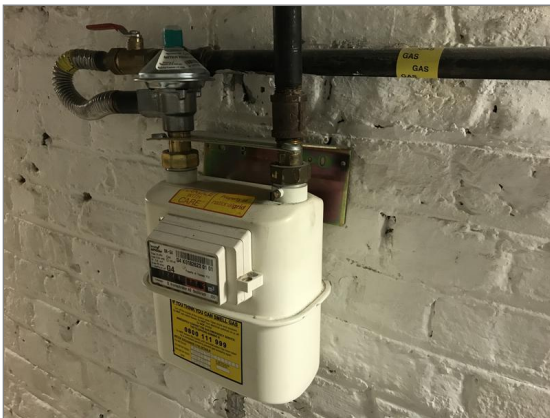
The gas meter is located in the basement of the property and this supplies gas to the hob and combination boiler in the kitchen. We tested the flow of gas by running all five burners to the hob and a good flow of gas was provided. We have no concerns with this installation.

Photo - 208 Gas meter

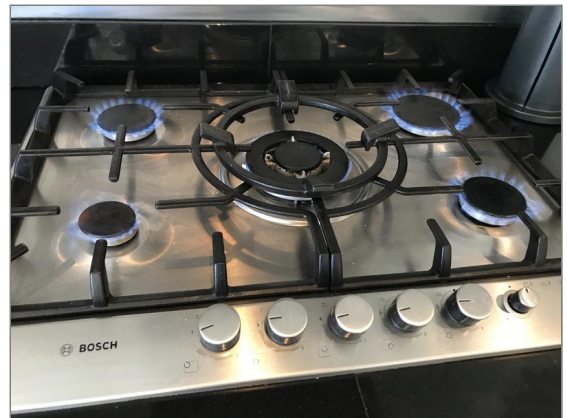
Photo - 209 Testing gas supply to hob

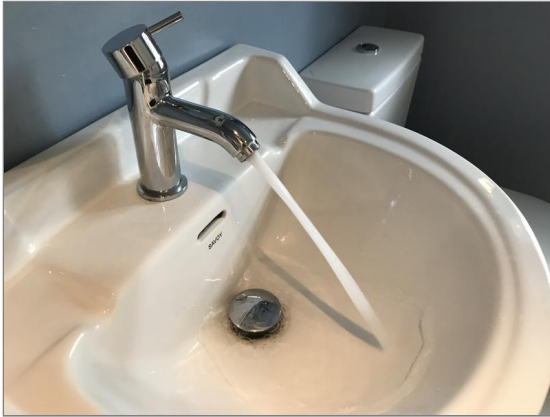
Water is supplied to the cold water outlets under direct mains pressure. We tested the flow of water by opening one and then two outlets. A slight drop in supply pressure was found on opening the second outlet, however, this is typical for systems of this type.

Photo - 210 Testing cold water supply with one outlet open

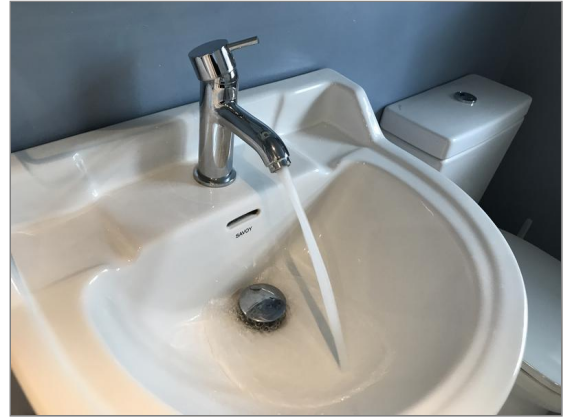
Photo - 211 Testing cold water supply with two outlets open

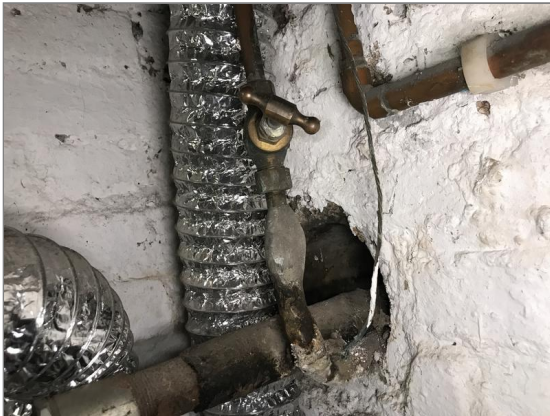
We noted that the incoming main is of lead and a new owner may wish to replace this with a plastic main (due to the health risks associated with lead). This will also provide the opportunity to install a large capacity main which would improve the cold water pressure within the property.

Photo - 212 Incoming lead main

We recommend that the lead water main is replaced with a plastic incoming main due to the health risks associated with this material.

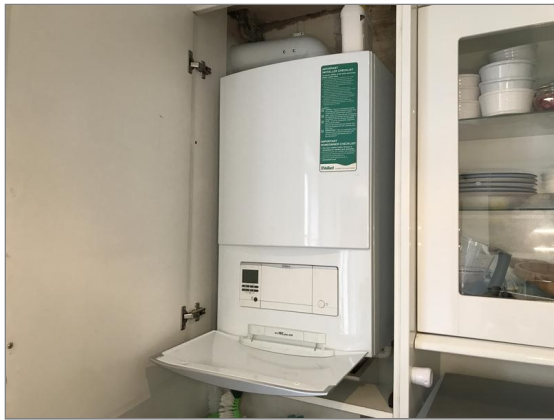
The property is heated by a gas fired boiler which is located in the kitchen. The boiler was found to respond to calls for heat and it should not require renewal for the next 5 years.

Photo - 213 Boiler

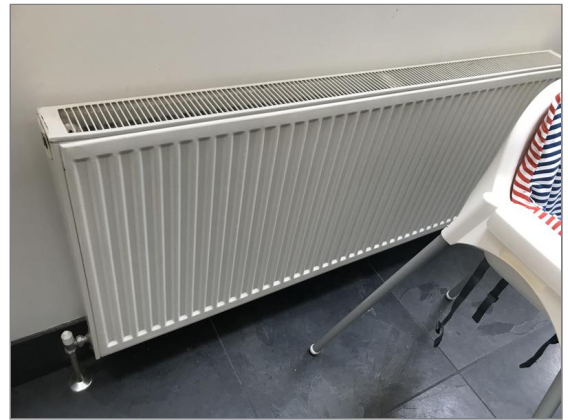
The boiler supplies hot water to radiators throughout the property. No areas of leaking and/or other significant wants of repair were identified with the radiators. We would expect these fittings to require renewal at the same time as the boiler.

Photo - 214 Radiator

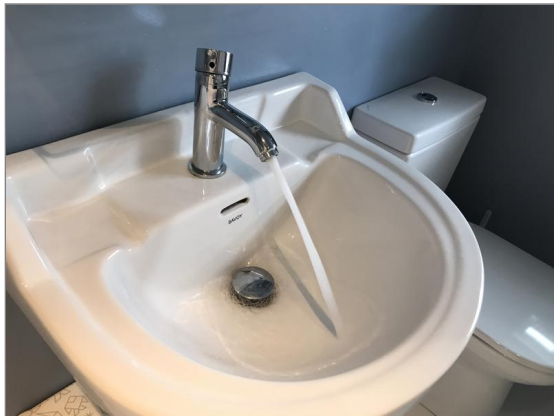
The property features a large capacity hot water cylinder in the basement. We tested the flow of hot water by opening one and then two outlets and a good flow of water was provided. This system is sufficient for a dwelling of this size and it should not require renewal for the next 5 years.

Photo - 215 Testing hot water supply with one outlet open

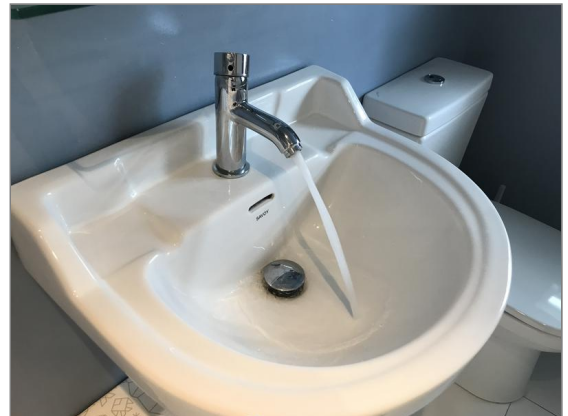
Photo - 216 Testing hot water supply with two outlets open

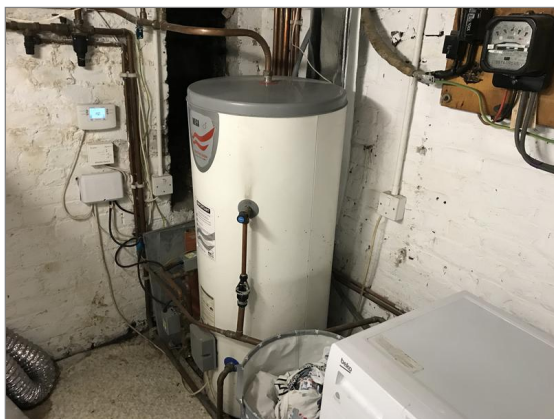
Photo - 217 Hot water cylinder in basement

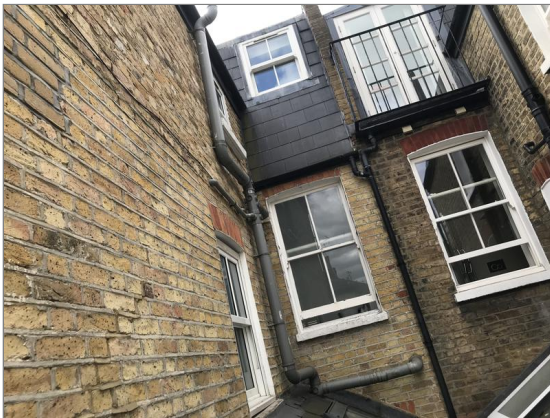
The drainage is connected to a soil stack that runs down the rear face of the property. This stack is boxed into the rear of the kitchen extension, before running out to an inspection chamber in the rear garden. The inspection chamber is paved with inset paving and we were unable to lift the lid to the chamber to complete an inspection of the subsurface drainage. During the inspection, the WCs were observed to flow readily away and no visual wants of repair were identified with this element.

Photo - 218 Soil pipe at rear of property

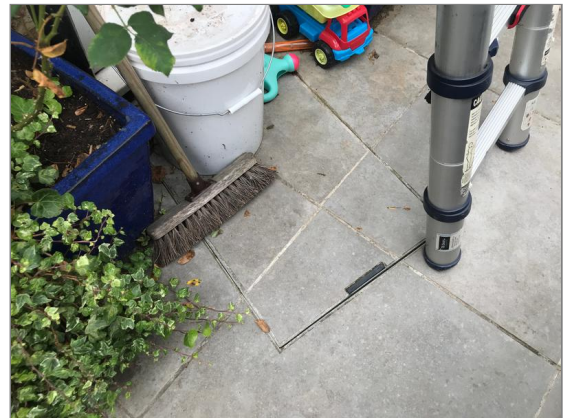
Photo - 219 Inspection chamber in rear garden

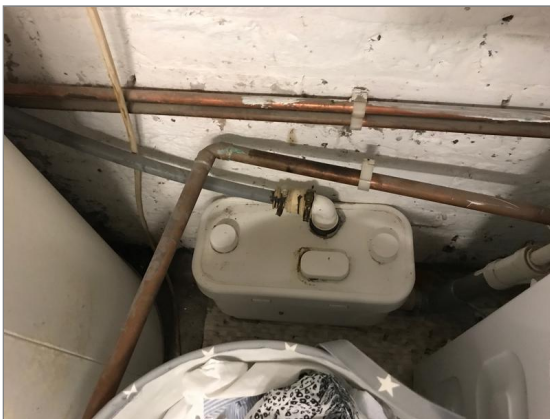
The wastewater pipework in the basement is connected to a pump unit that drives wastewater into the drainage at ground level. This unit will require annual servicing to ensure its function. We have no significant concerns with this service.

Photo - 220 Saniflo unit in basement

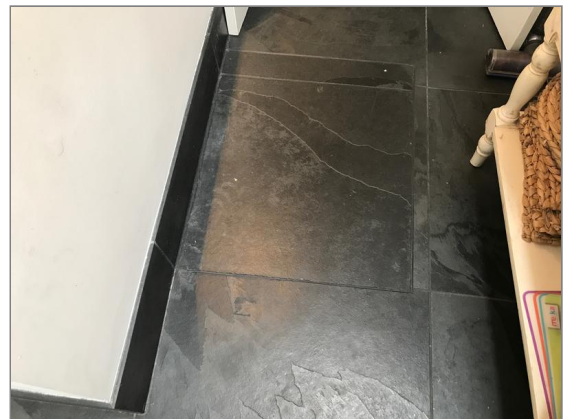
Photo - 221 Inspection chamber set into kitchen floor

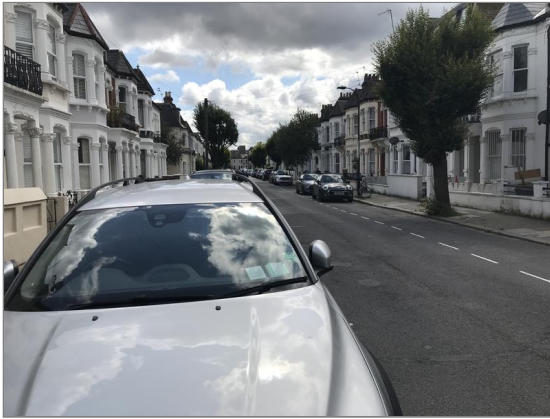
The property does not feature a garage, however, on-street, permit controlled parking is available on the road to the front of the dwelling.

Photo - 222 Permit controlled parking to front of property

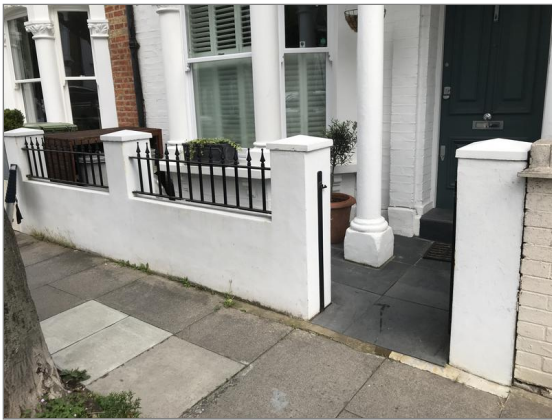
Photo - 223 Front garden

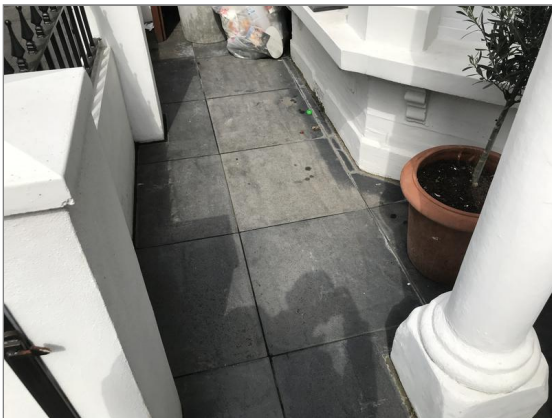
The front garden has been covered with paving. The paving directly abuts the external walls of the property. As mentioned, ideally, a channel drain should be introduced at this junction to remove water from the walls. A timber bin store is found in the front garden. The decorations to the structure are failing and require renewal.

Photo - 225 Paving in front garden

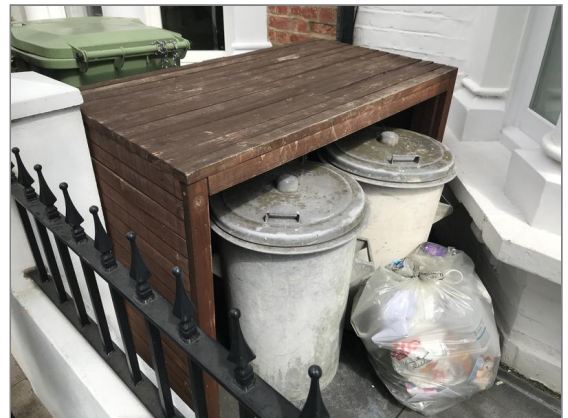
Photo - 226 Bin store in front garden

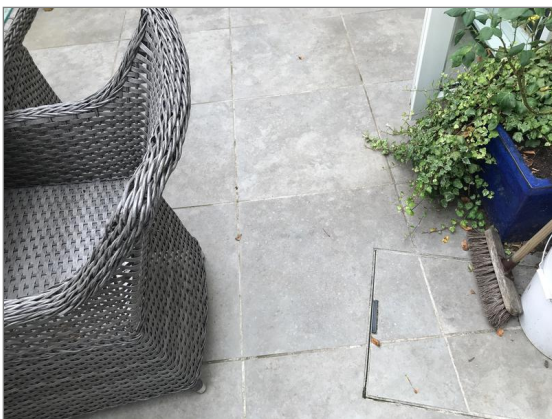
The rear garden has been fully paved. A channel drain has been introduced at the edge of this element to drain water from its surface. This should be cleared to ensure the free draining of this element.

Photo - 227 Paving in rear garden

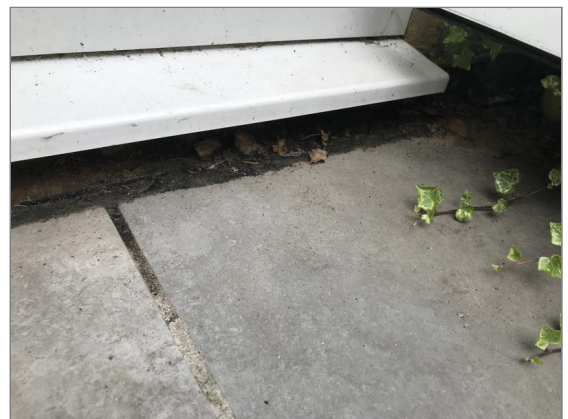
Photo - 228 Channel drain in rear garden

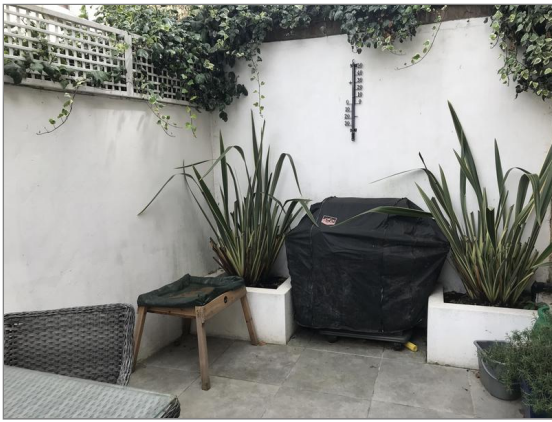
The walls surrounding the rear garden have been rendered and painted. These surfaces are in fair decorative condition and should not require redecoration for the next 2 to 3 years.

Photo - 229 Walls in rear garden

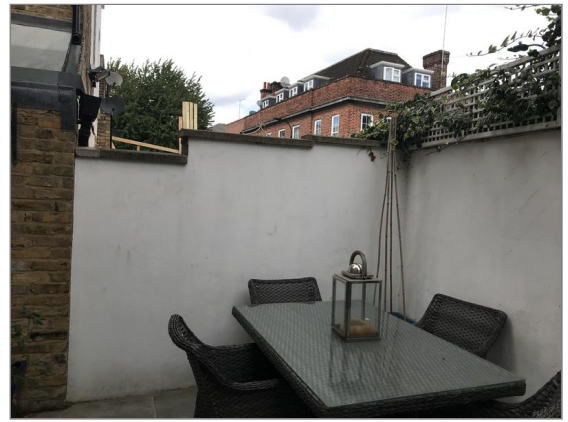
Photo - 230 Rear garden walls
