LEVEL 1

Your survey report

L1 Example Street, London, SW

17th October 2022

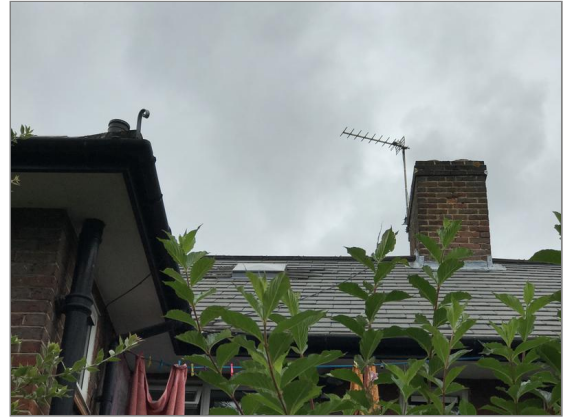
The property features a pitched timber framed roof and this roof has been clad with slate. These roof coverings look to have been renewed in the last 20 years. No failure of the slates was identified and renewal of these roof coverings should not be required for the next 20 years.

Photo - 8 Rear pitched roof coverings.

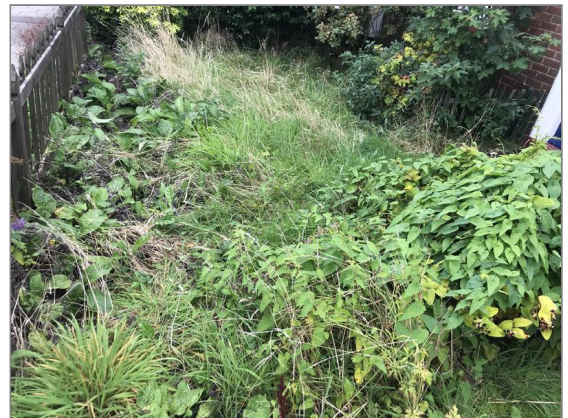
The grounds to the property are overgrown and a new owner will likely wish to have these plants cut back. The front garden is bordered by a low timber fence and this element is tired. In addition, cracking has developed to the oversite concrete path running around the front and side of the dwelling. (2)

Photo - 121 Front garden.

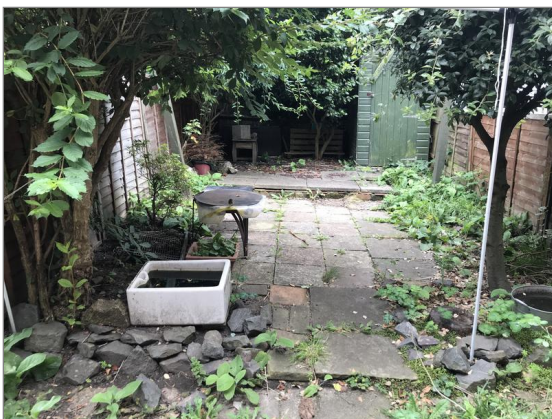
The rear garden has been inexpertly paved and the paving does not look to have been laid onto a suitable sub base. This will require relaying of the paving to resolve. There is a timber shed to the rear of the garden. The roof covering to this shed has failed and this structure requires renewal. The fencing in the rear garden would also benefit from repair. An area of orange quarry tiling is found to the rear of the dwelling. This tiling would benefit from being relaid.

Photo - 122 Rear garden.
