# Your survey report

L2 Example Street, London, SW

17th October 2022

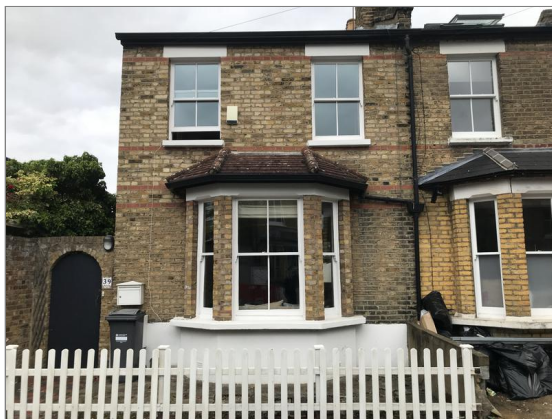
*Photo - 28 Front elevation of the property.*

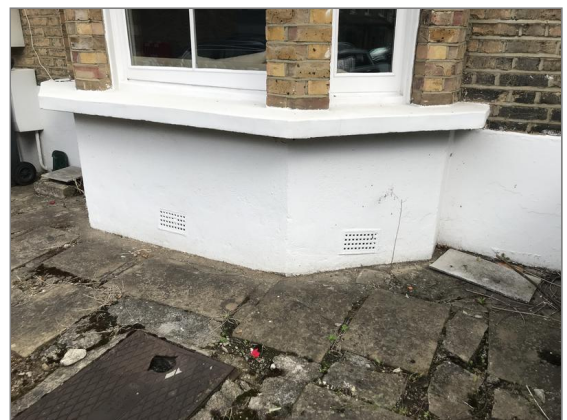
*Photo - 31 Rendered face of bay.*

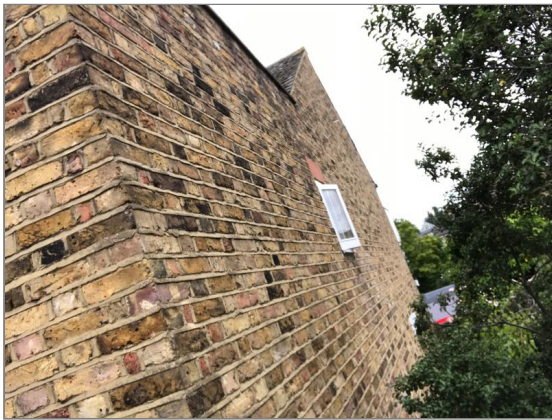
*Photo - 32 Flank wall of property.*

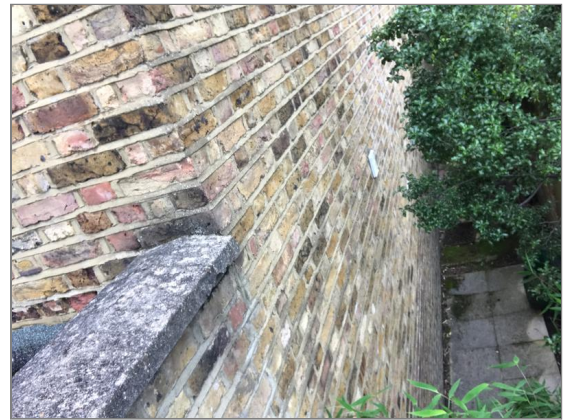
*Photo - 33 Flank wall of property.*

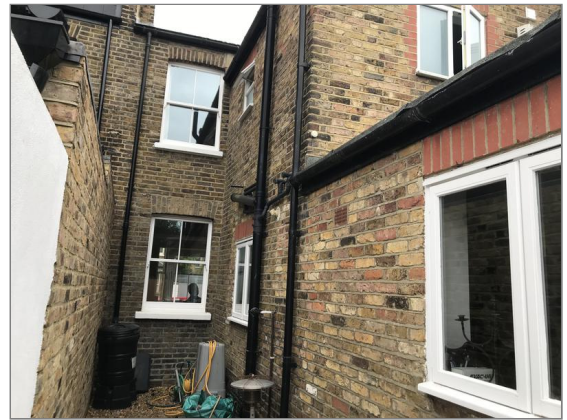
*Photo - 39 Walls at the back of the property.*

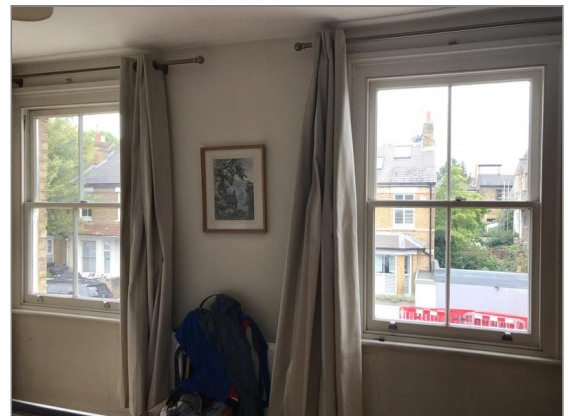
*Photo - 44 Front bedroom windows.*

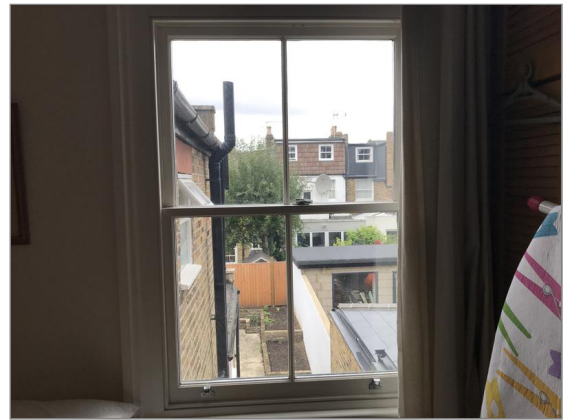
*Photo - 46 Rear bedroom window.*

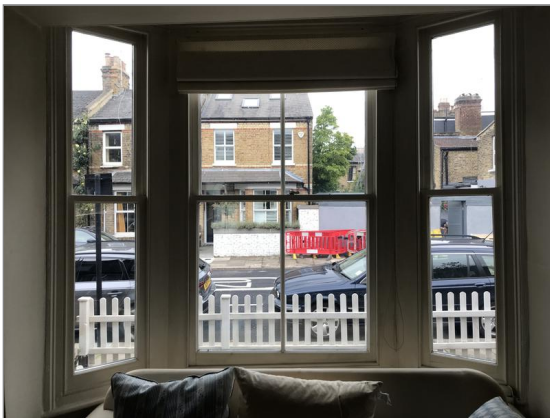
*Photo - 53 Living room window.*

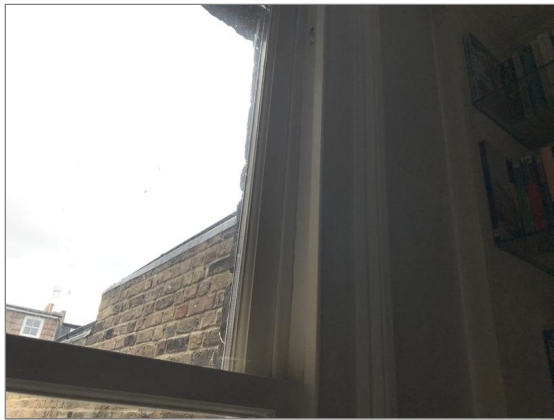
There is a double glazed timber framed sliding sash window at the rear of the living area. Again, the counter-weight mechanisms to this window have been removed and a new owner may wish to have these replaced. Redecoration of this fitting will be required within the next 18 months.

*Photo - 57 Counter-weight mechanism removed from rear living room window.*

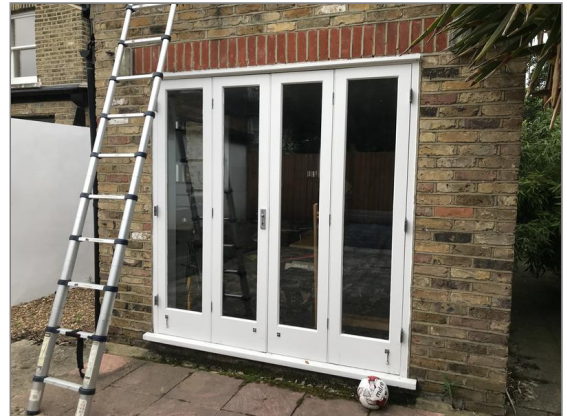
Double glazed timber framed folding doors lead out from the kitchen into the garden. Due to the items stored against the doors, we were unable to open them, however, no failure of the double glazing was identified. The external door handle to these fittings has failed and requires replacement. Redecoration of the doors should not be required for the next 24 months.

*Photo - 65 Folding doors leading to garden.*

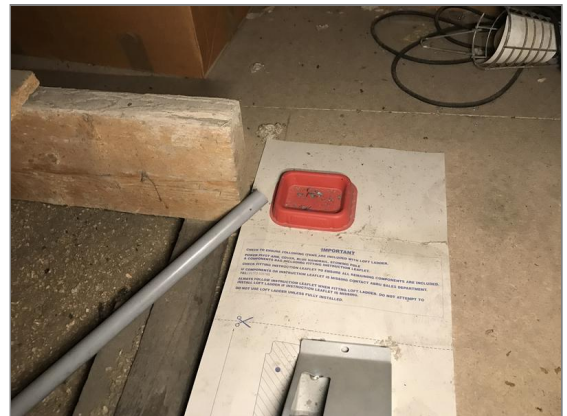
No significant deflection of the roof timbers was noted in this space, however, we did find evidence of water penetration around the chimney stacks. This will require the renewal of the flashings to these elements to resolve. Humidity staining was also noted to the roof timbers, indicating a lack of ventilation to this space. When the roof coverings are renewed, we recommend that they are laid onto a breathable membrane to allow for moisture to more readily escape the void. We also observed the presence of numerous mouse bait traps which indicates an active rodent infestation in the property.

Photo - 73 Mouse bait in loft void.

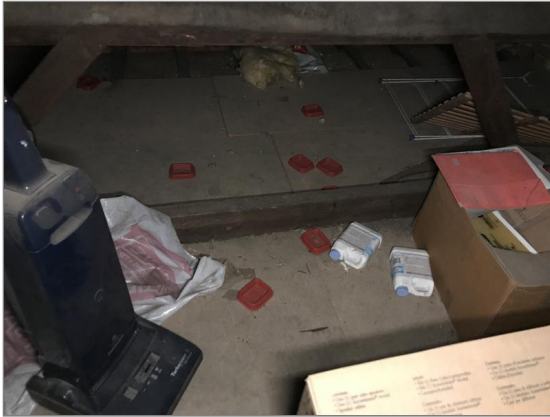
Photo - 74 Mouse bait in loft void.

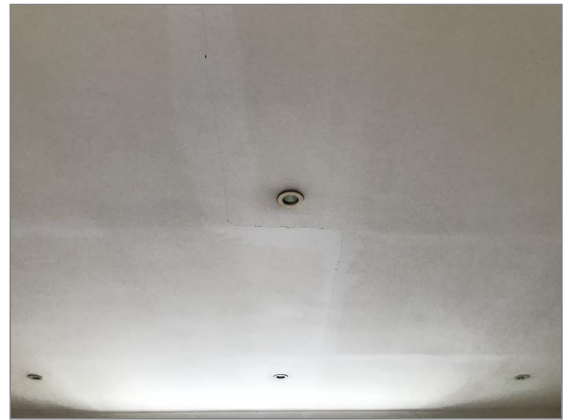
At ground level, cracking was also found to the ceiling in the living area. This has resulted at the joints of the plasterboard and can be made good when these surfaces are redecorated. The ground floor hallway ceiling is in slightly tired decorative condition and would benefit from redecoration

*Photo - 89 Front sitting room ceiling.*

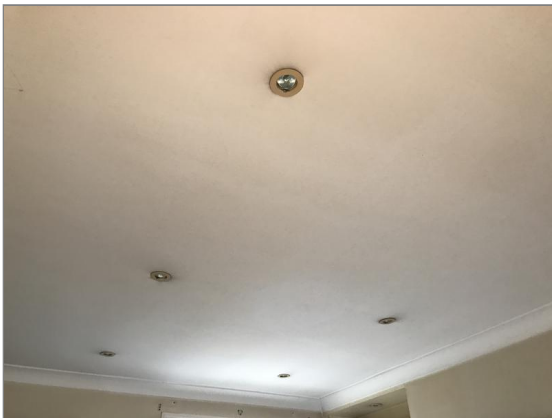
*Photo - 90 Rear sitting room ceiling.*

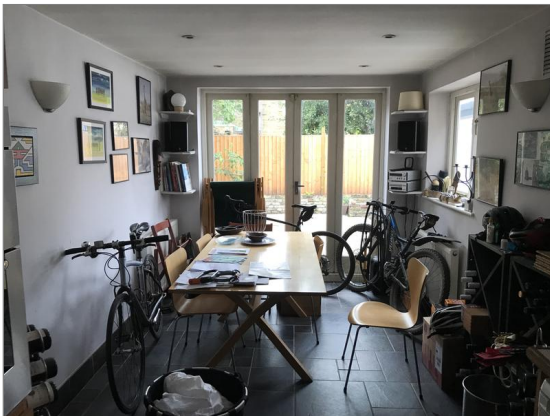
The rear dining area walls are in tired decorative condition. Cracking has developed to the surface of the walls, indicating slight movement of the back left hand corner of this structure. If an extension is to be carried out, then the depth of the foundations should be examined and reinforced as required. No significant areas of damp penetration through these walls were identified, however, the surfaces have been affected by high humidity. We recommend that a humidity activated extract fan is fitted in this space to improve the control of humidity in this area.

*Photo - 95 Dining area walls.*

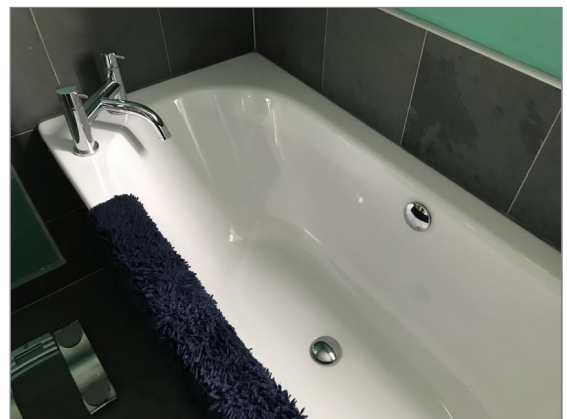
The property features a WC and a separate bathroom. The fittings in these spaces are tired and we recommend that these suites are renewed in the near future. As mentioned in E2, evidence of previous leaking from the shower tray was identified.

Photo - 156 WC fittings.

Photo - 157 Bath fittings.

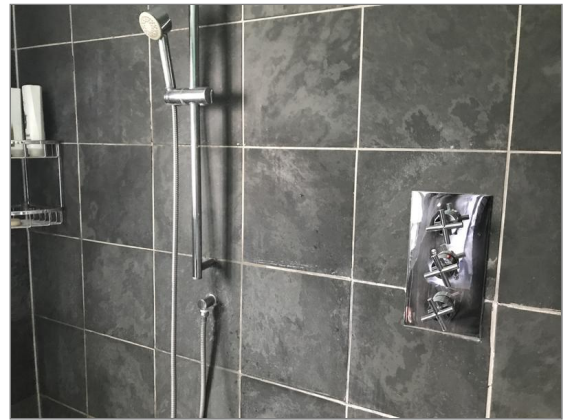
*Photo - 159 Shower fittings.*

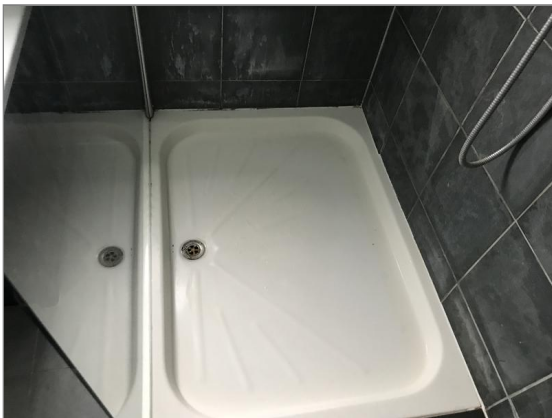
*Photo - 160 Shower tray.*

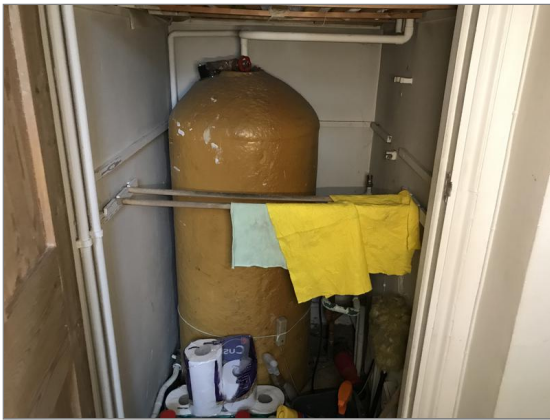
The property features a hot water cylinder located adjacent to the first floor landing. The cylinder has reached the end of its life and water damage to the flooring adjacent to the hot water cylinder was found. We recommend that the cylinder is renewed in the near future. Despite its age, the system was able to supply an adequate volume of hot water.

Photo - 173 Hot water cylinder

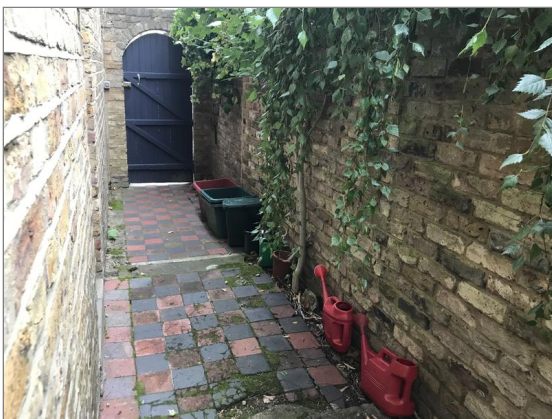
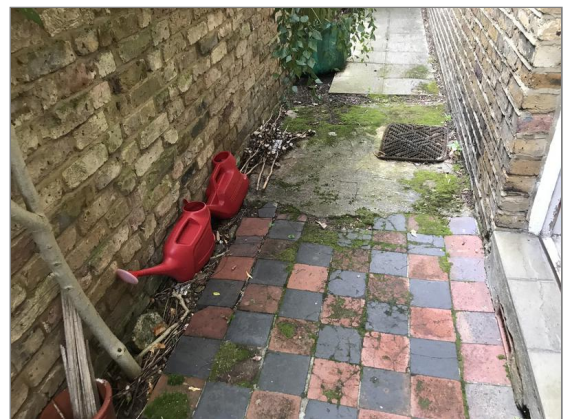
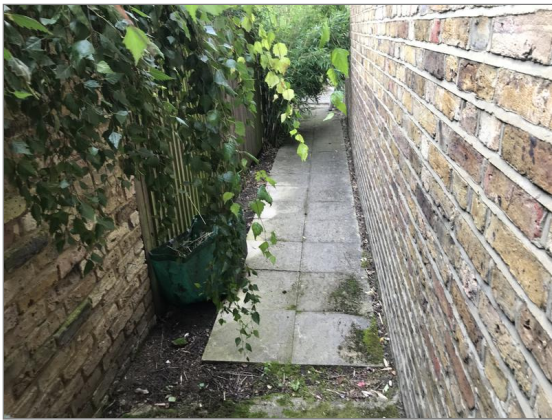
The paving to the side passageway is in poor condition and requires renewal. The paving slabs have been laid directly onto the soil (with a suitable sub-base).

*Photo - 186 Paving to the side of the property.*

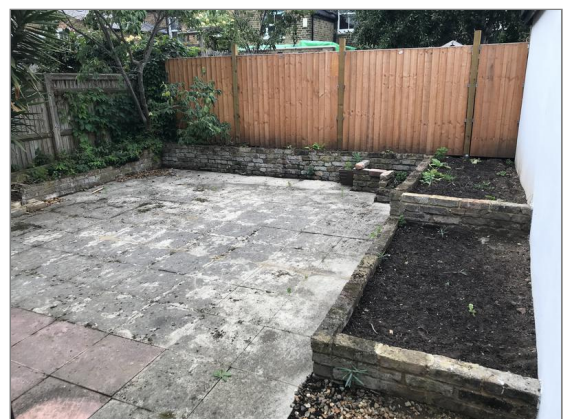
The rear garden area also features paving and this requires re-laying. A low border has been formed around the garden and this comprises a low brickwork wall. Mature plant growth has caused damage to this wall and it requires repair.

*Photo - 193 Rear garden walls.*
